# BARNSTABLE HISTORICAL COMMISSION

**November 17, 2020**

<b>2</b>	Agenda
<b>4</b>	NOID – 671 Old Post Road <i>Page 44 – Parcel Detail</i> <i>Page 51 – home inspection</i>
<b>133</b>	Correspondence – Planning Board, Regulatory Agreement
<b>174</b>	2021 Hearing & Deadline Schedule

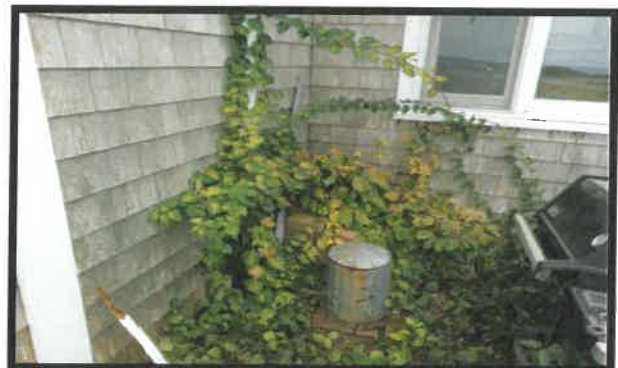
Detached gutter/drainage pipe, allowing diversion of moisture to other external surfaces of the home.

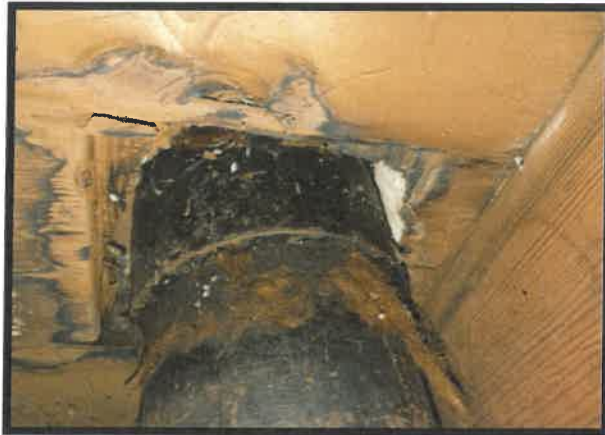
Water staining/damage on First Floor subfloor, as viewed by the basement.

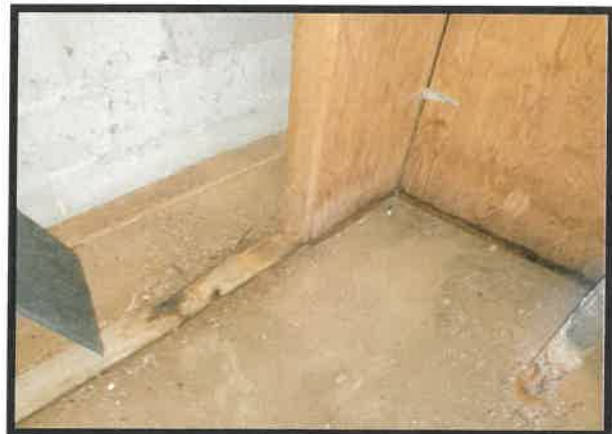
Evidence of moisture intrusion, water staining, and VMC at the base of wooden structures in the Basement.

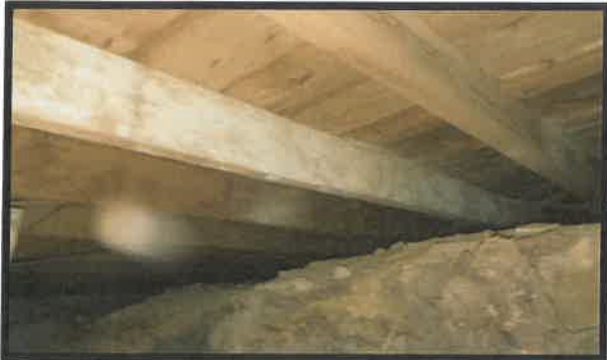
**PHOTO SUMMARY**  
 VMC located on floor joist above small crawlspace. Note the inaccessible areas in the crawlspace.

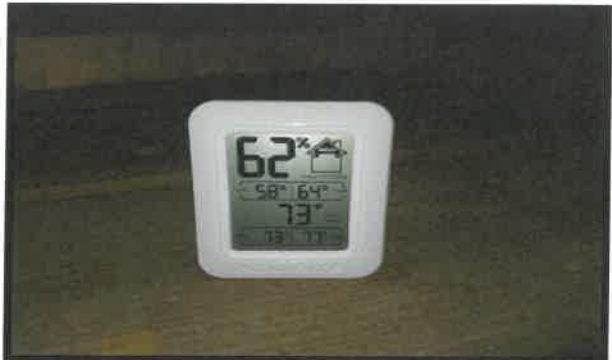
**PHOTO SUMMARY**  
 Elevated Humidity and temperature readings of the Basement. (EPA recommends 30%-60% for humidity levels and ideally between 30%-50%).

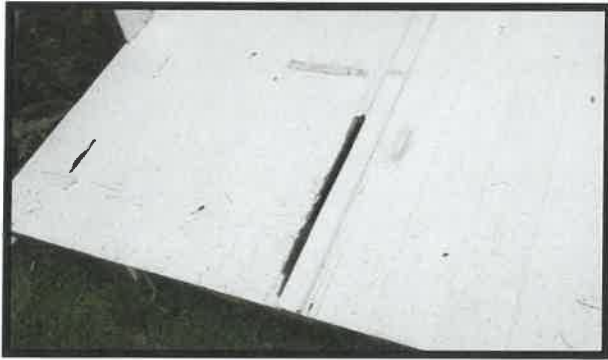
**PHOTO SUMMARY**  
 Damaged Bulkhead door, a suspected area for water/moisture intrusion.

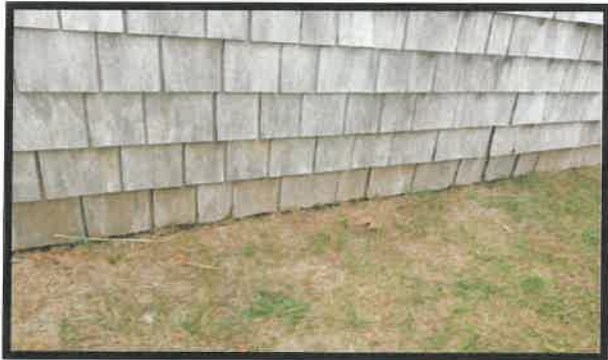
**PHOTO SUMMARY**  
 Damaged shingles at the base of the exterior walls, due to proximity of soil/vegetation.

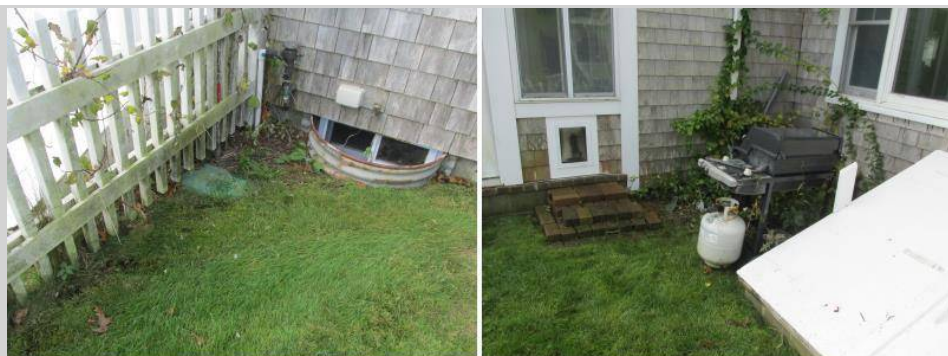
Observation: MANY areas of reversed grading are present along the perimeter of the foundation.

Recommendation: The grade of the landscaping should be elevated so that water will drain away from the home by gravity flow. When it is not feasible to elevate the grade along the foundation without contacting the siding, trim or basement windows; (LIKE IN THIS CASE) it will be necessary to try a different tact such as: (1) Lower the grade and pitch the soil away to remove surface water or (2) install a buried perimeter "French drain" around the foundation or (3) add a well placed "swale" or "berm" in the yard.

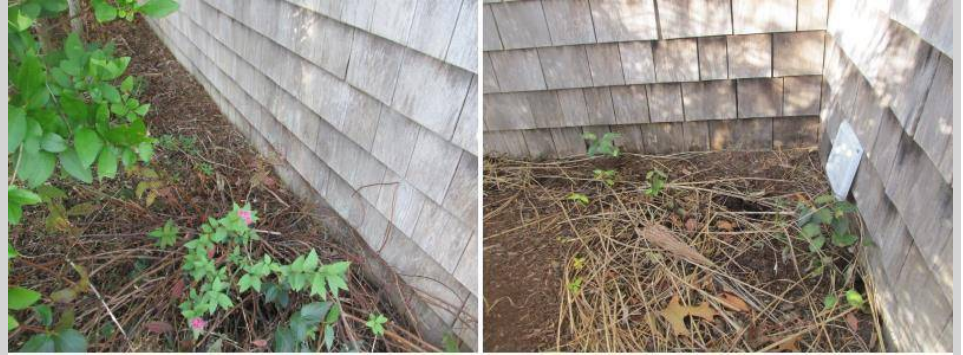
Observation: Areas of the siding & trim are in direct soil contact or close proximity.

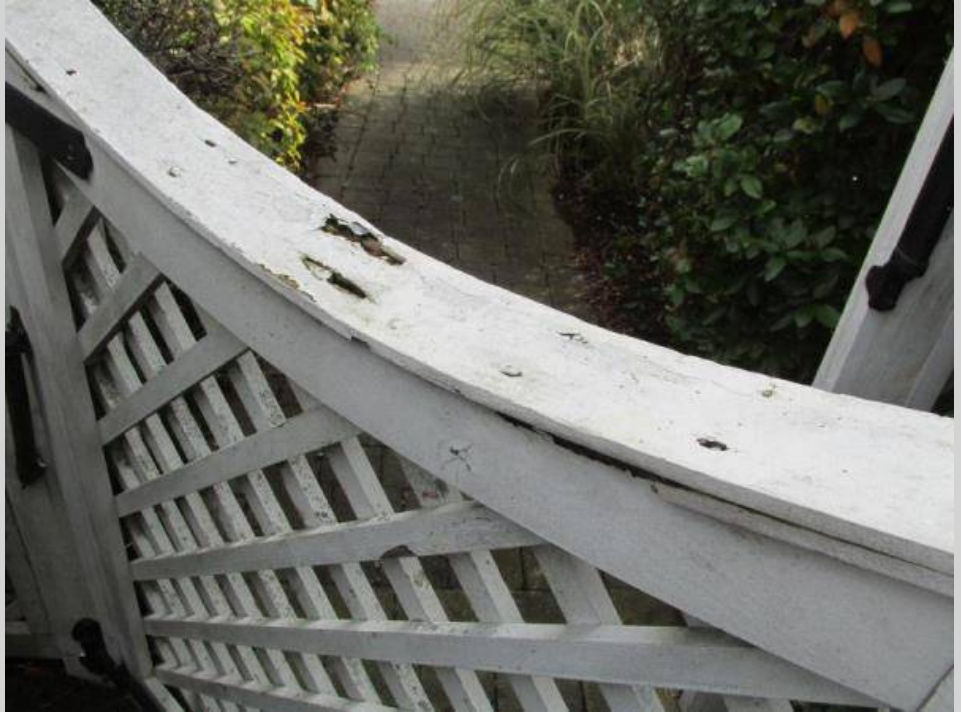
Observation: Wood fencing present. \*\* FUNCTIONAL with EXCEPTIONS:  
Observation: The fence on the property has the following issues:  
Rotted wood noted at areas of the fencing. Repair or replace the fencing as desired.

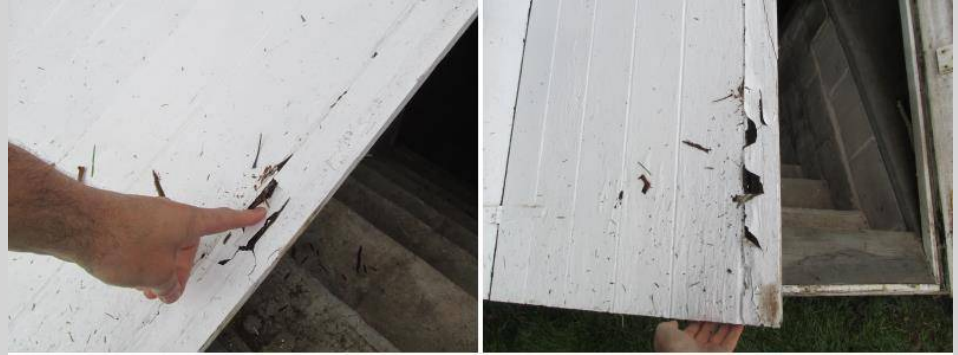
Observation: Rotted wood doors at bulkhead. Analysis: The untreated wood is at end of service life. Recommendation: Replace the wood doors are required or upgrade to a new steel bulkhead unit.

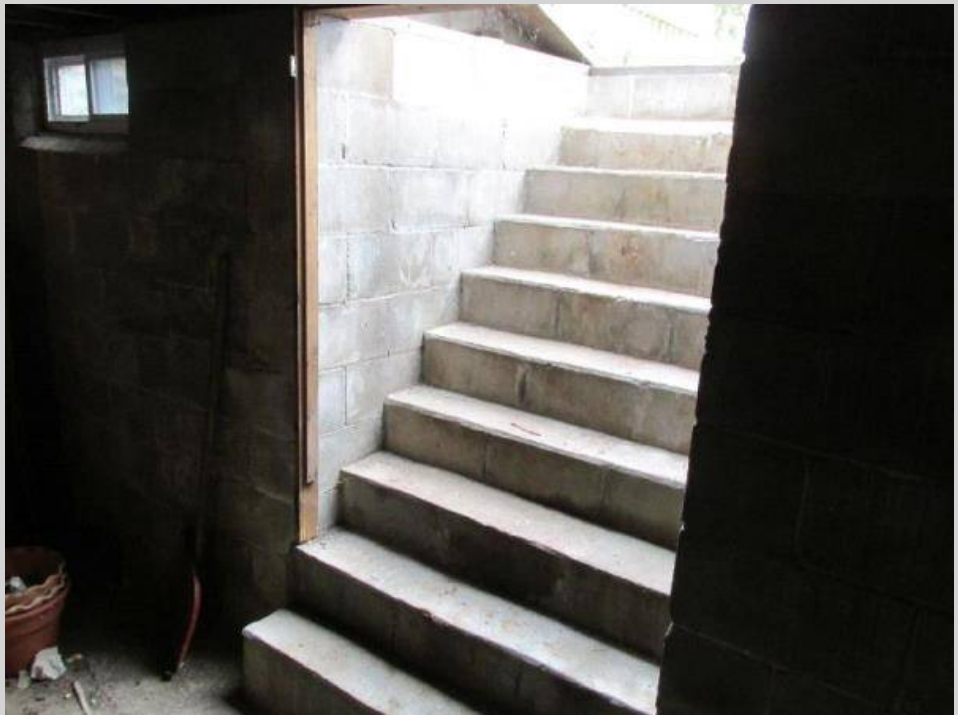
Observation: The basement entrance has no inner door. Analysis: While an inner door is not a requirement, heat loss will be excessive and mice are more likely to get into the basement without one. Recommendation: The installation of an inner insulated steel door is a recommended upgrade.

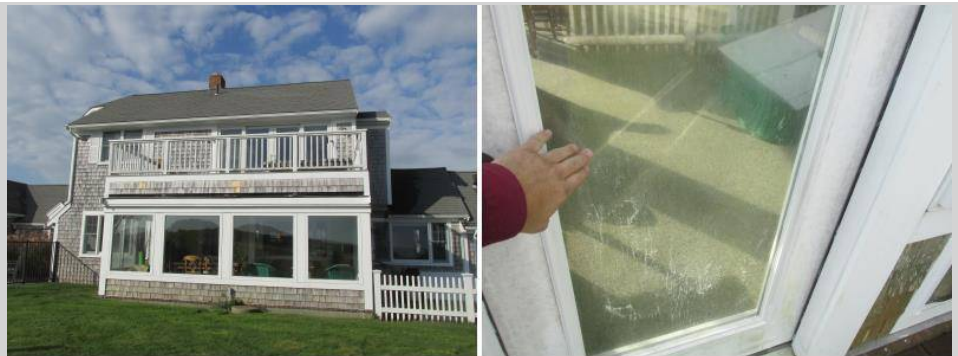
One or more of the glass panels have lost their seals. This condition is a cosmetic issue that will get worse over time.

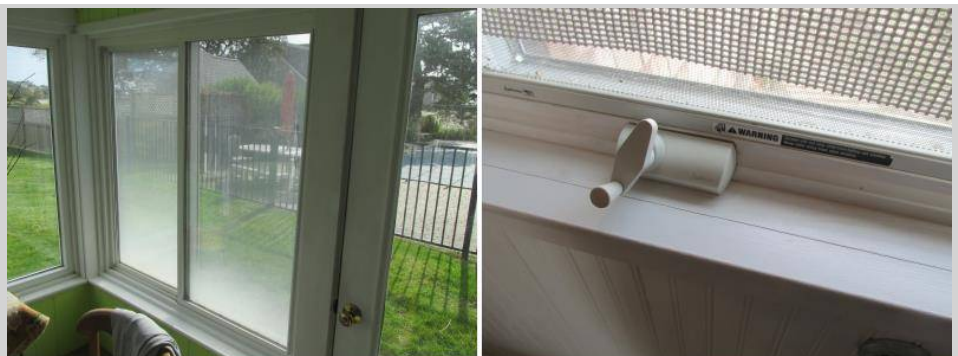
Inspection of the porch revealed the following defects that require repair or upgrading: A couple of windows are hard to slide. Maintenance needed.

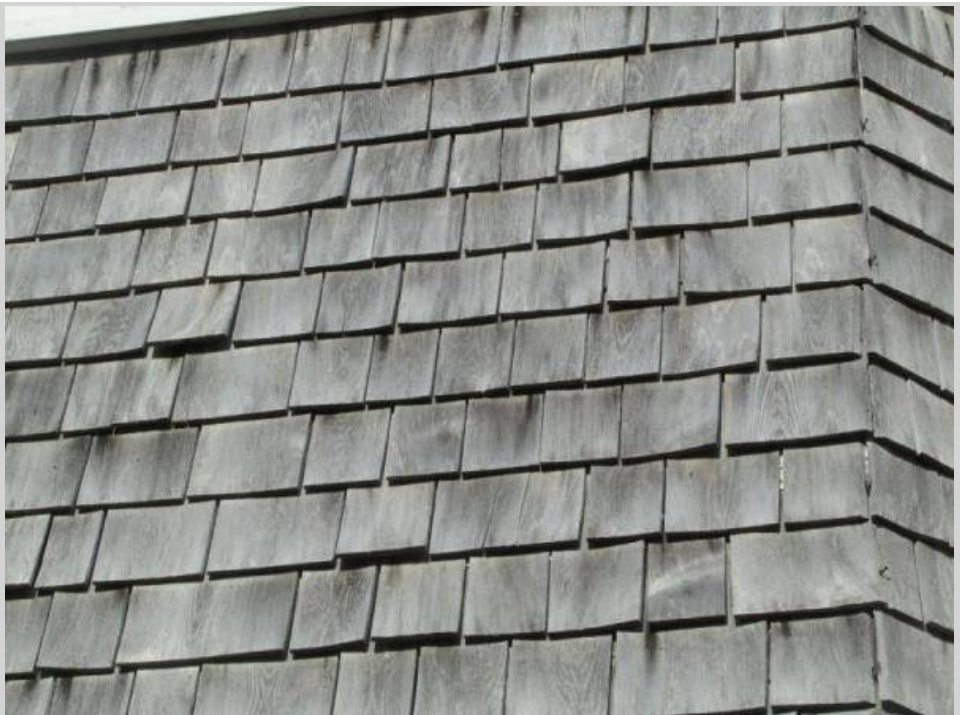
Observation: The siding has areas of standard wear. Analysis: The issues will most likely continue and will eventually needed repair or replacement. Recommendation: No repairs needed at this time.

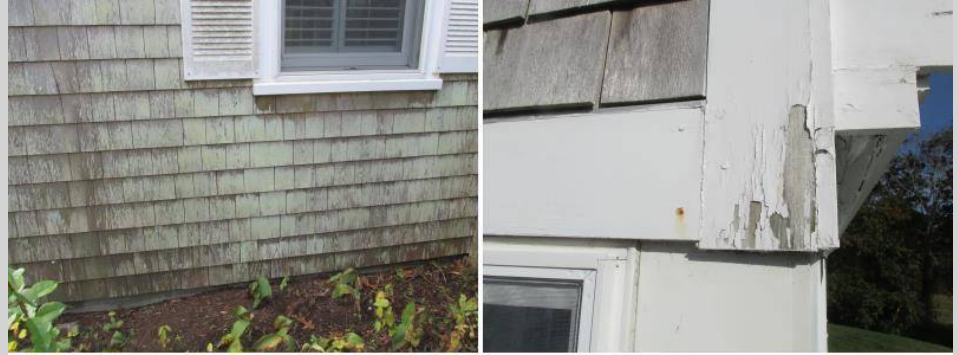
**\*\* FUNCTIONAL with EXCEPTIONS:**  
Observation: Some of the wood trim has peeling paint / finish product. Analysis: The finish on the SOME of the trim is at end of service life. Recommendation: Hire a painter to restore the finish on exterior trim components as needed.

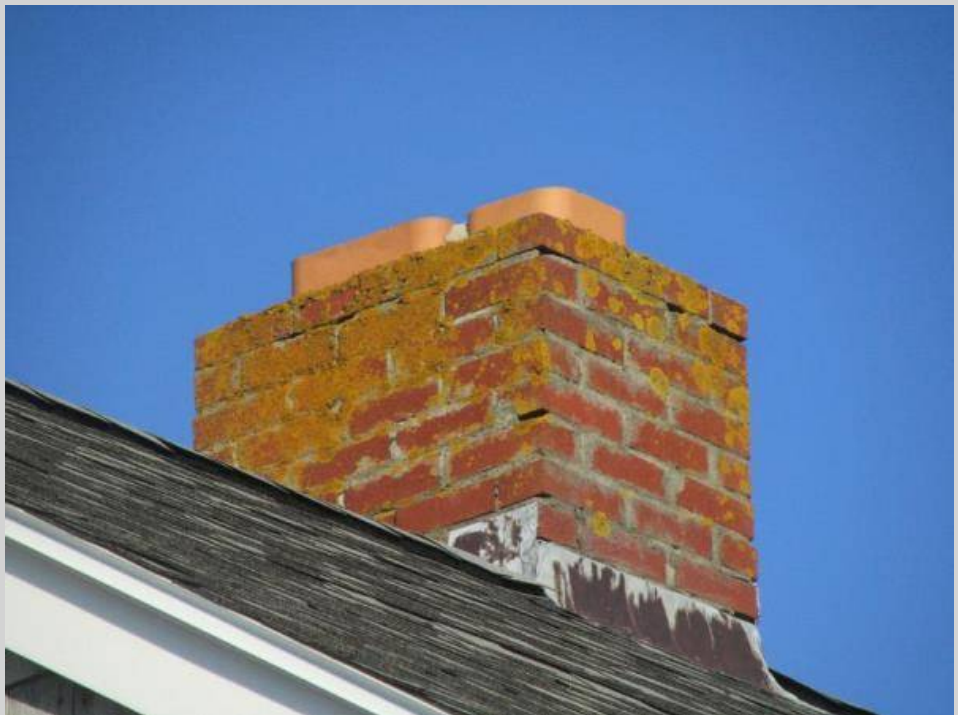
**Observation:** The chimney has eroded mortar joints. **Analysis:** Proper mortar joints have no gaps or missing mortar and are shaped, in a way that directs water out of the

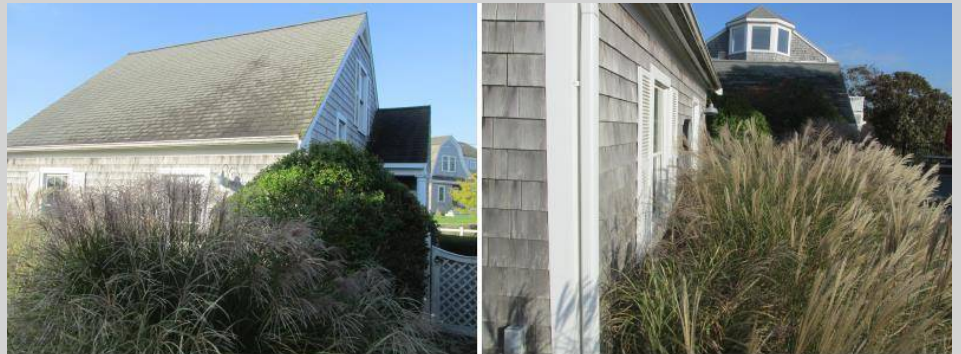
**\*\* FUNCTIONAL with EXCEPTIONS noted:** Observation: A few shrubs along parts of the perimeter of the garage are overgrown and are in contact. Analysis: Overgrown shrubs in contact with the home can prevent proper ventilation for the drying of wood siding & trim. Continuous damp conditions promote mildew, mold, damp rot and wood boring insect infestation. Recommendation: You should prune, remove or replace the shrubbery as required to provide a working clearance (24") between the shrubs and the garage.

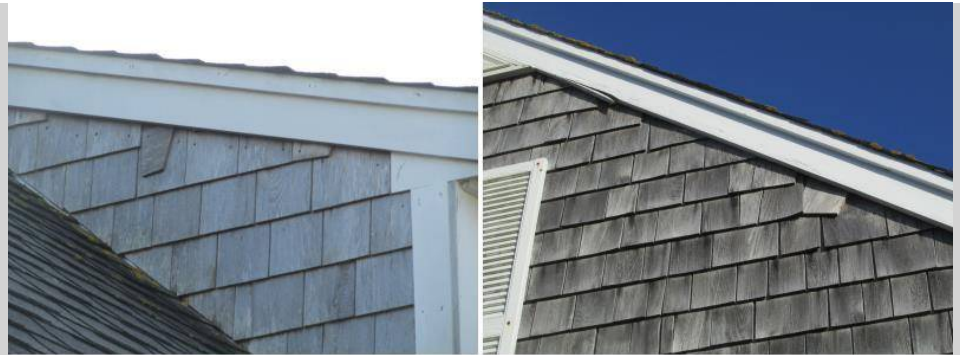
Observation: The cedar siding displayed the following issues:  
Observation: There are multiple cracked and or loose siding shingles below rake boards at the gable end(s) of the home. Analysis: Shingles below the rake boards, windows and other wall protrusions need to be nailed differently than the rest of the siding (face nailing). This type of nailing of shingles is standard but as the sun dries out and curls the shingles, it will often cause the shingles to crack at the point of nail entry. This is mostly a cosmetic issue. Recommendation: Replace the cracked and or loose shingles below the rake boards as desired.

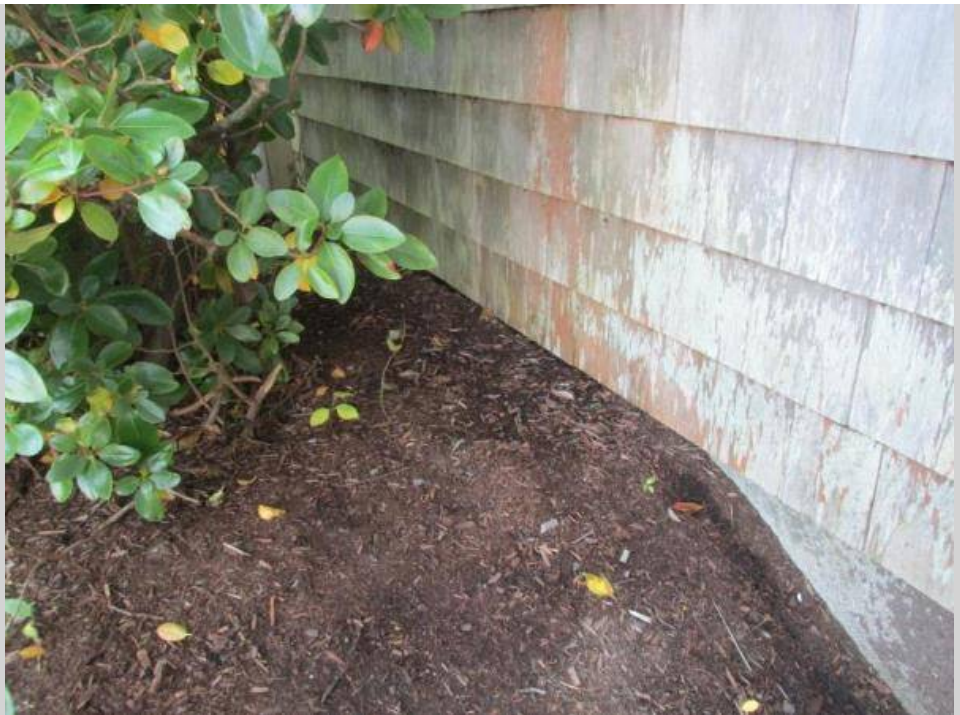
Some areas of siding sitting in direct contact with the dirt. This can promote decay and pest activity.

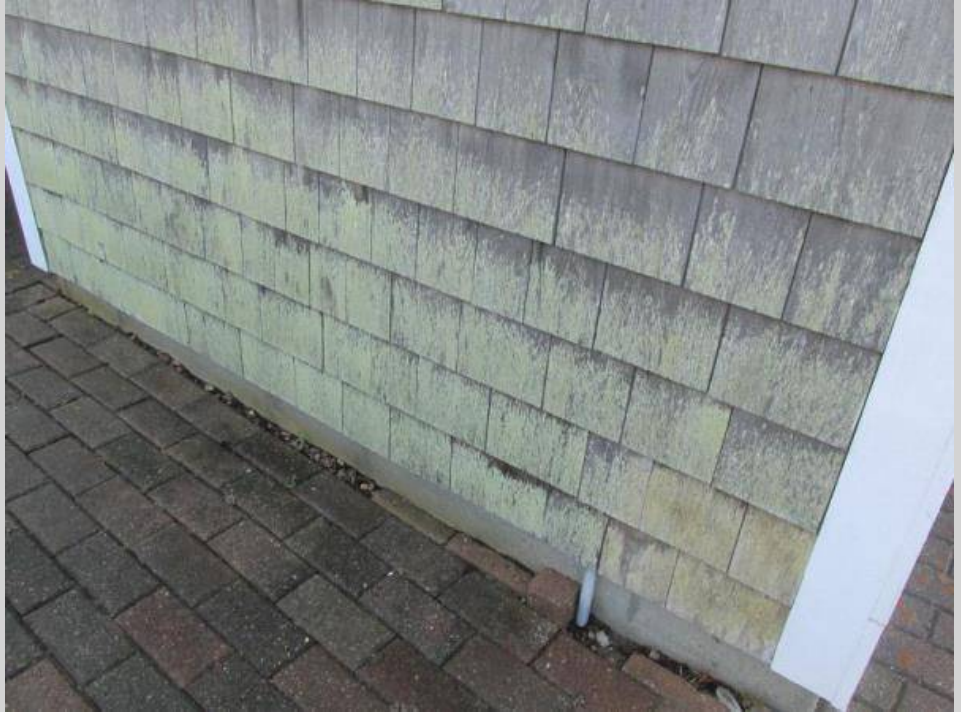
\*\* FUNCTIONAL with EXCEPTIONS: Observation: The exterior of the garage is a bit mossy. Analysis: The exterior appears otherwise functional. Recommendation: Consider hiring a professional to power wash the structure.

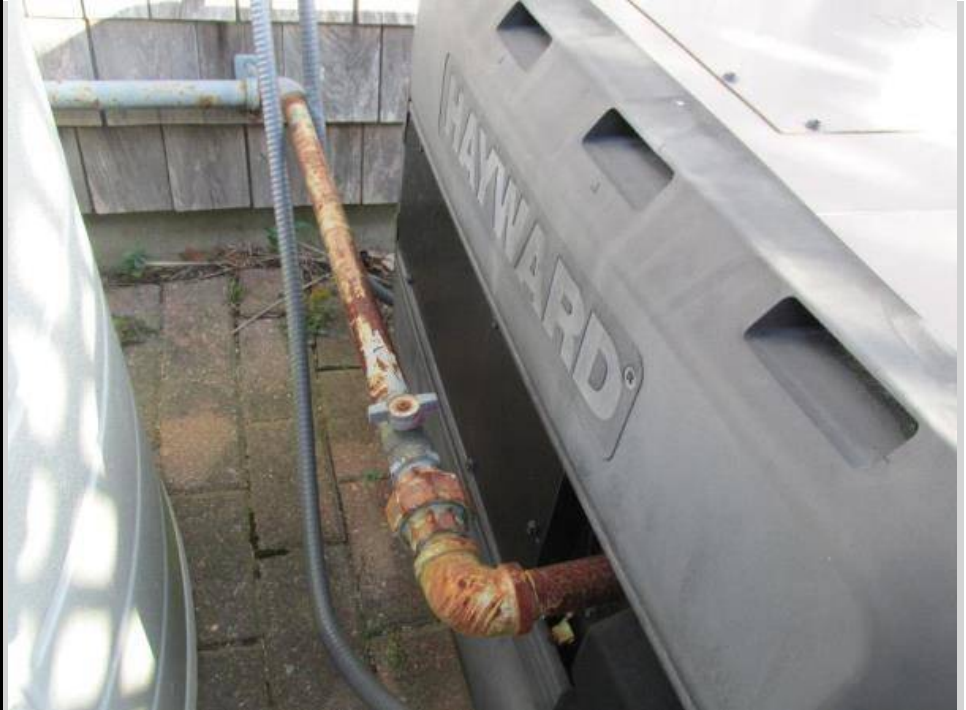
**Observation:** Inspection of the gas piping revealed the following problems: Rust / corrosion visible on exterior gas pipes. These pipes should be sanded, primed and painted to avoid further rust and possible leak / safety hazard.

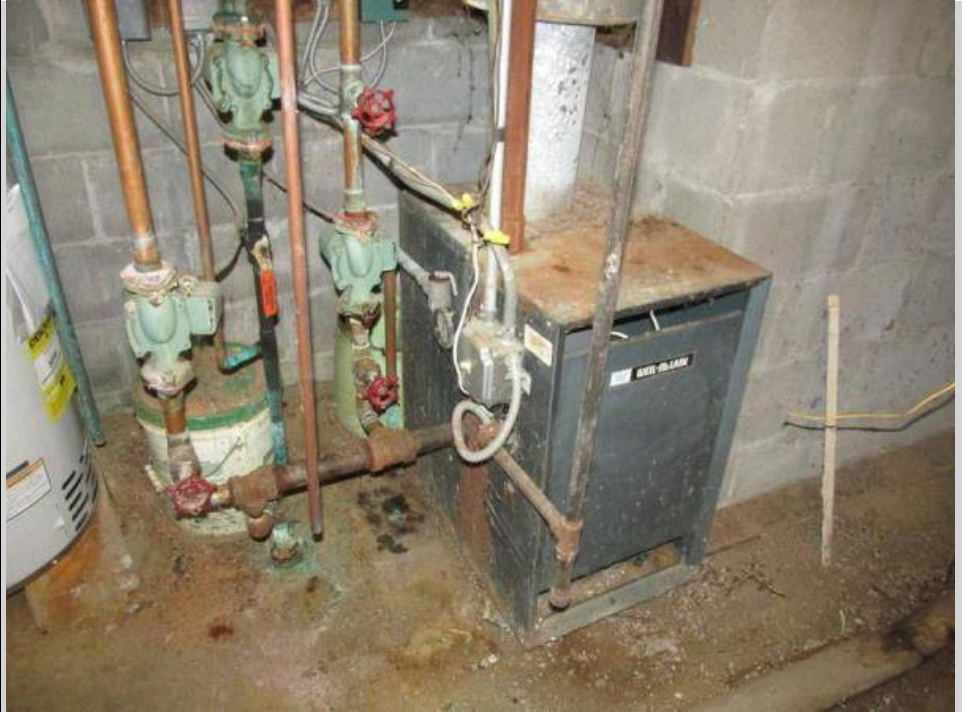
Observation: The age of the heating system is unknown. It appears to be 50+ years old.

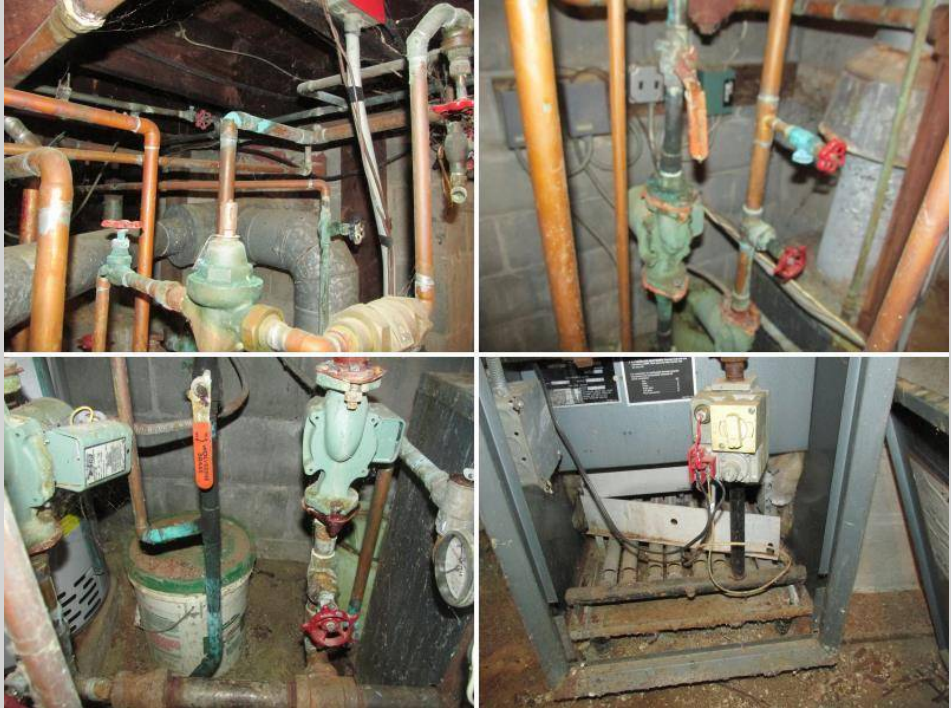
**Observation:** The boiler has MANY areas of rust and or current leaks on the outside and or on misc components exiting the boiler.  
**Recommendation:** The boiler does NOT appear to have been serviced in many years. You should hire a field professional and have the heating system serviced to make repairs as needed. **Other option is to replace the boiler.**

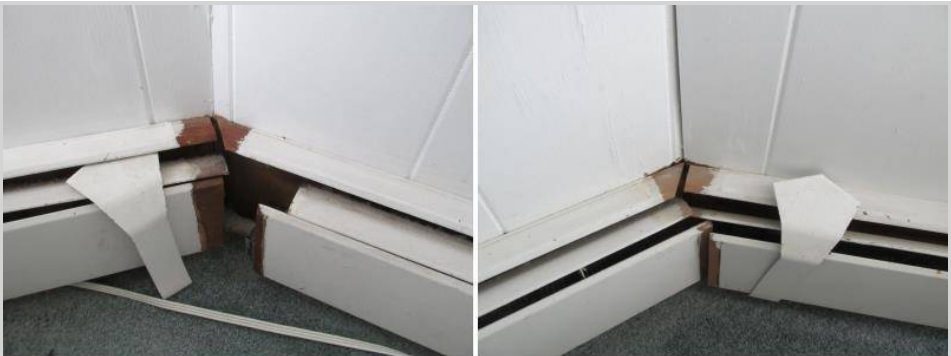
**Observation:** Baseboard heating convectors functional but are missing parts such as covers, end caps or trim. **Analysis:** Missing covers exposes people to razor sharp heating fins that could cause personal injury. Incomplete covers also misdirect air flow and reduce over-all efficiency. **Recommendation:** Repair or replace all covers & components as needed to restore safe & efficient heating function.

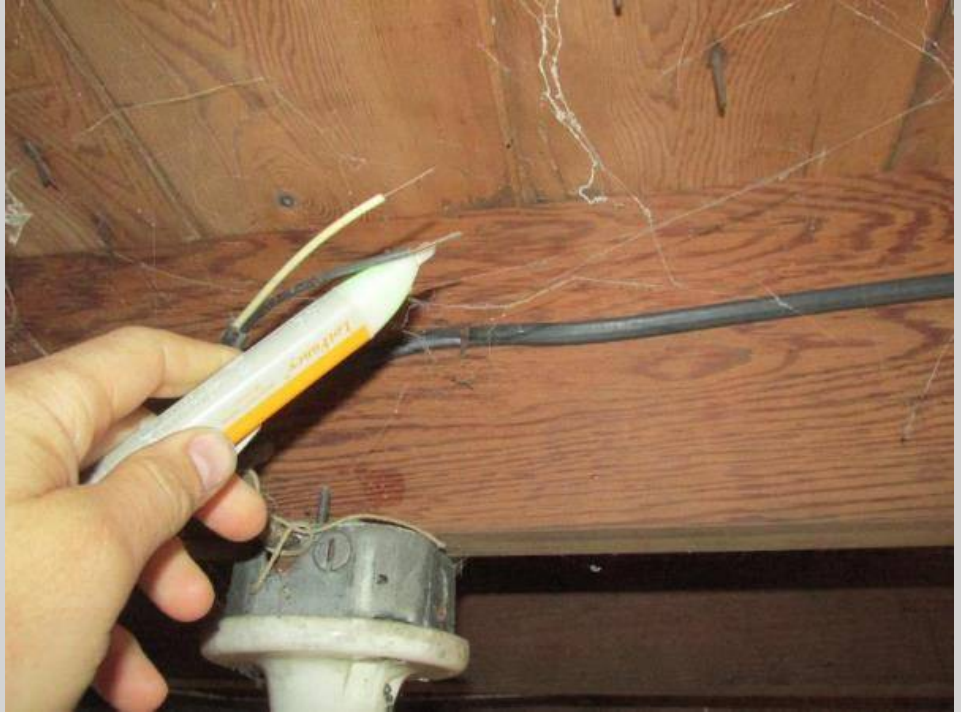
Observation: Inspection of the visible branch wiring in the accessible portions of the unfinished areas (basement, crawl space, attic, etc.) revealed the following problems:  
Observation: **EXPOSED DEAD ENDED WIRE IS VISIBLE.** Analysis: The wire was tested and found to have no electricity flowing at time of inspection. However, due to the fact that power could potentially be brought to these wires with the flip of a switch or breaker, I find the dead ended wires to be...\*\*\*\* **SAFETY HAZARD - POTENTIAL FOR SHOCK OR FIRE. REPAIR NEEDED.** Recommendation: Hire an electrician perform safety repairs as determined. (Note: Inspection by an electrician may reveal additional problems not documented in this limited report.)

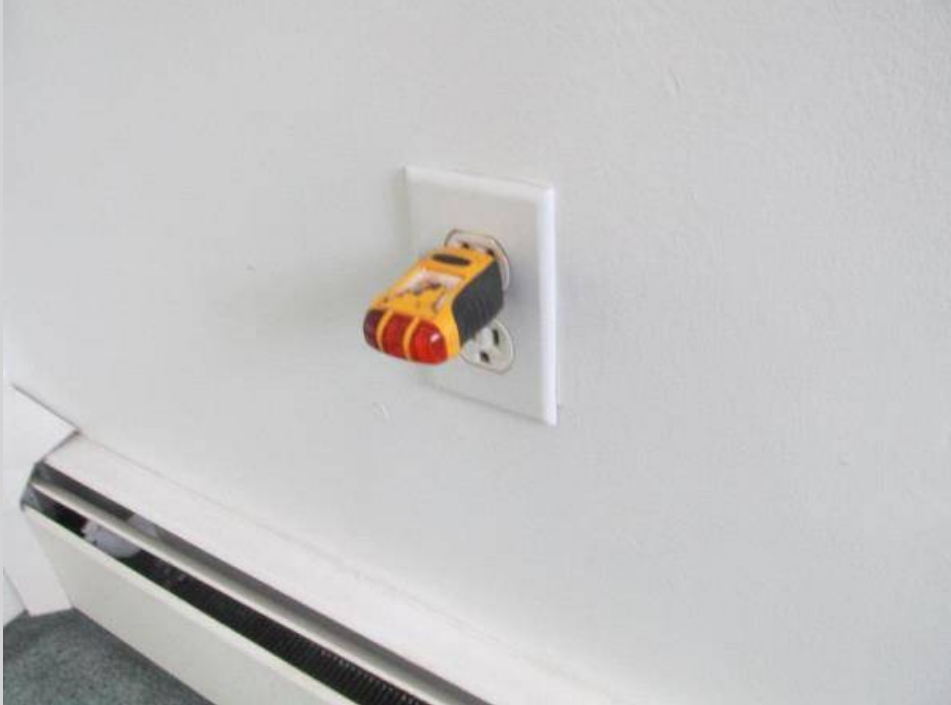
<p><u>Observation:</u> Random sampling &amp; inspection of the electrical receptacles revealed the following problems: <u>Observation:</u> A receptacle (outlet) tested as dead at: <u>Analysis:</u> <b>SAFETY WARNING -</b> Cause of the dead receptacle is undetermined. <u>Recommendation:</u> Hire an electrician to research this problem and to perform repairs as needed.</p>

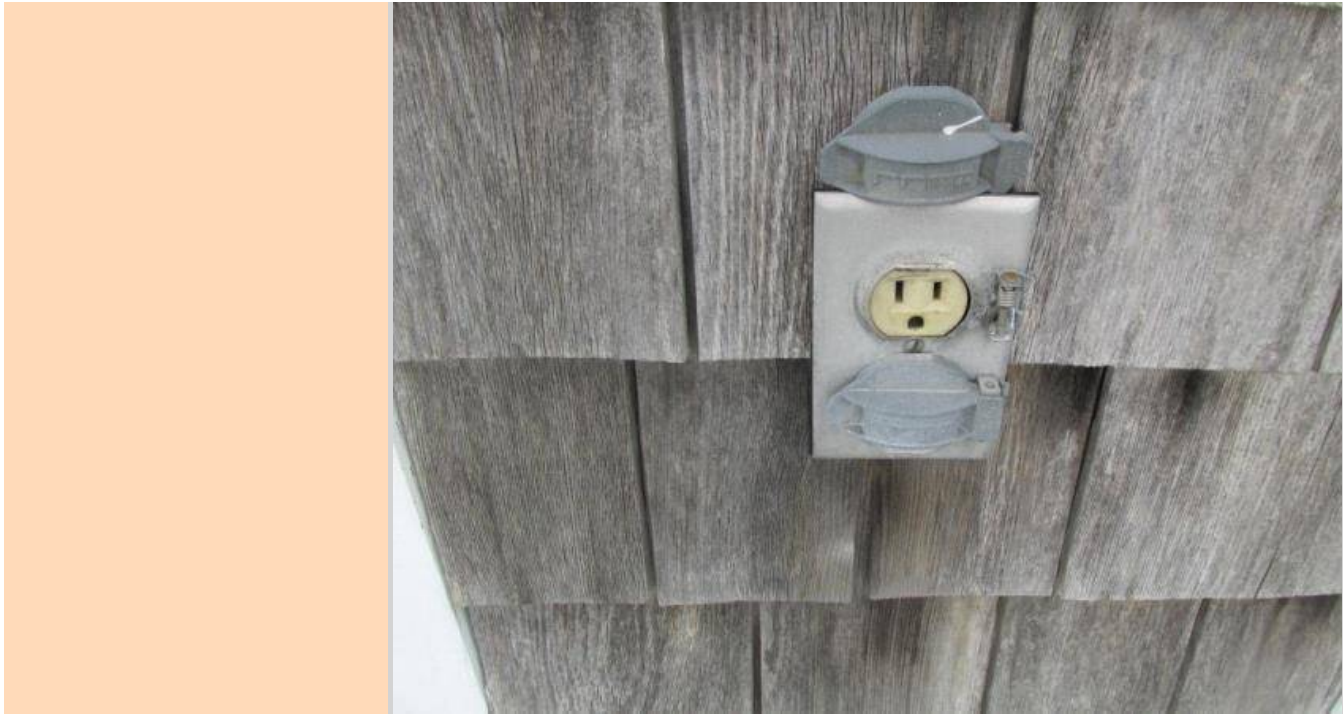
**Observation:** An exterior outlet is missing a proper water tight cover. **Analysis:** \*\*\*\*  
**SAFETY HAZARD-** Water can enter the outlet and cause personal injury or home damage  
**Recommendation:** You should hire an electrician to install proper water tight covers as needed.

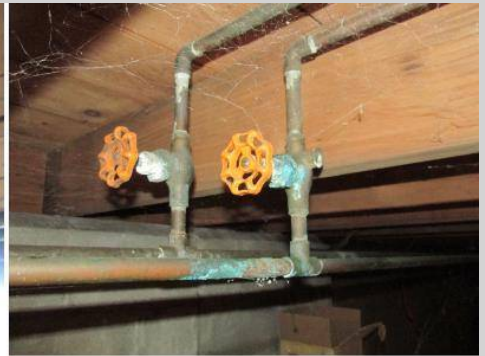
Observation: Extensive Greenish liming and white corrosion was visible on the copper pressure pipes, fittings or valves. Analysis: Such corrosion is typically caused by the acidic nature of the water supply but also indicates that repairs may be needed in the future to prevent leakage. Recommendation: Ask a plumber to reappraise all of the pressure piping, valves and fittings; and to provide estimates for repair or replacement to prevent leakage.

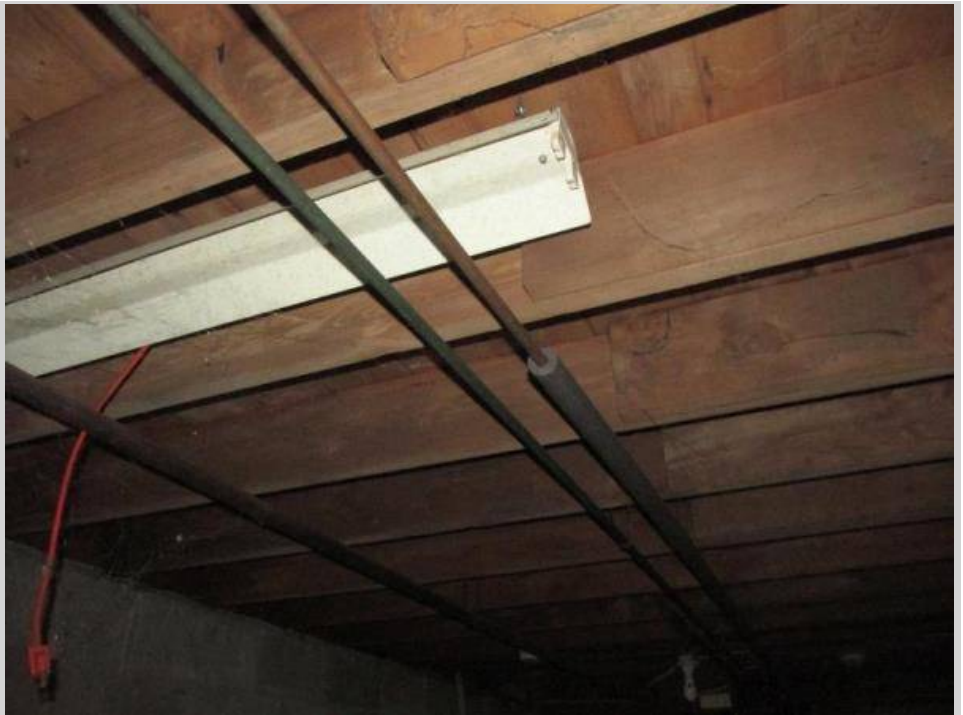
Observation: Where accessible, the hot water pipes are only partly insulated. Analysis: Non-insulated pipes will allow heat loss. Recommendation: Additional pipe insulation is advised to prevent heat loss.

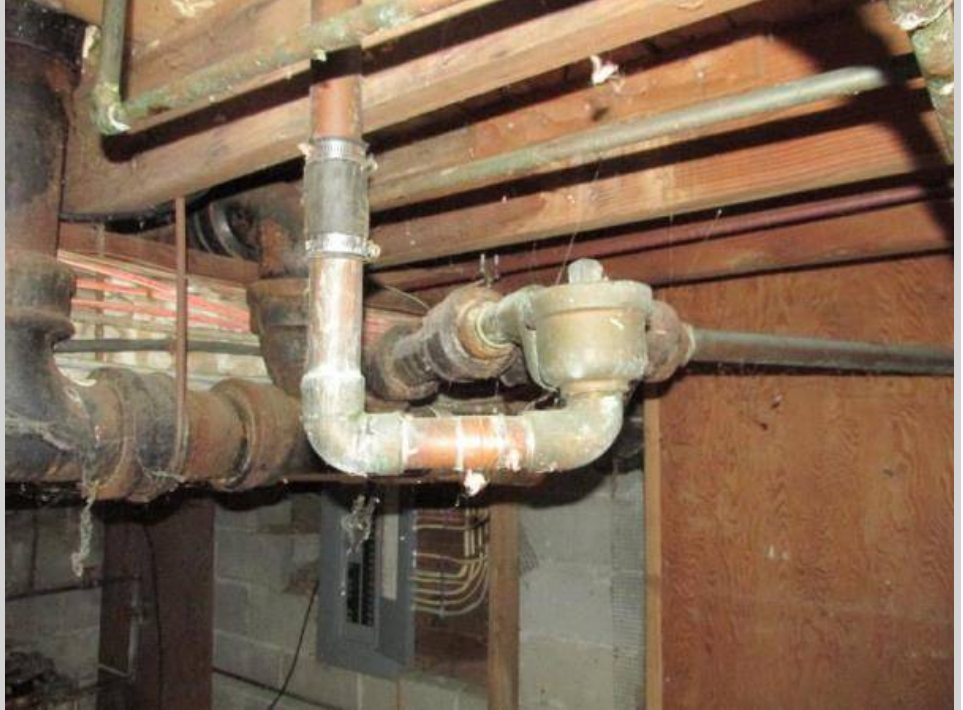
Observation: Old **OBSELETE** drum traps are present at plumbing fixtures. Analysis: Such traps are no longer allowed in modern plumbing systems because the seal of water inside an old trap can sometimes be lost during drainage, allowing sewer gas to enter the piping & living space. Such old traps typically produce a gurgling sound while draining. Be advised that old traps of this type are prone to collect grease, requiring maintenance cleaning to restore function. Recommendation: While no repair is required unless the fixture is remodeled, I advise that you hire a plumber to retire the old traps and install new P-shaped traps with required re-vents for compliance with modern healthy waste piping systems.

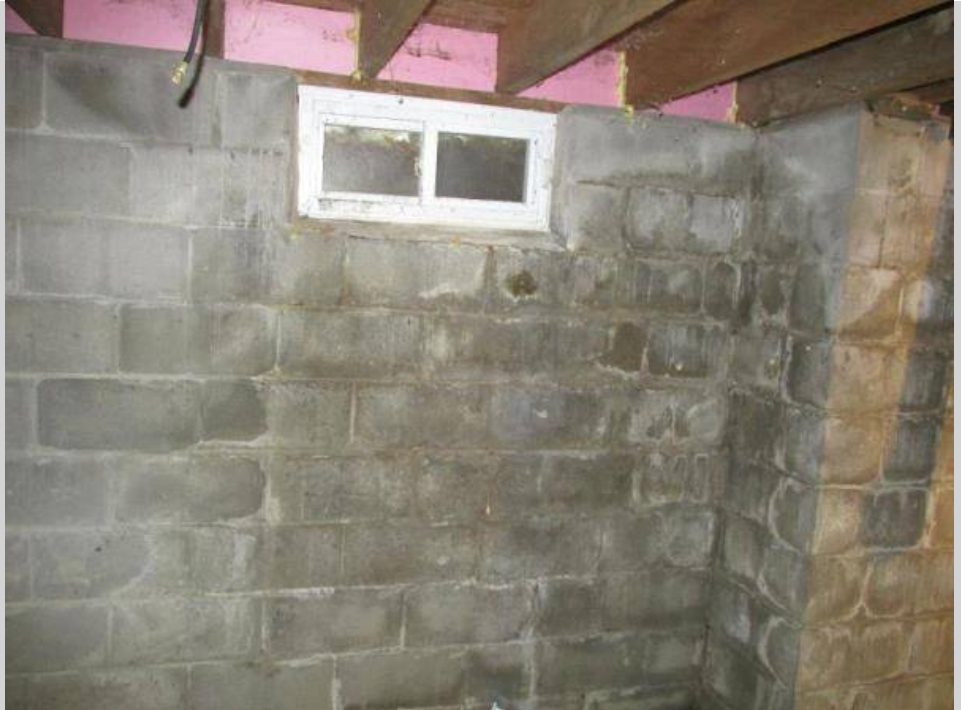
Observation: Suspected mold was visible in the home. (SEE THE "MOLD" SECTION OF THIS REPORT)

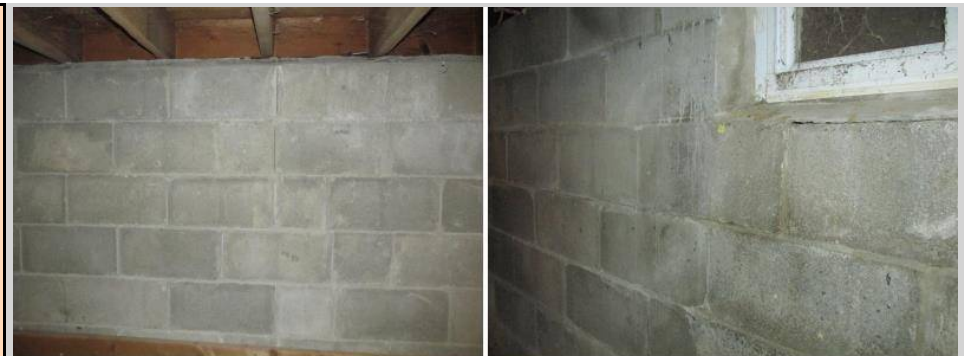
**Observation:** Inspection of the foundation revealed "step type cracks" in the foundation walls. **Analysis:** Step pattern cracks in a foundation wall usually indicate footing settlement in that area. Such settlement can be caused by the erosion of stable earth beneath the foundation footing. When roof drainage in older homes is allowed to discharge near the corners of the foundation over a period of years, the water sinks into the soil near the foundation and eventually erodes some of the stable earth beneath the footing of the foundation. Without a stable base of support, the load on the foundation can not be evenly distributed to the earth and stress is created. To relieve the stress, a foundation may settled into a void leaving a series of step pattern cracks in the foundation indicating movement. Step cracks are most prevalent in masonry type foundations (such as stone, brick or block). Depending on the severity of the settlement, there is cause for concern as excessive movement can weaken the structure, and can be telegraphed upwards into the floor and wall frames where the problems are exhibited as floors that are not level, walls that are out of plumb, diagonal cracks in finished wall surfaces and binding of doors or windows. Be advised that cracks are "time related" and that the movement to date may still be on-going. **Recommendation:** The professional appraisal and repair of step cracks depends upon their time span, location, severity and impact on the rest of the home. Severe step crack settlement may require a costly method of repair called underpinning; therefore, you should seek repair quotes from an **engineer or foundation repair contractor** prior to commitment. If there is any doubt in your mind as to the severity of the settlement, then further technical analysis by a **structural engineer** is advised **NOW as repairs may involve significant expense.**

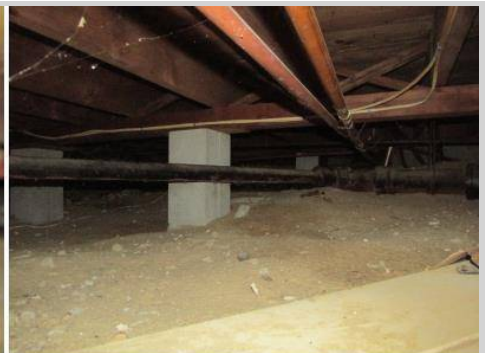
Observation: The crawl space has no vapor barrier on the soil.  
Analysis: A vapor barrier is required to control moisture migration. Humidity is constantly rising from the soil. Such humidity trapped within a crawl space may cause moisture problems such as wood rot, mold, mildew and pest activity.  
Recommendation: Add a vapor barrier of 4-6 mil plastic on the soil of the entire crawl space. ALSO, the crawl space area should have a means of cross ventilation OR a mechanical system that dehumidifys or exchanges the air in the crawl space.

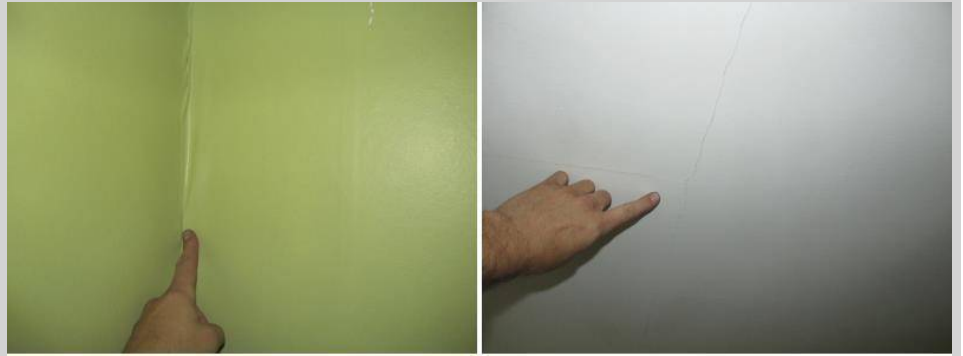
Observation: A few areas cracks are visible on some wall surfaces. Analysis: Plaster or drywall does not expand & contract; any movement in the house framing will result in cracks in the plaster as exhibited. Recommendation: Cosmetic repairs should include mud & tape or reinforced joint repair followed by priming & painting.

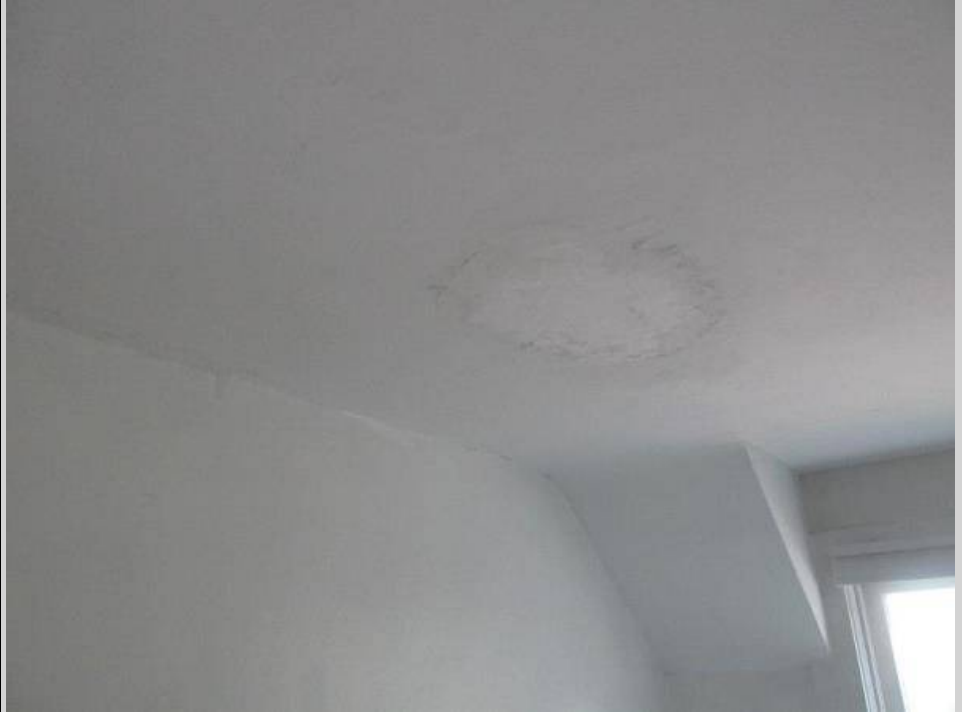
Observation: There are many cracks in the ceiling. Analysis: Drywall and plaster materials develop cracks in response to floor or ceiling frame expansion & contraction or vibration. Possible previous water leakage issues noted. Recommendation: Hire a field professional to perform cosmetic repairs as desired.

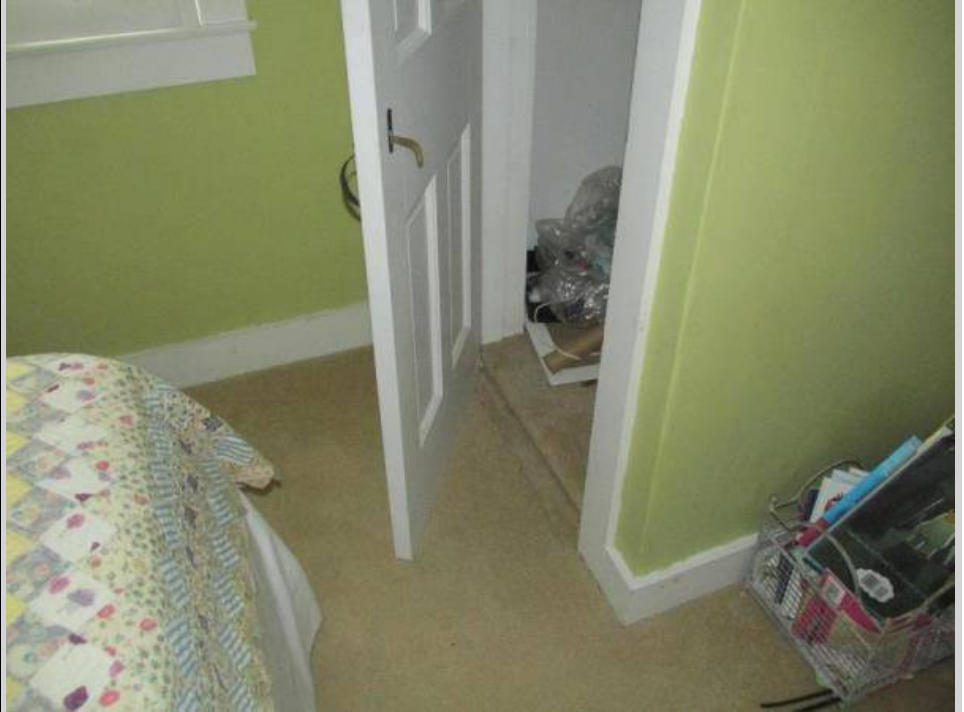
**\*\* FUNCTIONAL with EXCEPTIONS noted:** Observation: Inspection of the interior doors revealed the following issues:  
**\*\*\*** An interior door binds up and does not open and close easily.

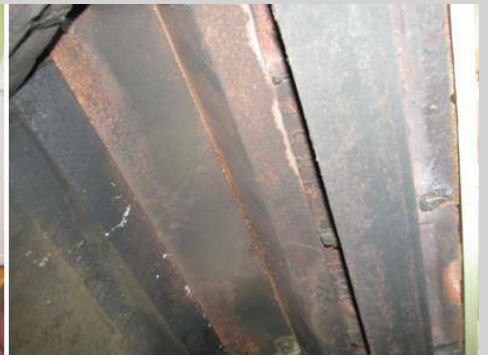
Observation: The fireplace damper handle is missing. Analysis: The damper will not open easily Recommendation: Do not use until a proper handle is added.
