Barnstable Municipal Airport

Town of Barnstable ADA Transition Plan

July 2021

**Town of Barnstable
Barnstable Municipal Airport**

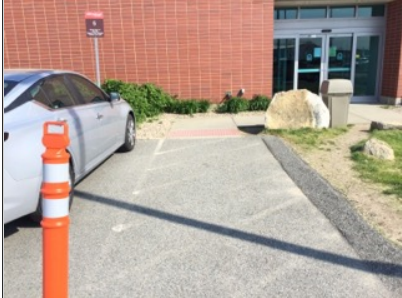
Accessible route not provided	-	See ID #2.	1	-	\$0
2	To Rental Cars From Terminal Entrance	Ext.		Exterior Access Route	Walkway

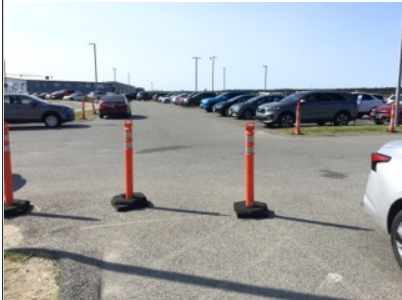
Accessible route not provided	-	Remove road barrier markers to maintain the accessible route.	1	Labor	\$0
Off-Street Parking Lot or Garage												
3	Parking Near Arrivals	Ext.		Off-Street Parking Lot or Garage	Visitor

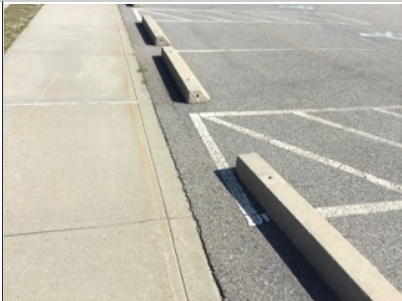
Access aisle not compliant	-	Relocate concrete block to maintain the required 60" min. width at the access aisle.	1	Labor	\$0
4	Parking Near Departures	Ext.		Off-Street Parking Lot or Garage	Visitor

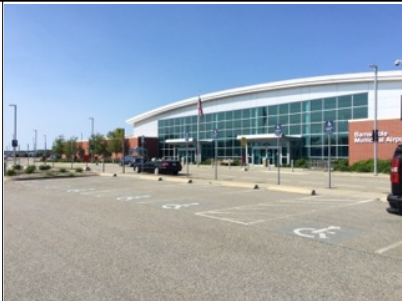
Sign not provided	-	Provide a sign with the bottom of the sign 60" min. above the ground and the top 96" max. above the ground at the accessible car parking space missing the sign.	1	500	\$500

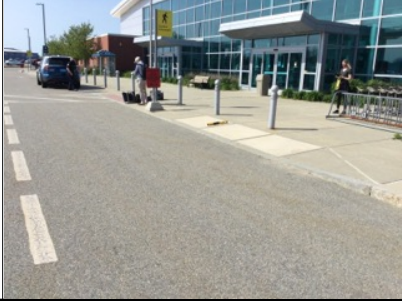
Sign with ISA not provided (MAAB)	-	Provide a sign that includes the International Symbol of Accessibility (ISA) at the head of the space. Locate the sign so that the bottom is 60" min. above the ground and the top is 96" max. above the ground.	1	500	\$500
Entrance												
6	Entry to Baggage Claim	Ext.	112	Entrance	Main Entrance

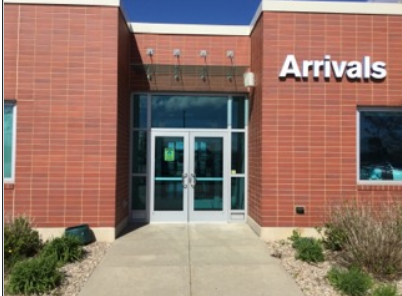
Door requires > 15 lbs. of force to open	23 lbs.	Adjust closers so doors do not require more than 15 pounds of force.	1	Labor	\$0
Bus Shelter												
7	Bus Shelter Near Terminal Main Entrance	Ext.		Bus Shelter	N/A

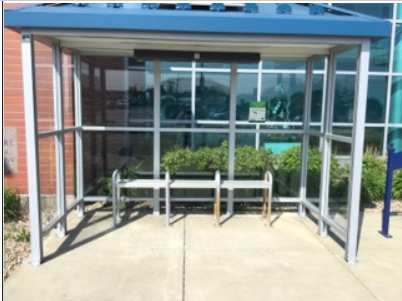
Clear ground space not provided	-	Relocate bench to ensure a 30" by 48" clear ground space is provided within the bus shelter.	1	256	\$256

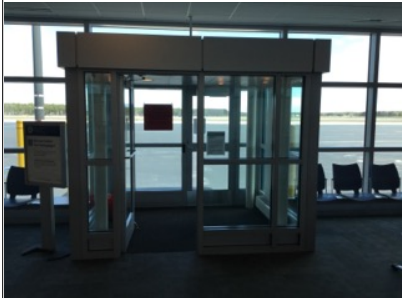
Tactile exit sign not provided	-	Ensure a tactile exit sign with raised characters and braille is provided at exit the doors. Mount sign between 48"- 60" above the finished floor located on the latch side of the door.	1	232	\$232

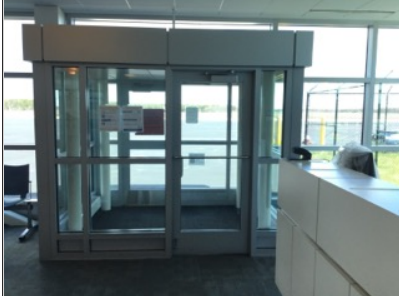
Tactile exit sign not provided	-	Ensure a tactile exit sign with raised characters and braille is provided at exit doors. Mount sign between 48"- 60" above the finished floor located on the latch side of the door.	1	232	\$232
10	Employees Entry/Exit	1	160	Means of Egress	N/A

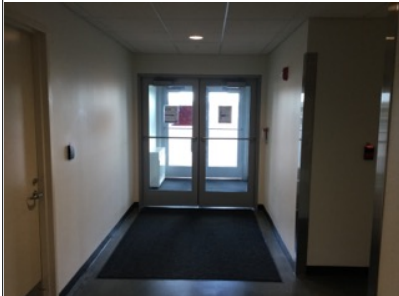
Tactile exit sign not provided	-	Ensure a tactile exit sign with raised characters and braille is provided at exit doors. Mount sign between 48"- 60" above the finished floor located on the latch side of the door. if an illuminated exit sign is provided, ensure the sign has the International Symbol of Accessibility (ISA).	1	232	\$232
11	From Secure Arrivals to Hall 161	1	160	Means of Egress	N/A

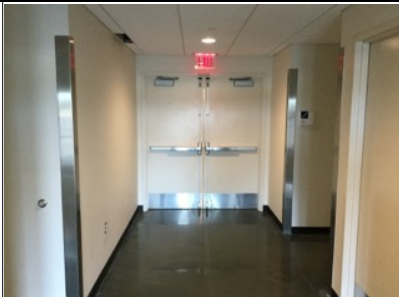
Tactile exit sign not provided	-	Ensure a tactile exit sign with raised characters and braille is provided at exit doors. Mount sign between 48"- 60" above the finished floor. When a tactile sign is provided at double doors with two active leafs, the sign shall be located to the right of the right hand door	1	232	\$232

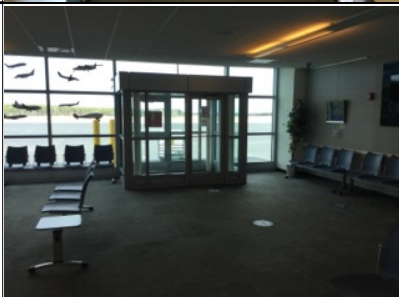
12	Exit/Entry - Non Secure Hold Room	1	118	Means of Egress	N/A

Tactile exit sign not provided	-	Ensure a tactile exit sign with raised characters and braille is provided at exit doors. Mount sign between 48"- 60" above the finished floor located on the latch side of the door.	1	232	\$232
13	Entry/Exit Near Concourse	1	176	Means of Egress	N/A

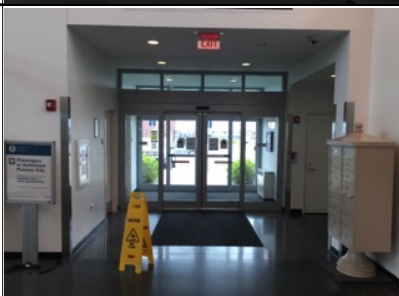
Tactile exit sign not provided Illuminated ISA symbol not provided (MAAB)	- -	Ensure a tactile exit sign with raised characters and braille is provided at exit doors. Mount sign between 48"- 60" above the finished floor located on the latch side of the door. Provide an illuminated sign with the International Symbol of Accessibility.	1	432	\$432

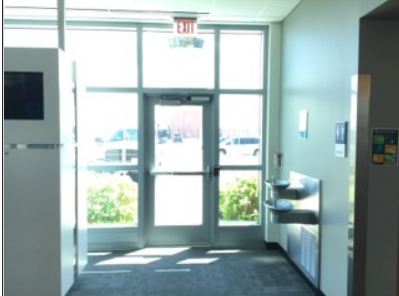
Tactile exit sign not provided Illuminated ISA symbol not provided (MAAB)	- -	Ensure a tactile exit sign with raised characters and braille is provided at exit door. Mount sign between 48"- 60" above the finished floor located on the latch side of the door. Provide an illuminated sign with the International Symbol of Accessibility.	1	432	\$432
15	Entry/Exit - From Ticketing Hall to Parking	1	139	Means of Egress	N/A

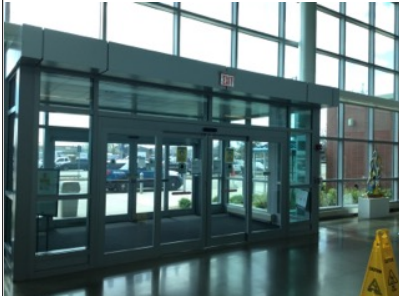
Tactile exit sign not provided Illuminated ISA symbol not provided (MAAB)	- -	Ensure a tactile exit sign with raised characters and braille is provided at exit doors. Mount sign between 48"- 60" above the finished floor located on the latch side of the door. Provide an illuminated sign with the International Symbol of Accessibility.	1	432	\$432

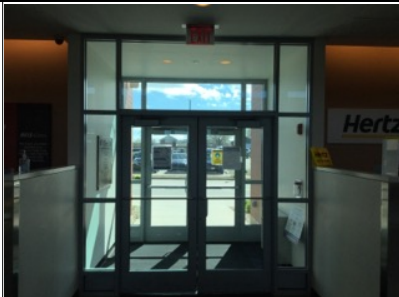
16	Exit - Near Baggage Claim	1	112	Means of Egress	N/A

Tactile exit sign not provided Illuminated ISA symbol not provided (MAAB)	- -	Ensure a tactile exit sign with raised characters and braille is provided at exit doors. Mount sign between 48"- 60" above the finished floor located on the latch side of the door. Provide an illuminated sign with the International Symbol of Accessibility.	1	432	\$432
17	Exit - Near Baggage Claim	1	104	Means of Egress	N/A

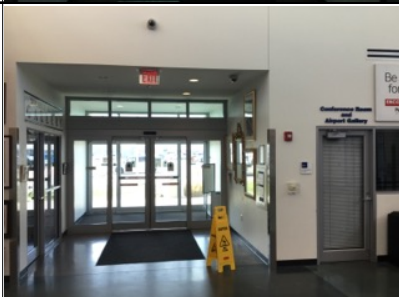
Tactile exit sign not provided Illuminated ISA symbol not provided (MAAB)	- -	Ensure a tactile exit sign with raised characters and braille is provided at exit doors. Mount sign between 48"- 60" above the finished floor located on the latch side of the door. Provide an illuminated sign with the International Symbol of Accessibility.	1	432	\$432
18	Entry/Exit - From Ticketing Hall to Parking	1	140	Means of Egress	N/A

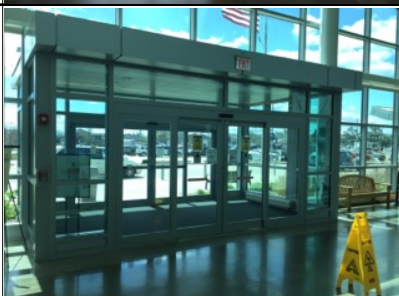
Tactile exit sign not provided Illuminated ISA symbol not provided (MAAB)	- -	Ensure a tactile exit sign with raised characters and braille is provided at exit doors. Mount sign between 48"- 60" above the finished floor located on the latch side of the door. Provide an illuminated sign with the International Symbol of Accessibility.	1	432	\$432

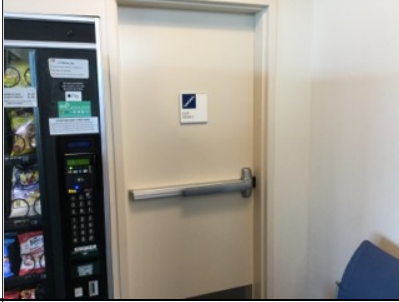
Sign not located on the latch side of the door	-	Locate sign alongside the door on the latch side.	1	Labor	\$0
20	From Secure Arrivals to Stair #2	1	160	Means of Egress

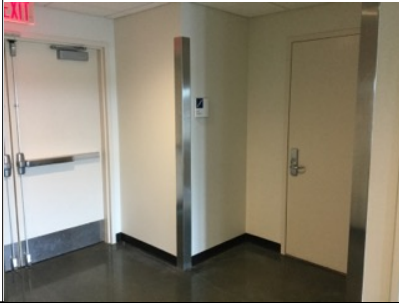
Sign not located on the latch side of the door		Locate sign alongside the door on the latch side.	1	Labor	\$0
Interior Access Route												
21	Boarding Area	1	166	Interior Access Route	N/A

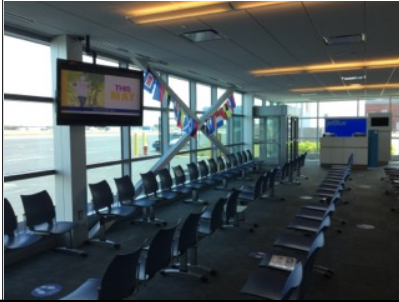
Route < 36" wide Vertical clearance < 80" above finished floor	32.5" 69"	Ensure that a clear width of 36" min. is maintained at the accessible route. Provide a cane-detectable barrier underneath the TV monitor.	1	Labor	\$0
22	Concourse	1	175	Interior Access Route	N/A

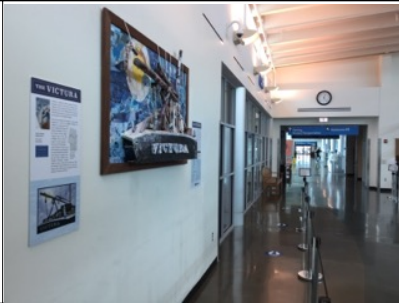
Obstructed by protruding objects	9.25"	Relocate display so it does not protrude into the circulation path.	1	Labor	\$0

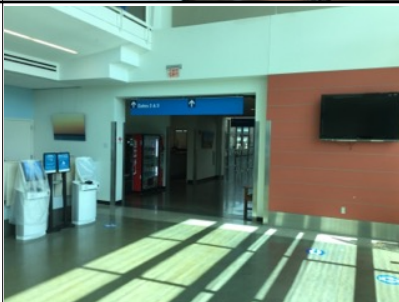
23	Ticketing Hall to Concourse 175	1	138	Interior Access Route	283

Obstructed by protruding objects	5.75"	Provide a cane-detectable barrier under the TV monitor.	1	878	\$878

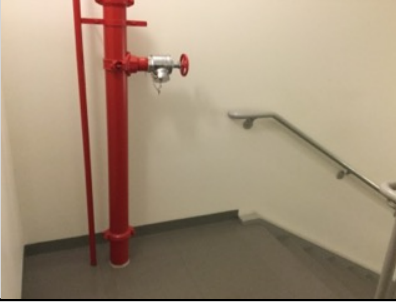
Obstructed by protruding objects	12"	Provide a cane-detectable barrier.	1	878	\$878
Doors, Doorways, & Gates												
25	Gates 2 & 3 - Concourse	1	175	Doors, Doorways, & Gates	Circulation

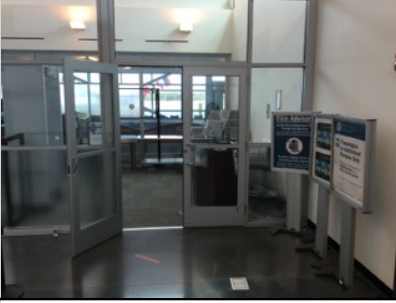
Clear width at door < 32"	31.25"	Keep both doors open during business hours.	1	Labor	\$0
26	Administrativ e Staff Offices	2	213	Doors, Doorways, & Gates	Office

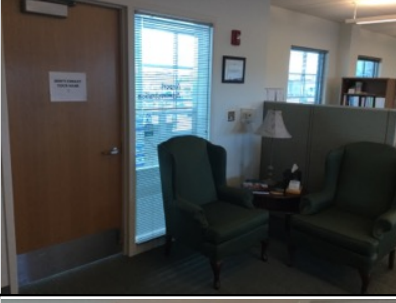
Maneuvering clearance(s) not provided Door requires > 5 lbs. of force to open	10" 15 lbs.	Relocate chairs to maintain the maneuvering clearance at door. Adjust closers so doors do not require more than 5 pounds of force to open.	1	Labor	\$0
27	Hall to Secure Arrivals	1	161	Doors, Doorways, & Gates	Circulation

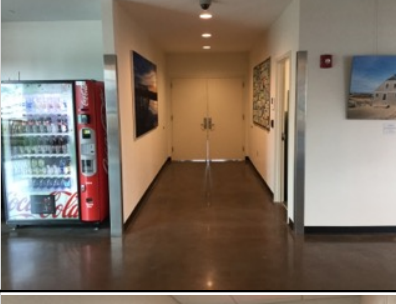
Door requires > 5 lbs. of force to open	17 lbs.	Adjust closers so doors do not require more than 5 pounds of force to open. Note: Fire doors shall have a minimum opening force allowable by the appropriate administrative authority.	1	Labor	\$0

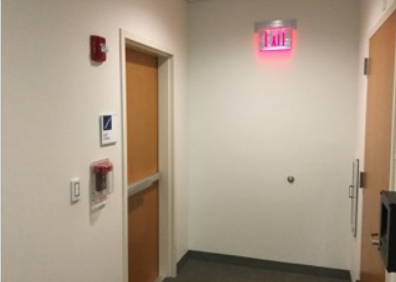
28	From Hallway to Stair #2	2	236	Doors, Doorways, & Gates	Emergency Egress

Door requires > 5 lbs. of force to open	16 lbs.	Adjust closers so doors do not require more than 5 pounds of force to open. Recommendation applies to all doors on Stair #2. Note: Fire doors shall have a minimum opening force allowable by the appropriate administrative authority.	1	Labor	\$0

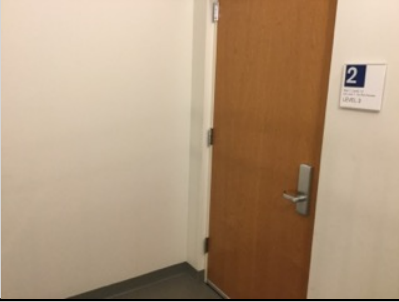
Door requires > 5 lbs. of force to open	18 lbs.	Adjust closers so doors do not require more than 5 pounds of force to open. Applies to all doors on Stair #1. Note: Fire doors shall have a minimum opening force allowable by the appropriate administrative authority.	1	Labor	\$0
Stairways												
30	Stair #2	1	158	Stairways	Egress

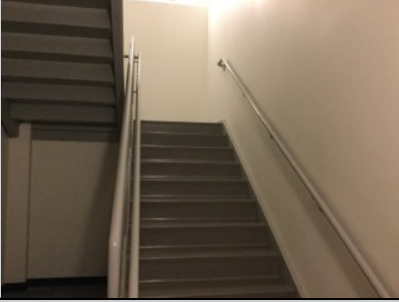
Handrail height < 34" or > 38"	39.25"	Alter so the handrails are 34"- 38" high above the floor.	1	Labor	\$0
Elevator												
31	Elevator	2	203	Elevator	Interior

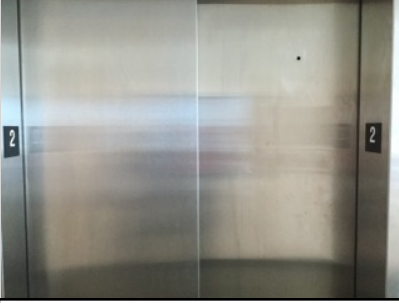
Hoistway signs < 48" > 60"	62"	Install hoistway signs on the inside of the door frame 60" above the finished floor.	1	Labor	\$0
32	Elevator - Concourse Level	1	122	Elevator	Exterior

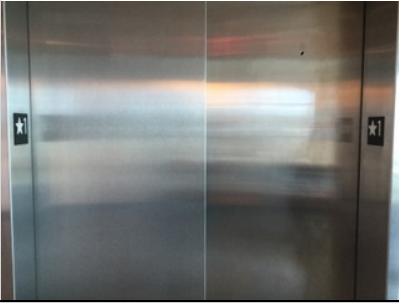
Hoistway signs < 48" > 60"	62"	Install hoistway signs on the inside of the door frame 60" above the finished floor.	1	Labor	\$0

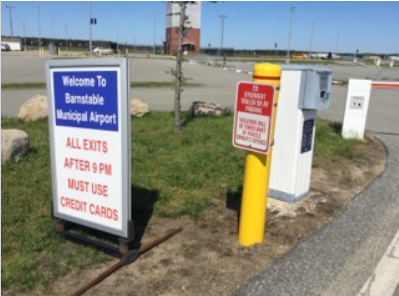
Signage												
33	Secondary Entrance From South West to South East Parking Lot & Accessible Parking Lot	Ext.		Signage	Informational

Visual characters < 40" above ground	28.25"	Mount visual sign so that the baseline of the lowest character is 40" min. above the finished floor.	1	Labor	\$0

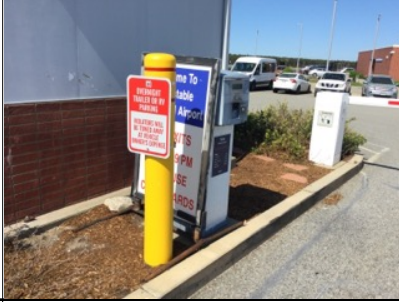
Visual characters < 40" above ground	25.25"	Mount visual sign so that the baseline of the lowest character is 40" min. above the finished floor.	1	Labor	\$0
35	Stair #2	1	158	Signage	Egress

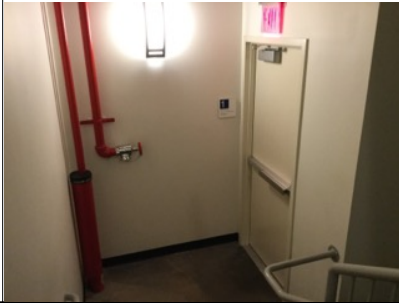
Sign not located on the latch side of the door	-	Locate sign alongside the door on the latch side.	1	Labor	\$0
36	Conference Room - Near Baggage Claim	1	101	Signage	Designation

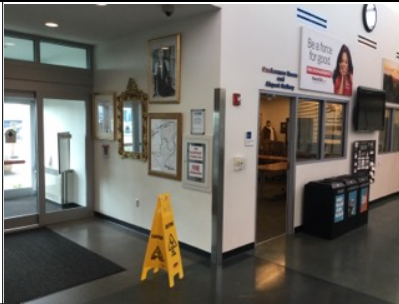
Sign not located on the latch side of the door	-	Locate sign alongside the door on the latch side. Relocate trash containers to maintain the required 18" min. clear floor space at the sign.	1	Labor	\$0
Service Counter												
37	Boarding Area - Near Toilet Room	1	166	Service Counter	N/A

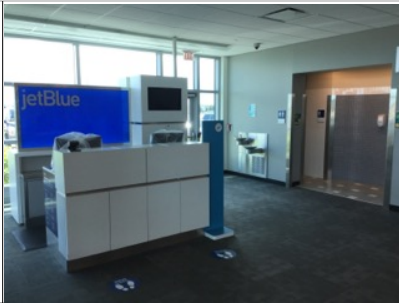
Counter > 36" high	50.25"	Provide a counter that is 36" max. above the ground or finished floor.	1	880	\$880

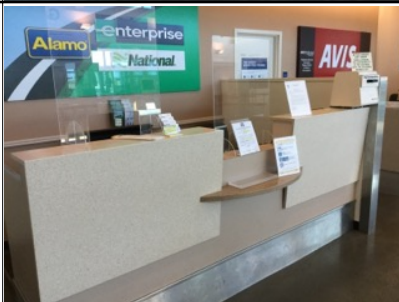
38	Rent a Car Counter	1	115	Service Counter	N/A

Counter not maintained in operable working condition	-	Remove items to ensure the accessible portion of the counter that is required to be readily accessible to and usable by persons with disabilities is maintained in operable working condition.	1	Labor	\$0

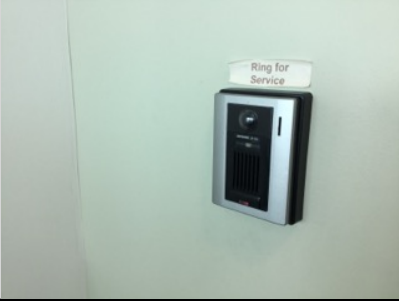
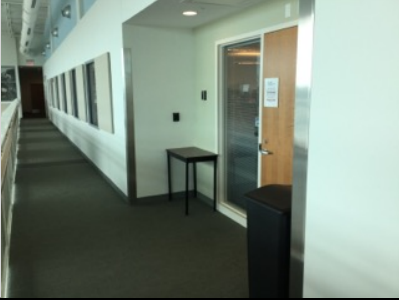
See ID #40.	1	-	\$0
40	Hallway	2	223	Operable Parts	Other

Side reach > 48"	57.75"	Relocate ring bell so that it is mounted 48" max. above the finished floor.	1	256	\$256
Toilet & Bathing Rooms												
Toilet Compartment												
41	Men's Toilet Room	1	172	Toilet Compartment	Accessible Compartment

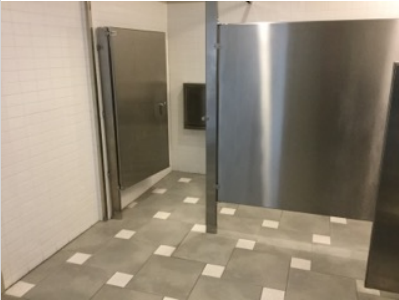
Door has malfunctioning self-closing hinge	-	Repair hinge.	1	Labor	\$0
42	Women's Toilet Room	1	162	Toilet Compartment	Accessible Compartment

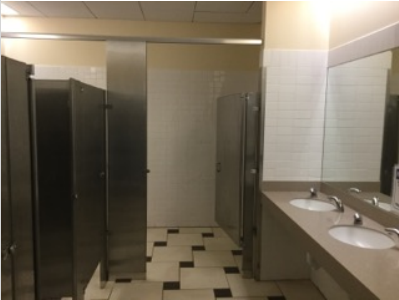
Door has malfunctioning self-closing hinge	-	Repair hinge.	1	Labor	\$0
43	Men's Toilet Room	1	163	Toilet Compartment	Accessible Compartment

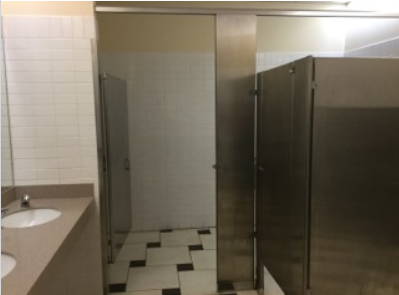
Door has malfunctioning self-closing hinge	-	Repair hinge.	1	Labor	\$0

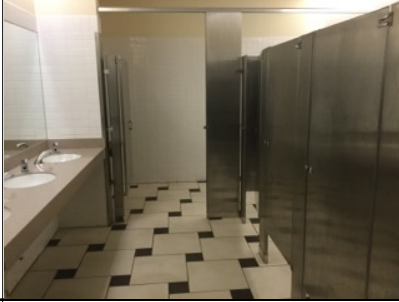
Door has malfunctioning self-closing hinge	-	Repair hinge.	1	Labor	\$0
45	Men's Toilet Room	1	126	Toilet Compartment	Accessible Compartment

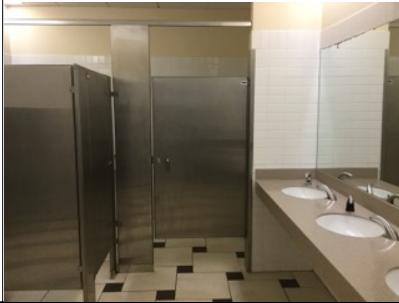
Door has malfunctioning self-closing hinge	-	Repair hinge.	1	Labor	\$0
46	Women's Toilet Room	1	171	Toilet Compartment	Accessible Compartment

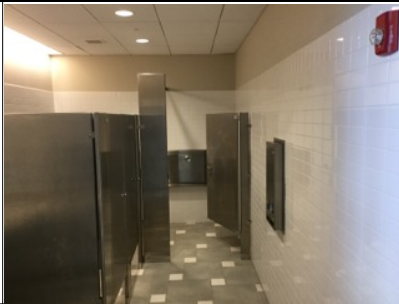
Door has malfunctioning self-closing hinge	-	Repair hinge.	1	Labor	\$0
Additional Access												
Drinking Fountains												
47	Water Fountains Near Restrooms Between Concourse and Ticketing Hall	1	162, 163	Drinking Fountains	Hi-Lo

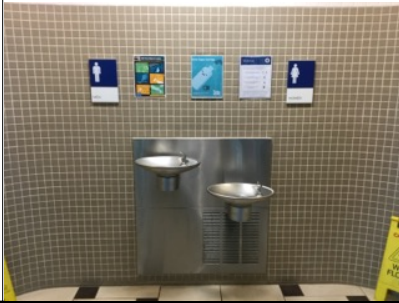
Standing height fountain does not have cane protection	-	Provide a cane-detectable barrier skirt under the high unit.	1	890	\$890
48	Water Fountain Near Restroom - Concourse	1	126, 127	Drinking Fountains	High

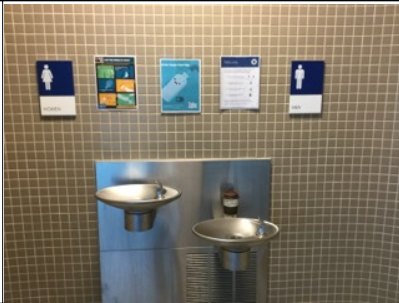
Standing height fountain does not have cane protection	-	Provide a cane-detectable barrier skirt under the high unit.	1	890	\$890

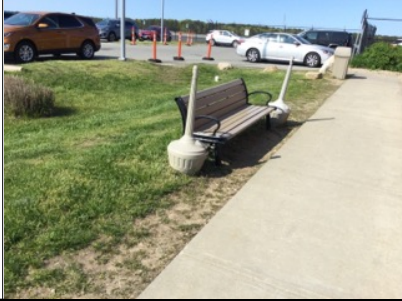
Recommend providing a 30" by 48" clear ground space adjacent to the bench.	1	-	\$0
Display												
50	Baggage Claim	1	107	Display	N/A

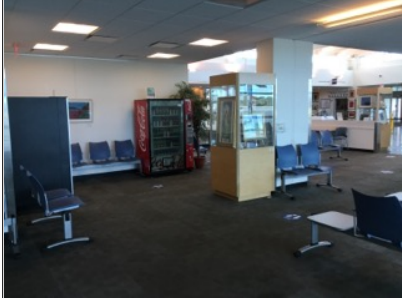
-	Relocate display to avoid glare.	1	-	\$0
Parking Lot												
51	Parking Near Departures	Ext.		Parking Lot	N/A

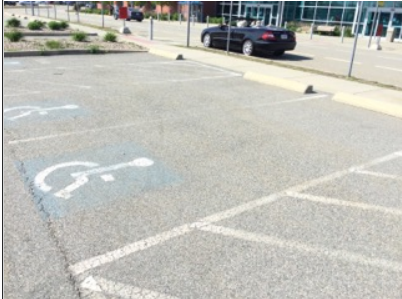
Recommending resurfacing the parking lot as the painting is fading.	1	-	\$0
Podium												
52	Conference Room	1	101	Podium	N/A

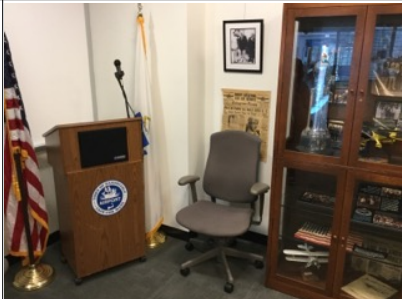
Recommend providing an adjustable podium with knee and toe clearance.	1	-	\$0

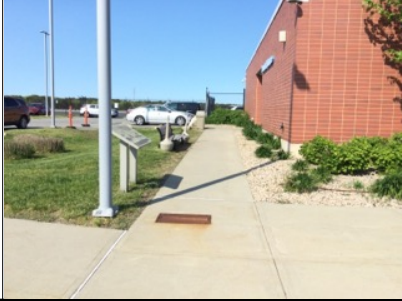
Recommend locating wayside closer to the walkway.	1	-	\$0
Signage												
54	Hallway	2	236	Signage	N/A

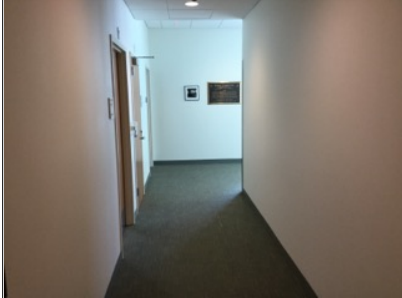
Recommend providing a directional sign at this location.	1	-	\$0
Gate												
55	Entry to Cafe From Outside	Ext.	177	Gate	N/A

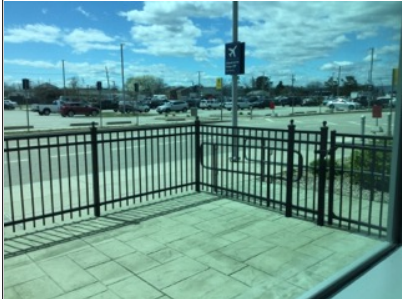
Recommended providing a gate surface within 10" of the finished floor on the push side of the gate.	1	-	\$0
Signage												
56	Entry to Airport Staff Offices	2	223	Signage	N/A

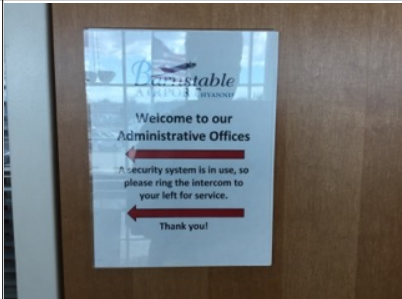
-	Recommend relocating the sign to avoid glare.	1	-	\$0
