# Band Shell

## Town of Barnstable ADA Transition Plan

July 2021

**Town of Barnstable  
Band Shell**

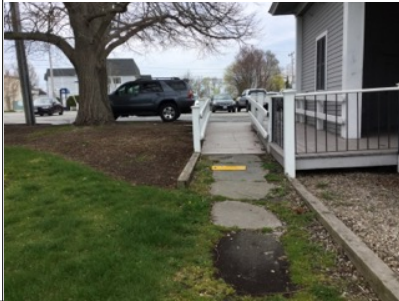
Accessibility issues include lack of a firm, stable and slip-resistant walkway from the base of the ramp where it meets the Village Green running along the Band Shell structure to the northwest corner at the front of the stage.

ID	Location	Floor	Room	Element	Type	Photo	Issues	Current Measure	Recommendations	Quantity	Price	Cost Estimation
<b>Approach and Entrance</b>												
<b>Exterior Access Route</b>												
1	Walkway From Base of Ramp to Front of Band Shell	Ext		Exterior Access Route	Exterior

Cross slope > 1:50 (2.00%) Surface is not stable, firm, and slip-resistant	3.4% -	Reduce cross slope to be no steeper than 1:50 (2.00%). Repair surface.  (Cost based on a 4' wide min. x 30' long stone dust path from the base of the ramp running along the Band Shell structure to the northwest corner at by the front of the stage.)	1	960	\$960
<b>Access to Goods and Services</b>												
<b>Ramps</b>												
2	Ramp From Ocean Street Parking Lot to Village Green (Right Side)	Ext		Ramps	Exterior

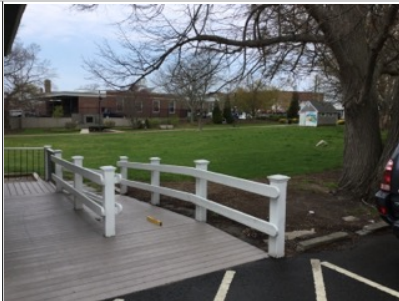
Accessibility issues include lack of edge protection and lack of handrails with a compliant cross section at the ramp from the Ocean Street Parking Lot to the Village Green.

Handrails do not extend 12" past top & bottom Handrails have non-compliant cross section Handrails not continuous where required	- - -	Alter handrails to extend horizontally above the landing for 12" min. beyond the bottom of the ramp run. Provide handrails with 1-1/4" to 1-1/2" circular cross section. Provide continuous handrails for the length of the ramp run. (Cost based on 4 30' sections of metal handrail (upper and lower) with a compliant cross section for right-side ramp.)	1	\$8880	\$8880

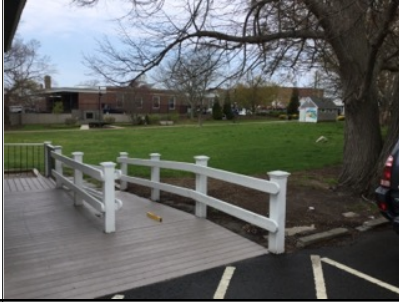
3	Ramp From Ocean Street Parking Lot to Village Green (Right Side)	Ext		Ramps	Exterior

Edge protection < 4" high	-	Provide edge protection that prevents the passage of a 4" diameter sphere, where any portion of the sphere is within 4" of the finished floor or ground surface.  (Cost based on 30' of edge protection along the right-most side of the ramp to the Village Green.)	1	2520	\$2520
<b>Best Practice</b>												
<b>Bench</b>												
4	Ext.	Ext		Bench	N/A
