Barnstable Harbor Marina

ADA Transition Plan

October 2021

Institute for Human Centered Design

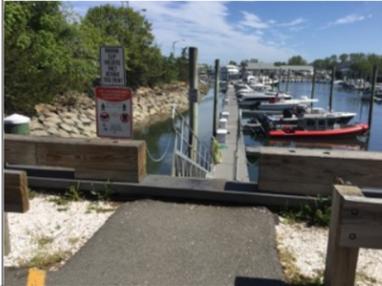
ID	Location	Floor	Room	Element	Type	Photo	Issues	Current Measure	Recommendations	Quantity	Price	Cost Estimation
Approach and Entrance												
Exterior Access Route												
1	Dock Ramp 4	Ext.		Exterior Access Route	Dock

Exterior route < 36" wide Level changes > 1/4"	29" 6.75"	Ensure that a clear width of 36" min. is maintained at the accessible route. Alter change in level to be 1/4" high max.	1	-	\$0
2	Dock Ramp 2	Ext.		Exterior Access Route	Walkway

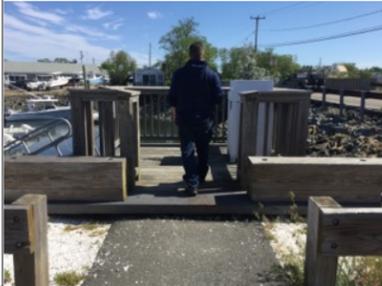
Level changes > 1/4"	6"	Alter change in level to be 1/4" high max.	1	-	\$0
3	Dock Ramp 3 Left Side	Ext.		Exterior Access Route	Sidewalk

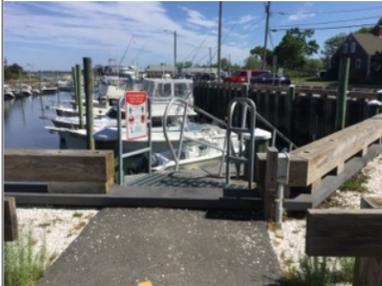
Level changes > 1/4"	5"	Alter change in level to be 1/4" high max.	1	-	\$0
4	Route from Parking Lot to Dock	Ext.		Exterior Access Route	Walkway

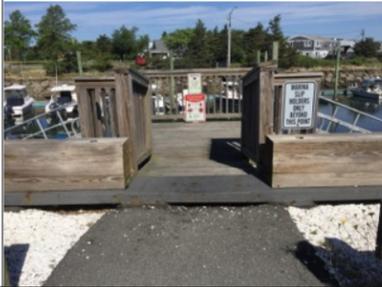
Level changes > 1/4" Accessible route not provided	5.5" -	Alter change in level to be 1/4" high max. Ensure an accessible route is provided.	1	-	\$0
Off-Street Parking Lot or Garage

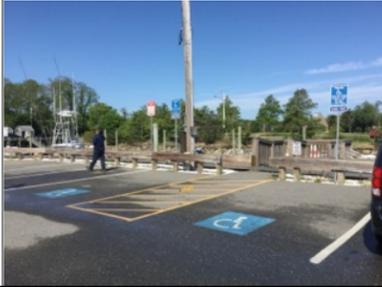
5	Parking Lot Accessible Parking Space East Side	Ext.		Off-Street Parking Lot or Garage	Visitor

Sign does not have the designation "Van Accessible" Sign top > 96" above finished grade	- 111"	Add the designation "Van Accessible" to the sign located at the van accessible space. Locate sign with the top of the sign 96" above the ground.	1	500	\$500

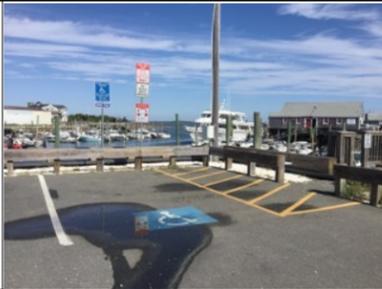
ID	Location	Floor	Room	Element	Type	Photo	Issues	Current Measure	Recommendations	Quantity	Price	Cost Estimation
6	Accessible Parking Space North Side	Ext.		Off-Street Parking Lot or Garage	Visitor

Sign top > 96" above finished grade	107"	Locate sign with the top of the sign 96" above the ground.	1	Labor	\$0
Access to Goods and Services												
Ramps												
8	Dock Ramp Right Side by Accessible Parking	Ext.		Ramps	Exterior

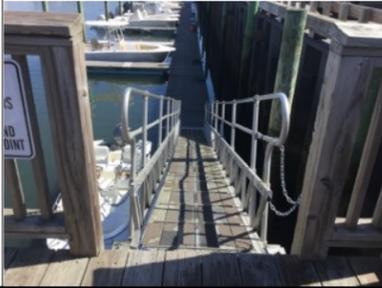
Ramp < 36" wide	29"	Widen ramp so that the clear width is 36" min. (Repair to this ramp might be technically infeasible.)	1	-	\$0
9	Dock Ramp 3 Left Side	Ext.		Ramps	Exterior

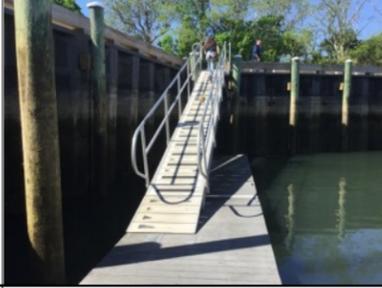
Ramp < 36" wide	31.5"	Widen ramp so that the clear width is 36" min. (Repair to this ramp might be technically infeasible.)	1	-	\$0
10	Dock Ramp 5	Ext.		Ramps	Exterior

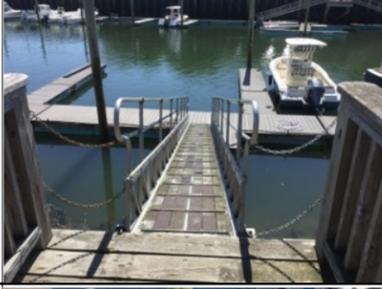
Ramp < 36" wide Running slope >1:12 (8.33%)	29" 32.1%	Widen ramp so that the clear width is 36" min. (Repair to this ramp might be technically infeasible.) Reduce running slope to be no steeper than 1:12 (8.33%)./Repair to this ramp might be technically infeasible.	1	-	\$0

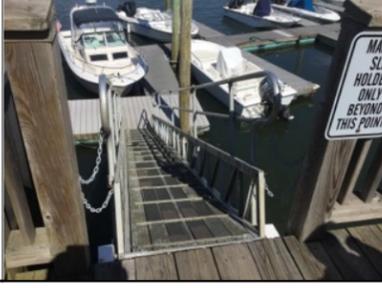
7	Dock Ramp 2	Ext.		Ramps	Exterior

Ramp < 36" wide Running slope >1:12 (8.33%) Handrails do not extend 12" past top & bottom	30" 52.5% -	Widen ramp so that the clear width is 36" min. (Repair to this ramp might be technically infeasible.) Reduce running slope to be no steeper than 1:12 (8.33%)./Repair to this ramp might be technically infeasible. Alter handrails to extend horizontally above the landing for 12" min. beyond the top and bottom of ramp runs.	1	-	\$0

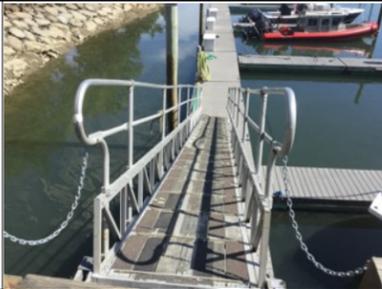
ID	Location	Floor	Room	Element	Type	Photo	Issues	Current Measure	Recommendations	Quantity	Price	Cost Estimation
11	Dock Ramp 4	Ext.		Ramps	Exterior

Ramp < 36" wide Running slope >1:12 (8.33%) Handrails do not extend 12" past top & bottom	19" 38.3% -	Widen ramp so that the clear width is 36" min. (Repair to this ramp might be technically infeasible.) Reduce running slope to be no steeper than 1:12 (8.33%)./Repair to this ramp might be technically infeasible. Alter handrails to extend horizontally above the landing for 12" min. beyond the top and bottom of ramp runs.	1	-	\$0
12	Dock Ramp 1 Right Side by Accessible Parking	Ext.		Ramps	Exterior

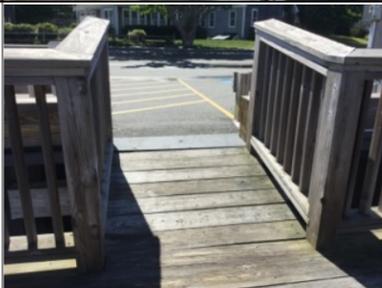
Running slope >1:12 (8.33%) Handrails do not extend 12" past top & bottom Handrails have non-compliant cross section	16.3% - -	Widen ramp so that the clear width is 36" min. (Repair to this ramp might be technically infeasible.) Alter handrails to extend horizontally above the landing for 12" min. beyond the top and bottom of ramp runs. Provide handrails with 1-1/4" to 1-1/2" circular cross section.	1	-	\$0

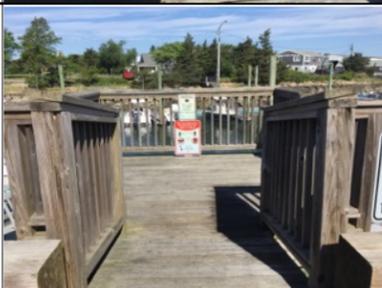
13	Dock Ramp 1 Left Side by Accessible Parking	Ext.		Ramps	Exterior

Handrails < 34" or > 38" above ramp surface Handrails do not extend 12" past top & bottom Handrails have non-compliant cross section	45.25" - -	Alter so the handrails are 34"- 38" high above the ramp surface. Alter handrails to extend horizontally above the landing for 12" min. beyond the top and bottom of ramp runs. Provide handrails with 1-1/4" to 1-1/2" circular cross section.	1	-	\$0
14	Dock Ramp 2	Ext.		Ramps	Exterior

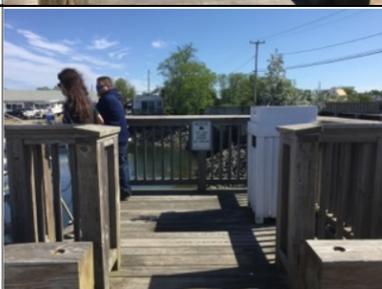
Handrails < 34" or > 38" above ramp surface Handrails do not extend 12" past top & bottom Handrails have non-compliant cross section	45" - -	Alter so the handrails are 34"- 38" high above the ramp surface. Alter handrails to extend horizontally above the landing for 12" min. beyond the top and bottom of ramp runs. Provide handrails with 1-1/4" to 1-1/2" circular cross section.	1	-	\$0
15	Dock Ramp 5	Ext.		Ramps	Exterior

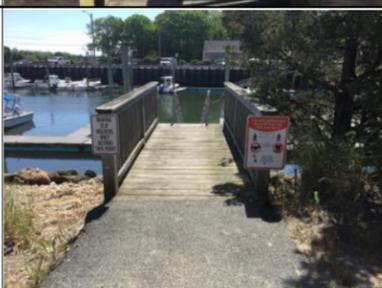
Handrails < 34" or > 38" above ramp surface Handrails do not extend 12" past top & bottom Handrails have non-compliant cross section	39.5" - -	Alter so the handrails are 34"- 38" high above the ramp surface. Alter handrails to extend horizontally above the landing for 12" min. beyond the top and bottom of ramp runs. Provide handrails with 1-1/4" to 1-1/2" circular cross section.	1	-	\$0

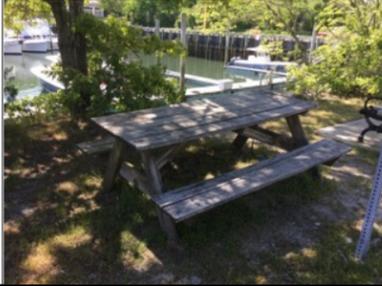
ID	Location	Floor	Room	Element	Type	Photo	Issues	Current Measure	Recommendations	Quantity	Price	Cost Estimation
Picnic Tables												
16	Picnic Table Next to Dock Ramp 5	Ext.		Picnic Tables	N/A

Toe or knee clearance at table not provided	-	Provide at least one picnic table with top between 28"- 34" above the ground and 27" clear height underneath.	1	1400	\$1400
17	Picnic Table Next to Dock Ramp 5	Ext.		Picnic Tables	N/A

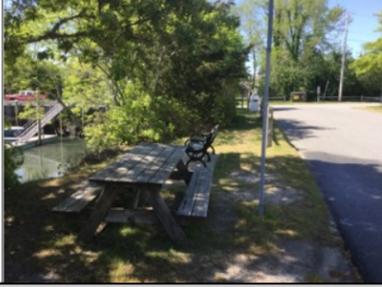
Picnic table not on an accessible route	-	Ensure that the dining surface is connected to an accessible route.	1	240	\$240
Benches												
18	Memorial	Ext.		Benches	N/A

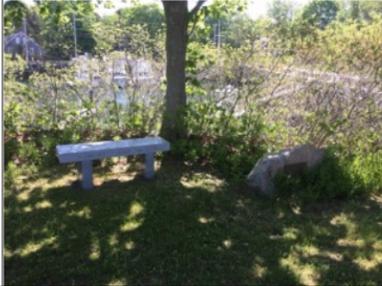
No accessible route to one bench in this area	-	Provide an accessible route to the bench.	1	240	\$240
19	Bench Next to Dock Ramp 5	Ext.		Benches	N/A

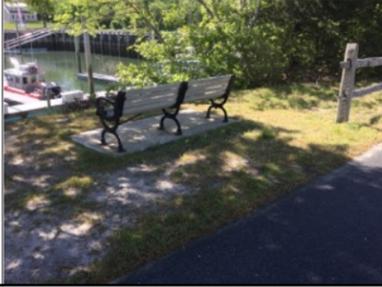
No accessible route to one bench in this area	-	Provide an accessible route to the bench.	1	240	\$240
