Marine and Environmental Affairs

ADA Transition Plan

October 2021

**Town of Barnstable
Marine Environmental Affairs**

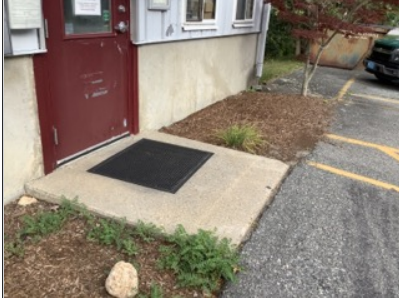
Surface openings > 1/2" Route not maintained in operable working condition	2" -	Renovate so that openings are 1/2" max. and the long opening dimension is perpendicular to the dominant direction of travel. Ensure the accessible route is maintained in operable working condition. (Cost provided in ID #2.)	1	-	\$0
2	Main Entrance/ Egress	Ext.		Exterior Access Route	Exterior

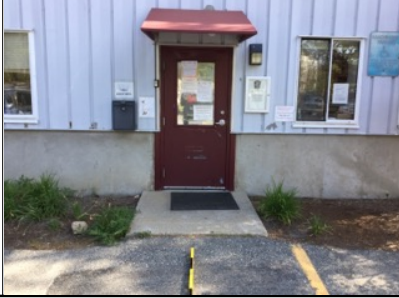
Running slope > 1:20 (5%) Level changes > 1/4"	12.1% 0.75"	Reduce running slope to be no steeper than 1:20 (5%). Alter change in level to be 1/4" high max. (Cost estimate of 4' wide min. by 6' long asphalt path.)	1	240	\$240
Off-Street Parking Lot or Garage												
3	Parking Lot	Ext.		Off-Street Parking Lot or Garage	Visitor

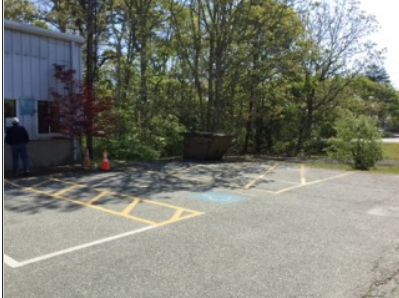
Running or cross slope at access aisle > 1:50 (2.00%)	3.6%	Reduce running or cross slope to be no steeper than 1:50 (2.00%).	1	1440	\$1440

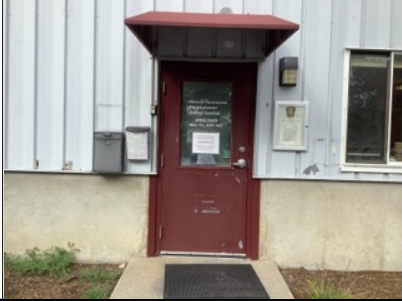
Maneuvering clearance is not provided	5"	Provide an automatic door opener.	1	3060	\$3060
Emergency Exit												
6	Main Entrance/ Egress	1		Emergency Exit	N/A

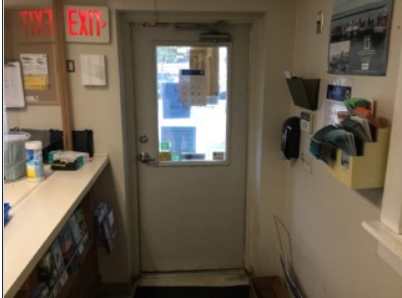
Tactile sign not provided at exit Illuminated Int. Symbol of Acc. not provided (MAAB) Maneuvering clearance not provided at recess > 6"	- - 11"	Provide tactile exit signs with raised characters and braille at exit doors. Mount signs between 48"- 60" above the finished floor located on the latch side of the door. If the exit sign is replaced with an illuminated exit sign, provide an illuminated International Symbol of Accessibility (ISA). (Cost of automatic door opener provided in ID #5.)	1	432	\$432
Access to Goods and Services												
Interior Access Route

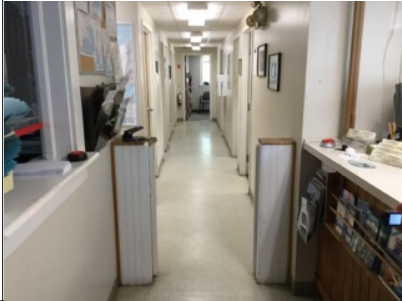
7	Reception to Toilet Rooms	1		Interior Access Route	N/A

Route < 36" wide	28.75"	Ensure that a clear width of 36" min. is maintained at the accessible route.	1	Labor	\$0
8	Men's Toilet Room	1		Interior Access Route	N/A

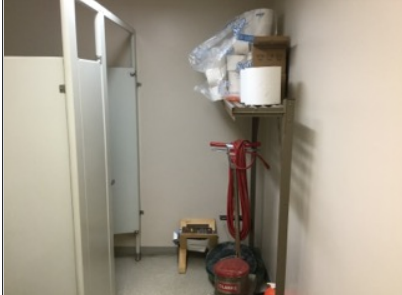
Route < 36" wide Obstructed by protruding objects	24" 12"	Remove furniture to ensure that a clear width of 36" min. is maintained at the accessible route.	1	Labor	\$0

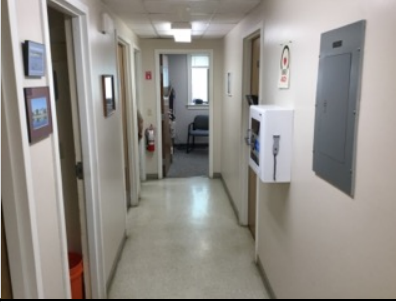
Obstructed by protruding objects	7"	Provide a cane-detectable barrier.	1	306	\$306
10	Service Counters	1		Interior Access Route	N/A

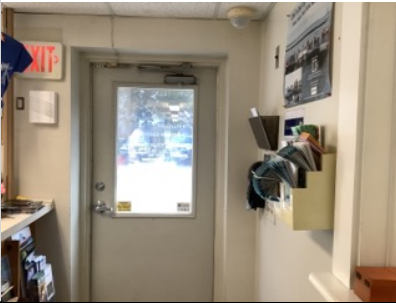
Obstructed by protruding objects	5.25"	Provide a cane-detectable barrier.	1	306	\$306
Doors, Doorways, & Gates												
11	Women's Toilet Room	1		Doors, Doorways, & Gates	Toilet Room

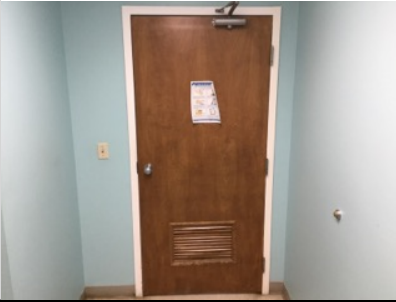
Maneuvering clearance(s) not provided	16.5"	Install an automatic door opener.	1	3060	\$3060
12	Men's Toilet Room	1		Doors, Doorways, & Gates	Toilet Room

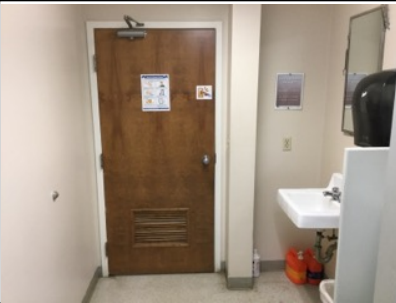
Maneuvering clearance not provided at recess > 6"	10"	Install an automatic door opener.	1	3060	\$3060
13	Women's Toilet Room	1		Doors, Doorways, & Gates	Toilet Room

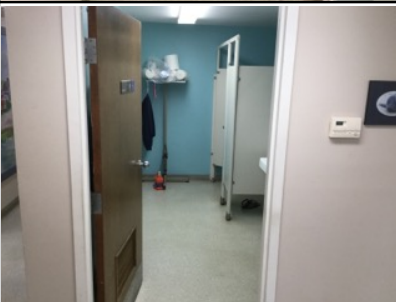
Hardware not operable with a closed fist No visible fire alarm provided within room	-	Provide hardware that can be operable with one hand and not require tight grasping, pinching, or twisting of the wrist. When fire system is updated, ensure that a visible fire alarm is installed in each room.	1	484	\$484

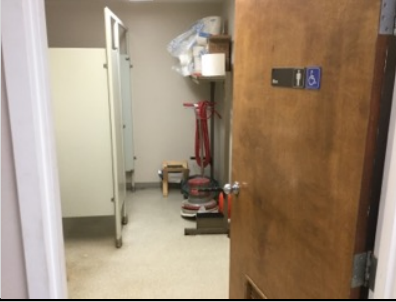
Hardware not operable with a closed fist No visible fire alarm provided within room	-	Provide hardware that can be operable with one hand and not require tight grasping, pinching, or twisting of the wrist. When fire system is updated, ensure that a visible fire alarm is installed in each room.	1	484	\$484
Signage												
15	Women's Toilet Room	1		Signage	Designation

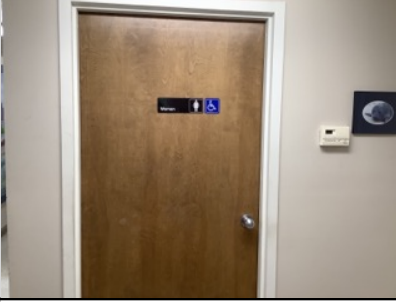
Raised characters not provided on sign Braille not provided on sign Sign not located on the latch side of the door	- - -	Provide text with raised characters duplicated in braille on sign. Locate sign at permanent rooms alongside the door on the latch side.	1	232	\$232
16	Men's Toilet Room	1		Signage	Designation

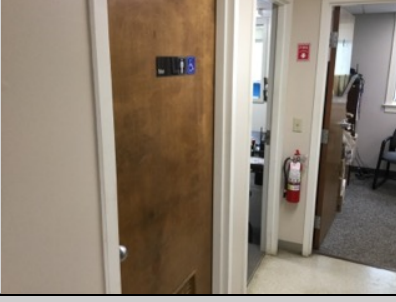
Raised characters not provided on sign Braille not provided on sign Sign not located on the latch side of the door	- - -	Provide text with raised characters duplicated in braille on sign. Locate sign at permanent rooms alongside the door on the latch side.	1	232	\$232

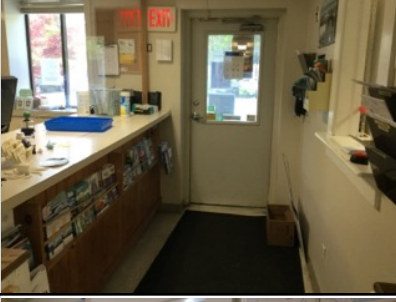
Counter > 36" high	42.75"	Provide a counter that is 36" max. above the finished floor.	1	880	\$880
18	Reception	1		Service Counter	N/A

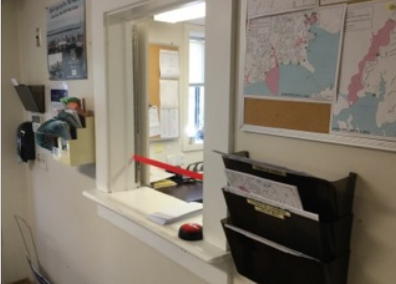
Counter > 36" high	44.5"	Provide a counter that is 36" max. above the ground.	1	880	\$880

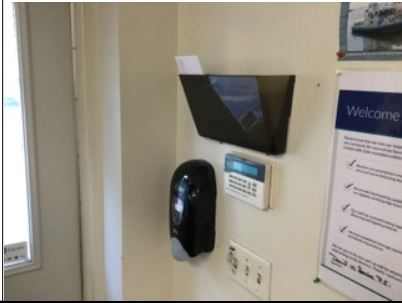
Side reach > 54"	65"	Relocate brochures so that controls are between 15" - 48" above the finished floor.	1	Labor	\$0
Toilet & Bathing Rooms												
Lavatory												
21	Women's Toilet Room	1		Lavatory	N/A

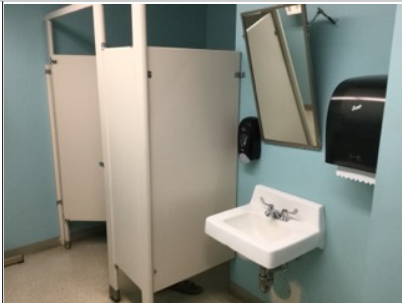
Toe or knee clearances not provided Plumbing underneath is exposed Mirror above lavatory w/reflective surface > 40"	23.5" 47" 43.5"	Provide at least one lavatory with knee and toe clearance positioned for a forward approach. Insulate or otherwise configure pipes to prevent contact for at least one lavatory. Lower mirror so that the bottom surface is at 40" max. above the finished floor.	1	2034	\$2034

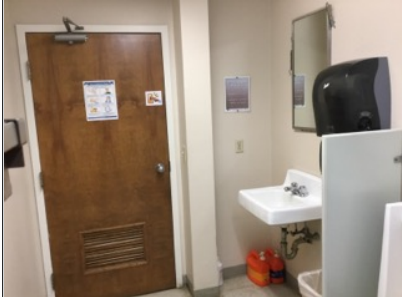
22	Men's Toilet Room	1		Lavatory	N/A

Plumbing underneath is exposed Mirror above lavatory w/reflective surface > 40"	- 50"	Insulate or otherwise configure pipes to prevent contact for at least one lavatory. Lower mirror so that the bottom surface is at 40" max. above the finished floor.	1	348	\$348

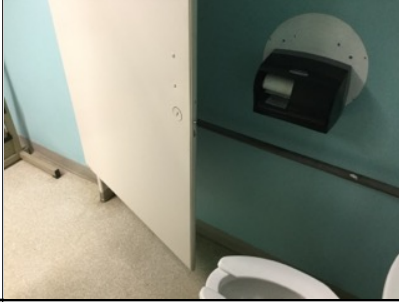
Door has malfunctioning self-closing hinge	-	Repair hinge.	1	Labor	\$0
24	Women's Toilet Room	1		Toilet Compartment	Accessible Compartment

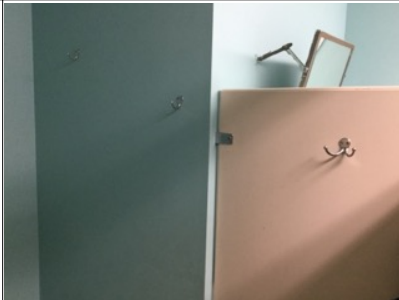
Door has malfunctioning self-closing hinge Coat hook > 48"	- 64"	Repair hinge. Lower coat hook so that it is no higher than 48".	1	150	\$150
25	Men's Toilet Room	1		Toilet Compartment	Accessible Compartment

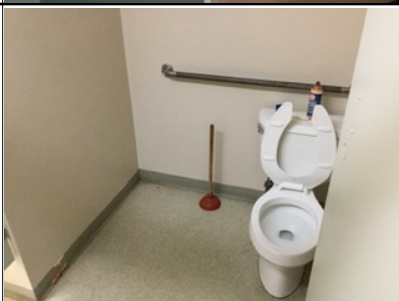
Toilet seat <17" or > 19" high Non-compliant toilet paper dispenser Clearance at toilet < 72" clear depth (MAAB) Centerline < or > 18" (MAAB)	14.5" 47.75" 71.5" 16.5"	Install a toilet with a seat height 17"- 19" above the floor. Relocate toilet paper so that it is 24" min. high, located under the grab bar, and between 7" and 9" from the front of the toilet. Provide a wheelchair accessible compartment that is 60" wide and 72" deep. Relocate toilet so the centerline is 18" from the side wall.	1	9266	\$9266

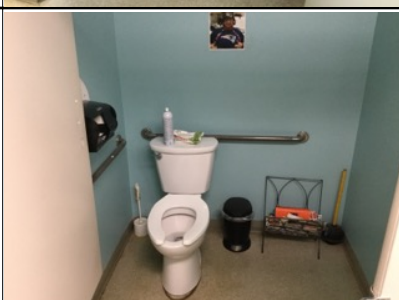
26	Women's Toilet Room	1		Toilet Compartment	Accessible Compartment

Side or rear grab bar < 33" or >36" high Flush control not on open side Non-compliant toilet paper dispenser Clearance at toilet < 72" clear depth (MAAB) Centerline < or > 18" (MAAB)	31" - 41.5" 67.75" 19"	Locate grab bars between 33"- 36" above the finished floor. Provide the flush control on the open side of the toilet (transfer side). Relocate toilet paper so that it is 24" min. high, located under the grab bar, and between 7" and 9" from the front of the toilet. Provide a wheelchair accessible compartment that is 60" wide and 72" deep. Relocate toilet so the centerline is 18" from the side wall.	1	9842	\$9842
27	Men's Toilet Room	1		Toilet Compartment	Accessible Compartment

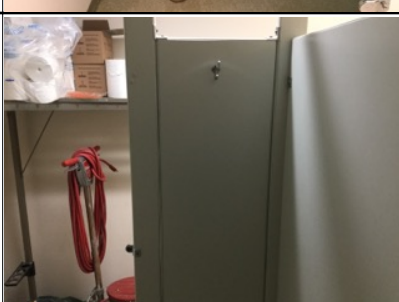
Coat hook > 48"	65.5"	Lower coat hook so that it is no higher than 48".	1	150	\$150

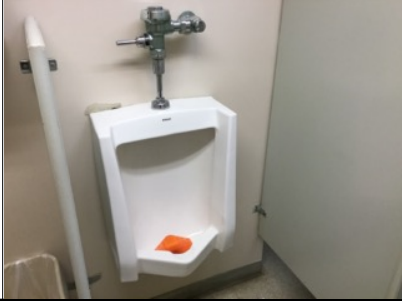
Rim > 17" high Flush control too high or not properly located	23.5" 51.75"	Provide at least one urinal with the rim no higher than 17" above the finished floor. Mount flush control at 44" max. above the finished floor.	1	3248	\$3248
Dispensers												
29	Men's Toilet Room	1		Dispensers	Paper Towel Dispenser

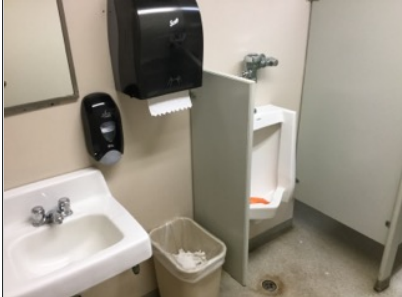
Controls > 42" high	51.25"	Relocate so the operable part is 42" max. above the finished floor.	1	256	\$256
