US Custom House Museum and Carriage House

Town of Barnstable ADA Transition Plan

September 2021

Town of Barnstable
US Custom House Museum and Carriage House

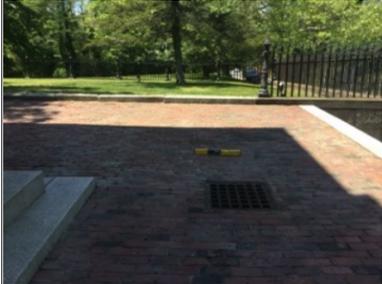
ID	Location	Floor	Room	Element	Type	Photo	Issues	Current Measure	Recommendations	Quantity	Price	Cost Estimation
Approach and Entrance												
Exterior Access Route												
1	Path to Open Field at East Side	1		Exterior Access Route	Exterior

Cross slope > 1:50 (2.00%)	2.9%	Reduce cross slope to be no steeper than 1:50 (2.00%).	1	-	\$0
2	Main Street (West Side)	1		Exterior Access Route	Sidewalk

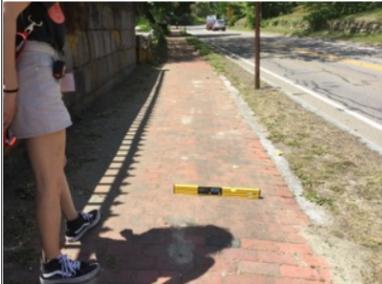
Cross slope > 1:50 (2.00%)	4%	Reduce cross slope to be no steeper than 1:50 (2.00%).	1	-	\$0
3	Main Street (East Side)	Ext.		Exterior Access Route	Sidewalk

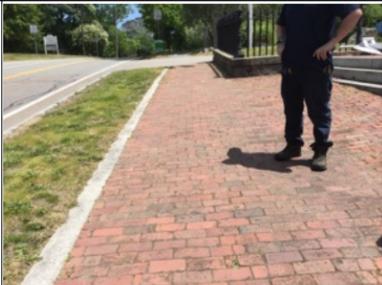
Cross slope > 1:50 (2.00%)	5.7%	Reduce cross slope to be no steeper than 1:50 (2.00%).	1	-	\$0
4	Main Street (East Side)	Ext.		Exterior Access Route	Sidewalk

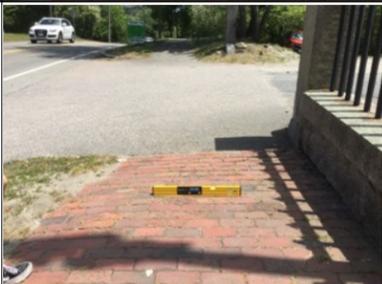
Cross slope > 1:50 (2.00%)	5,2%	Reduce cross slope to be no steeper than 1:50 (2.00%).	1	-	\$0
5	Main Street (West Side)	Ext.		Exterior Access Route	Sidewalk

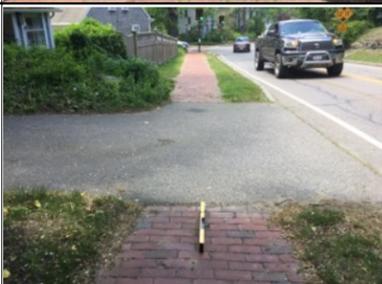
Running slope > 1:20 (5%)	9.6%	Reduce running slope to be no steeper than 1:20 (5%).	1	-	\$0

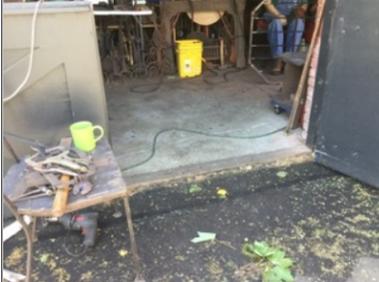
ID	Location	Floor	Room	Element	Type	Photo	Issues	Current Measure	Recommendations	Quantity	Price	Cost Estimation
6	Carriage House West Side Door	Ext.		Exterior Access Route	Exterior

Level changes > 1/4"	1"	Alter change in level to be 1/4" high max.	1	160	\$160
7	Carriage House East Side Door	Ext.		Exterior Access Route	Walkway

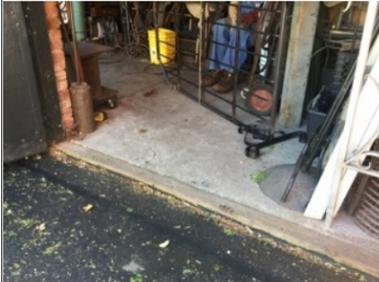
Level changes > 1/4"	1.5"	Alter change in level to be 1/4" high max.	1	160	\$160
8	Rear Entrance (South Side)	Ext.		Exterior Access Route	Walkway

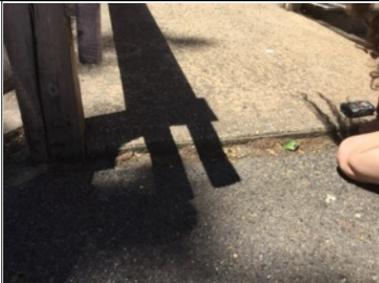
Level changes > 1/4" Does not prevent accumulation of water	2" -	Alter change in level to be 1/4" high max. Repair surface.	1	160	\$160
9	Main Street (West Side)	Ext.		Exterior Access Route	Sidewalk

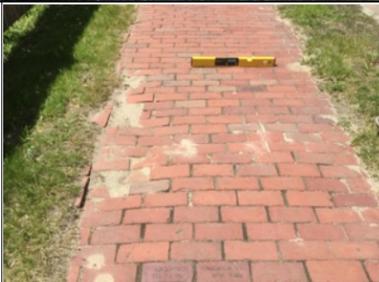
Route not maintained in operable working condition	-	Ensure the accessible route is maintained in operable working condition.	1	-	\$0
10	Entrance to Parking	Ext.		Exterior Access Route	Exterior

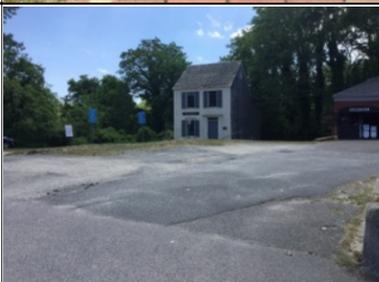
Route not maintained in operable working condition	-	Ensure the accessible route is maintained in operable working condition.	1	-	\$0

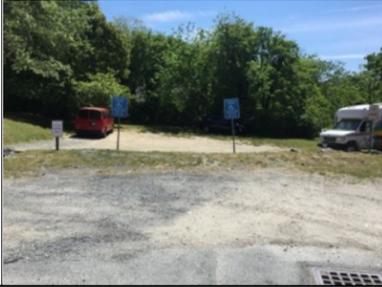
ID	Location	Floor	Room	Element	Type	Photo	Issues	Current Measure	Recommendations	Quantity	Price	Cost Estimation
Off-Street Parking Lot or Garage												
11	Parking Lot	Ext.		Off-Street Parking Lot or Garage	Visitor

Access aisle not provided Surface not stable, firm, and slip-resistant	- -	Provide a marked access aisle that is at least 96" wide. Repair surface.	1	300	\$300
Exterior Ramp												
12	Rear Entrance (South Side)	Ext.		Exterior Ramp	N/A

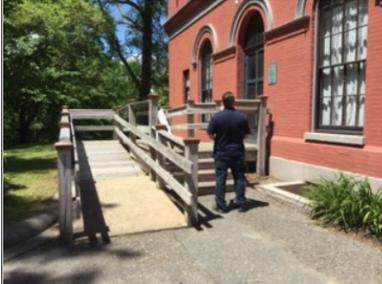
Handrails have non-compliant cross section Edge protection < 4" high	- -	Provide handrails with 1-1/4" to 1-1/2" circular cross sections. Provide edge protection that prevents the passage of a 4" diameter sphere, where any portion of the sphere is within 4" of the finished floor or ground surface.	1	3900	\$3900
Entrance												
13	Main Entrance (north side)	1		Entrance	Main Entrance

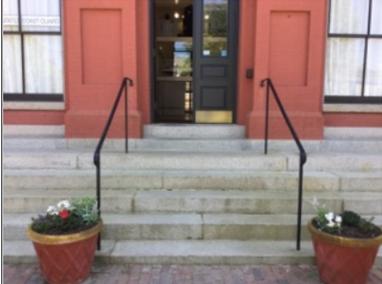
Directional sign to accessible entrance not provided	-	Provide a directional sign indicating the location of the nearest accessible entrance.	1	346	\$346

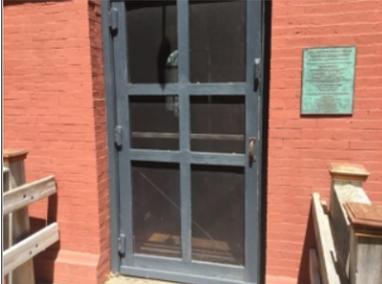
14	Rear Entrance (South Side)	1		Entrance	Secondary Entrance

International Symbol of Accessibility not provided	-	Provide a sign with the International Symbol of Accessibility (ISA).	1	346	\$346
Access to Goods and Services

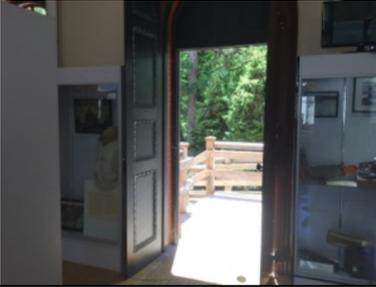
ID	Location	Floor	Room	Element	Type	Photo	Issues	Current Measure	Recommendations	Quantity	Price	Cost Estimation
Means of Egress												
15	Rear Egress (South Side)	1		Means of Egress	N/A

Tactile exit sign not provided	- -	Ensure tactile exit signs with raised characters and braille are provided at exit doors. Mount signs between 48"- 60" above the finished floor located on the latch side of the door. If an illuminated exit sign is provided, ensure it has the illuminated International Symbol of Accessibility (ISA).	1	232	\$232
16	Main Entrance (North Side)	1		Means of Egress	N/A

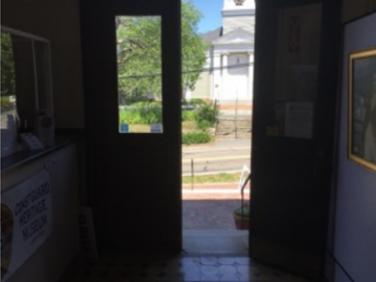
Directional sign to accessible emergency exit not provided	-	Provide a directional sign indicating the location of the nearest accessible emergency exit.	1	232	\$232
Interior Access Route												
17	Exhibit Area	1		Interior Access Route	N/A

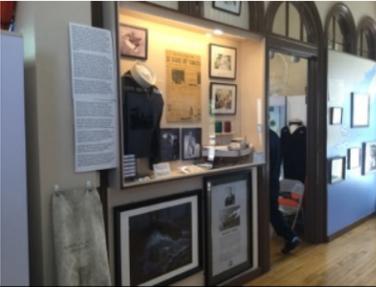
Obstructed by protruding objects	-	Provide a cane-detectable barrier at the exhibit.	1	306	\$306

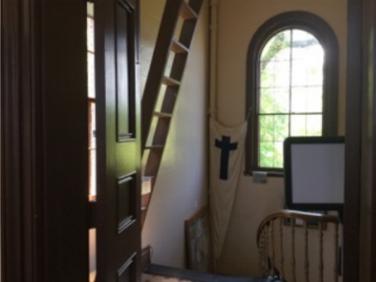
18	From Exhibit Area to Stairs	2		Interior Access Route	N/A

Obstructed by protruding objects	-	Provide a cane-detectable barrier.	1	306	\$306
Doors, Doorways, & Gates												
19	Exhibit Area	2		Doors, Doorways, & Gates	Circulation

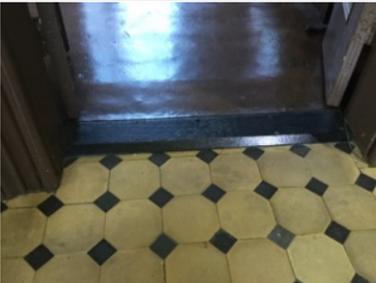
Threshold > 1/2" high	1.5"	Alter the threshold to be 1/2" high max.	1	-	\$0

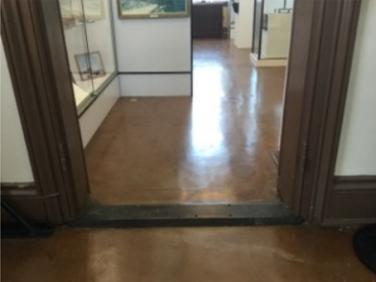
ID	Location	Floor	Room	Element	Type	Photo	Issues	Current Measure	Recommendations	Quantity	Price	Cost Estimation
20	Exhibit Area	2		Doors, Doorways, & Gates	Circulation

Threshold > 1/2" high	1.5"	Alter the threshold to be 1/2" high max.	1	-	\$0
21	Exhibit Area	2		Doors, Doorways, & Gates	Circulation

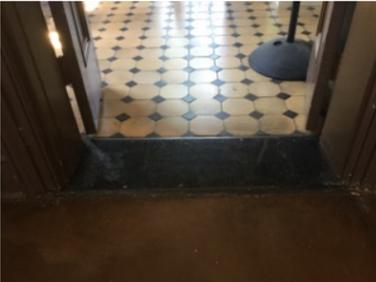
Threshold > 1/2" high	1.5"	Alter the threshold to be 1/2" high max.	1	-	\$0
22	Single-User Toilet Room	1		Doors, Doorways, & Gates	Toilet Room

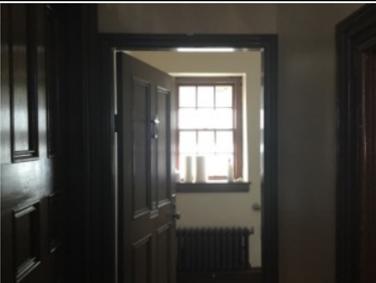
Hardware not operable with a closed fist	-	Provide hardware that can be operable with one hand and not require tight grasping, pinching, or twisting of the wrist.	1	484	\$484
Signage												
23	Toilet Room	1		Signage	Designation

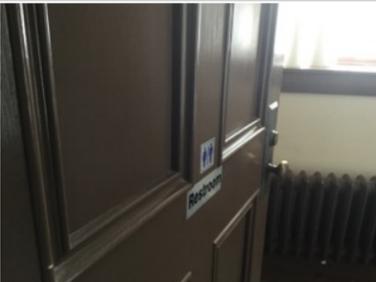
Raised characters not provided on sign Braille not provided on sign Sign not located on the latch side of the door	- - -	Provide text with raised characters duplicated in braille on sign. Locate sign at permanent rooms alongside the door on the latch side.	1	232	\$232

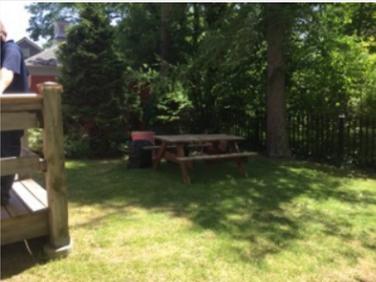
Picnic Tables												
24	Near Rear Entrance (West Side)	Ext.		Picnic Tables	N/A

At least 5% accessible spaces not provided Picnic table not on an accessible route	- -	Ensure that one (1) picnic table is accessible. Ensure that the picnic table is connected to an accessible route.	1	1400	\$1400
Toilet & Bathing Rooms

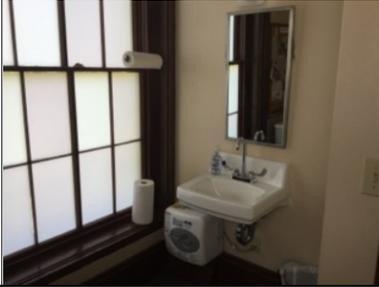
ID	Location	Floor	Room	Element	Type	Photo	Issues	Current Measure	Recommendations	Quantity	Price	Cost Estimation
Lavatory												
25	Single-User Toilet Room	1		Lavatory	N/A

Toe or knee clearances not provided Plumbing underneath is exposed	25.75" -	Provide at least one lavatory with knee and toe clearance positioned for a forward approach. Insulate or otherwise configure pipes to prevent contact for at least one lavatory.	1	1778	\$1778
Single-User Toilet												
26	Single-User Toilet Room	1		Single-User Toilet	N/A

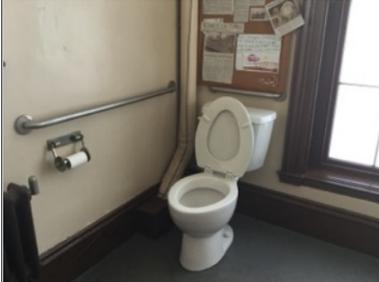
Flush control not on open side Centerline < or > 18" (MAAB) Rear grab bar < 42" long (MAAB)	- 19.5" 18"	Relocate the flush control to the open side. Relocate toilet so that the centerline is 18" from the side wall. Provide a rear wall grab bar that is 42" long min. and extends from the toilet 12" min. on one side and 24" min. on the other side (open side).	1	4100	\$4100

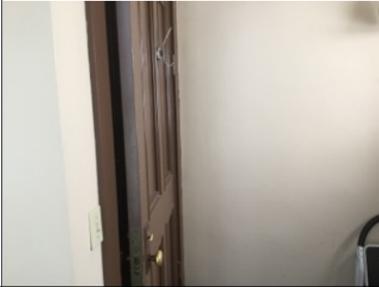
27	Single-User Toilet Room	1		Single-User Toilet	N/A

Hook located > 48" high	67"	Locate hook no higher than 48" above the finished floor.	1	150	\$150
Best Practice												
28	Main Entrance (North Side)	1		Main Entrance

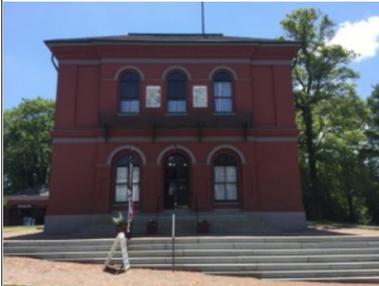
Recommend adding contrasting strips at the edge of each step at exterior stairs.	1	-	\$0

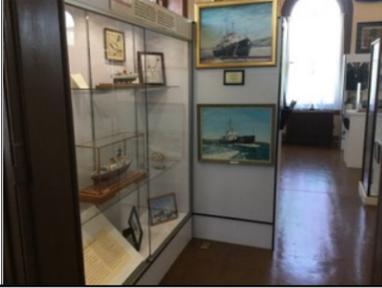
ID	Location	Floor	Room	Element	Type	Photo	Issues	Current Measure	Recommendations	Quantity	Price	Cost Estimation
29	Exhibit Area	1			N/A

Recommend switching to a matte flooring finish. The floor is so highly polished that it creates a glare problem. Many people with low vision and some with perceptual differences related to brain-based issues cannot comfortably navigate that floor surface.	1	-	\$0
