Meetinghouse Farm Barn

Town of Barnstable
ADA Transition Plan

September 2021

**Town of Barnstable
Meetinghouse Farm Barn**

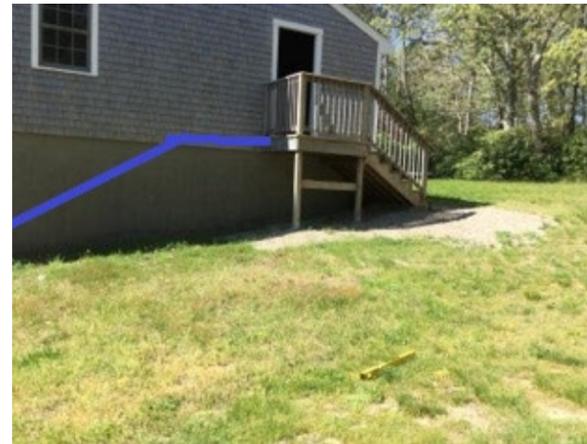
Accessibility issues include lack of an accessible route to the second-floor entry door on the north side (See Figure 3 for a possible route to the second floor.) and lack of an accessible route from the west side of the barn to the Rhododendron Forest pathway entry. There is also lack of an accessible route through the Rhododendron Forest.

Figure 3: The blue line shows the approximate orientation of a ramp running from an area near where an accessible parking space could be located along the north side of the building to the second-floor entry door.

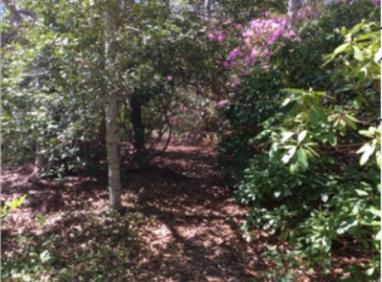
ID	Location	Floor	Room	Element	Type	Photo	Issues	Current Measure	Recommendations	Quantity	Price	Cost Estimation
Approach and Entrance												
Exterior Access Route												
1	Path Through the Rhododendron Forest	Ext.		Exterior Access Route	Walkway

Cross slope > 1:50 (2.00%) Running slope > 1:20 (5%) Surface is not stable, firm, and slip-resistant Accessible route not provided	6% 13.2% - -	Reduce cross slope to be no steeper than 1:50 (2.00%). Reduce running slope to be no steeper than 1:20 (5%). Repair surface. Ensure an accessible route is provided. (Cost to provide an accessible route through the Rhododendron Forest not provided.)	1	-	\$0
2	Route From Barn to Start of Rhododendron Forest Path	Ext.		Exterior Access Route	Exterior

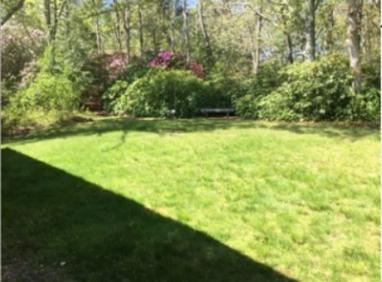
Accessible route not provided	-	Ensure an accessible route is provided. Cost based on a 4' wide min. x 45' long stone dust path from the north side of the building to the entry point of the Rhododendron Forest path by the bench and sign.	1	2880	\$2880

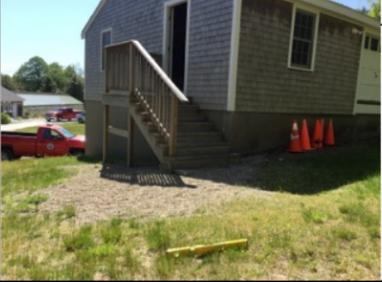
3	Stairs to Second Floor - North Side	Ext.		Exterior Access Route	Exterior

Accessible route not provided	-	Ensure an accessible route is provided to the landing for the stairs to the second floor entry door. Ensure route has a 1:20 (5%) max. running and 1:50 (2%) max. cross slope. (Cost based on a 4' wide min. x 45' long stone dust path from the parking area to the stair landing.)	1	2880	\$2880
Off-Street Parking Lot or Garage												
4	Parking at Barn	Ext.		Off-Street Parking Lot or Garage	N/A

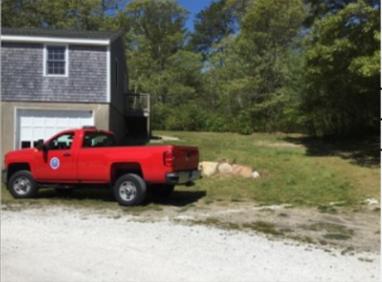
Total # of parking Total # of designated accessible parking spaces Total # of designated van accessible spaces Access aisle not provided Sign not provided	1 - - -	Provide a van accessible parking space and a marked access aisle each at least 96" wide. Provide a sign with the International Symbol of Accessibility (ISA) and the words "Van Accessible" with the bottom of the sign 60" min. above the ground and the top 96" max. above the ground. (See the narrative report for an example of how to designate parking in an unpaved area.)	1	1850	\$1850

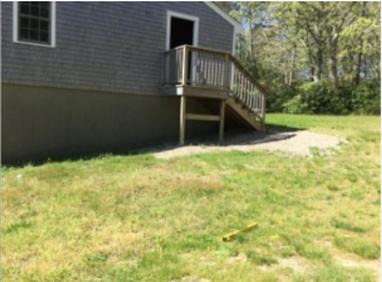
Entrance												
5	Route to Stairs to Second Floor - North Side	Ext.		Entrance	Main Entrance

Entrance not on an accessible route	-	Provide a compliant exterior ramp with handrails, edge protection and landings running along the north side of the structure and connecting with the second floor entry door. See Figure 1 in the narrative report. (Cost based on a 30' straight pressure-treat wood ramp.)	1	7843	\$7843

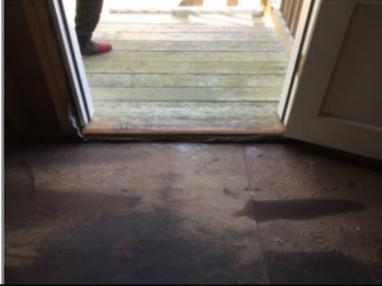
ID	Location	Floor	Room	Element	Type	Photo	Issues	Current Measure	Recommendations	Quantity	Price	Cost Estimation
Emergency Exit												
6	Second Floor Egress Door Threshold	2		Emergency Exit	N/A

Threshold > 1/2" high	2"	Alter the threshold to be 1/2" high max.	1	150	\$150
Access to Goods and Services												
Stairways												
7	Stairs to Second Floor	Ext.		Stairways	Egress

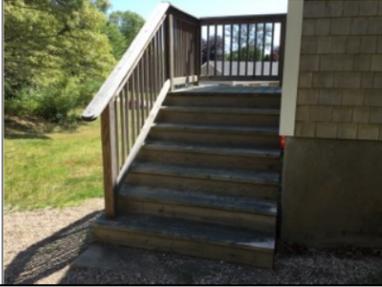
Handrail height < 34" or > 38" Handrail not provided on both sides Handrails have non-compliant cross section	-47" - -	Alter so the handrails are 34"- 38" high above the floor. Provide handrail on both sides with 1 1/4" - 2" circular cross section. (Cost based on two 10' long wooden handrails mounted between 34" and 38" high.)	1	880	\$880
Exterior Benches												
8	Lawn Behind Barn	Ext.		Exterior Benches	N/A

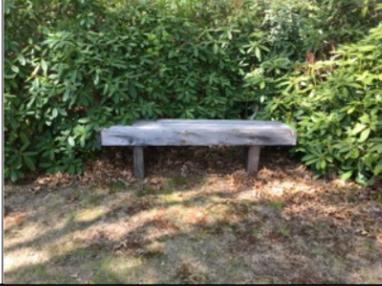
No accessible route to one bench in area	-	Provide an accessible route to at least one bench in each area where benches are provided. (Cost included in the cost for the 45' stone dust path to the Rhododendron Forest entry point.)	1	-	\$0
