# UNITARIAN CHURCH OF BARNSTABLE

*Exterior Restoration Project Update - Barnstable CPC*

**BARNSTABLE UNITARIAN CHURCH**  
Barnstable, Massachusetts  
February 2021

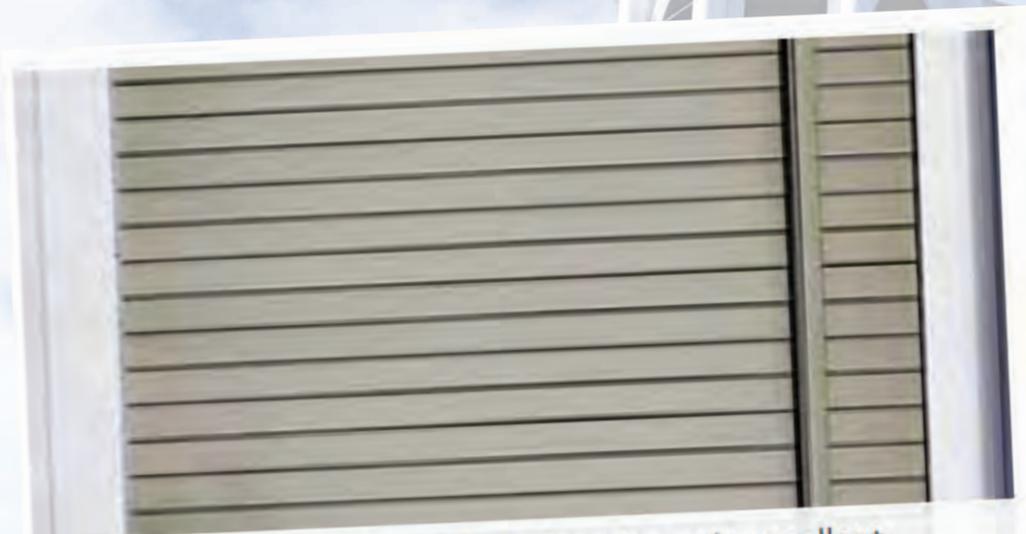
**Image 01:** In general, wood clapboards are in excellent condition, both tight and sound.

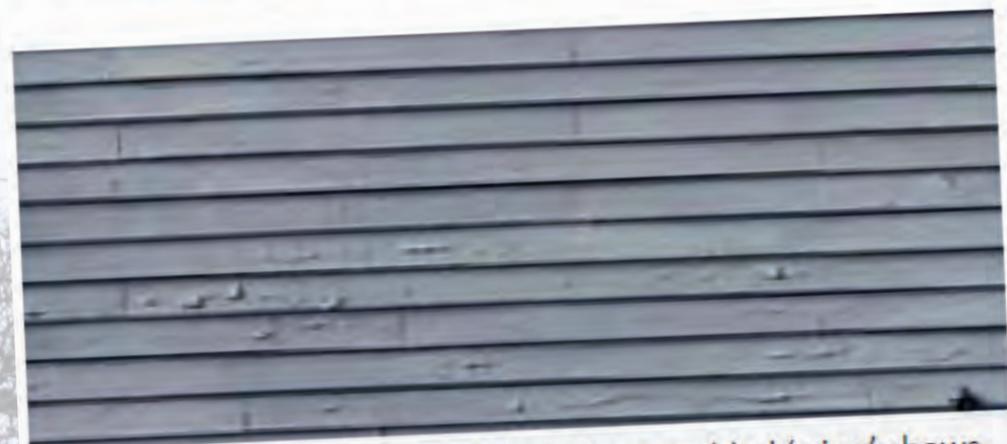
**Image 02:** One instance at the northeast gabled 'wing' shows peeling paint and visible joints.

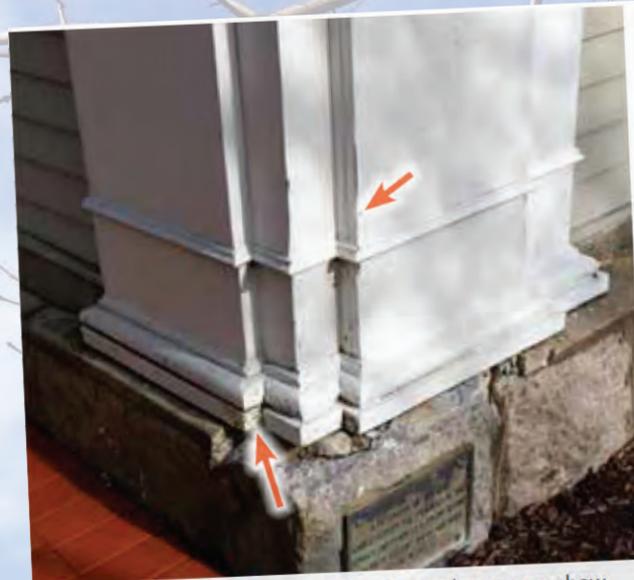
**Image 07:** Wood mouldings at the pilaster bases may show more wear due to snowbanks and splashing rainwater.

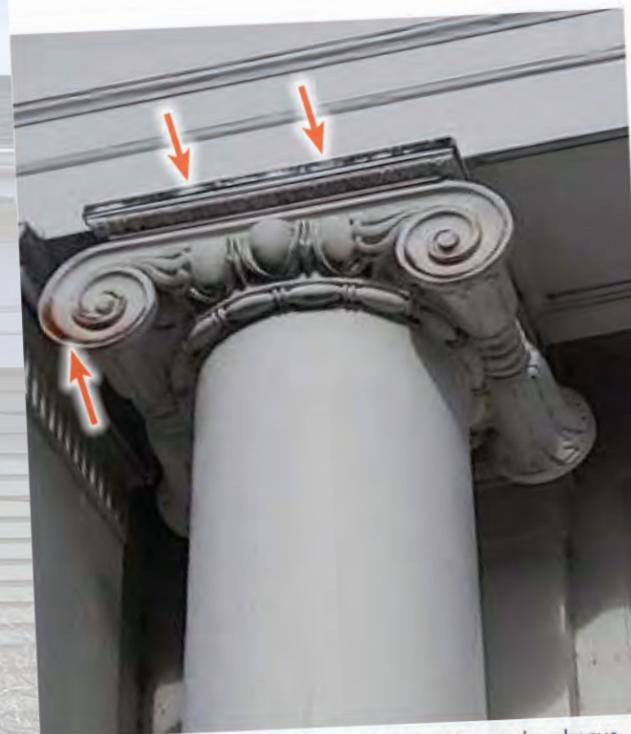
**Image 08:** Discolored capitals and stray paint on the abacus flashing are unsightly.

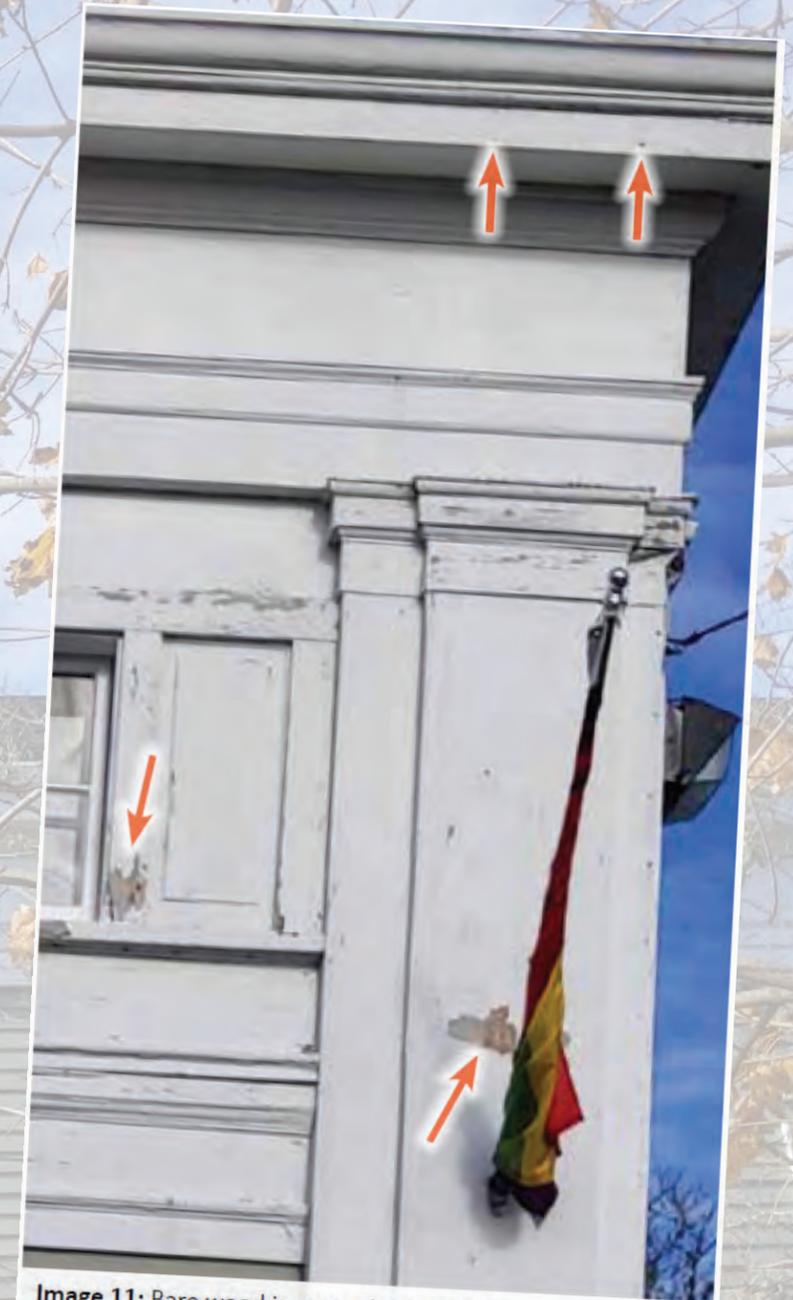
**Image 11:** Bare wood is seen where paint is most worn or peeled altogether. Small nail heads are visible throughout.

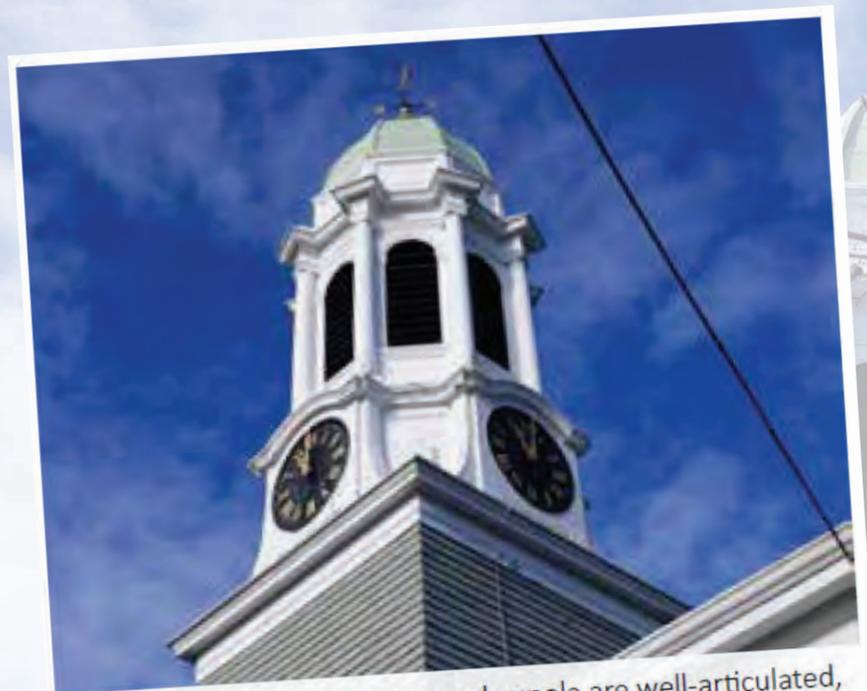
**Image 32:** The church tower and cupola are well-articulated, although in need of repair and refinishing.

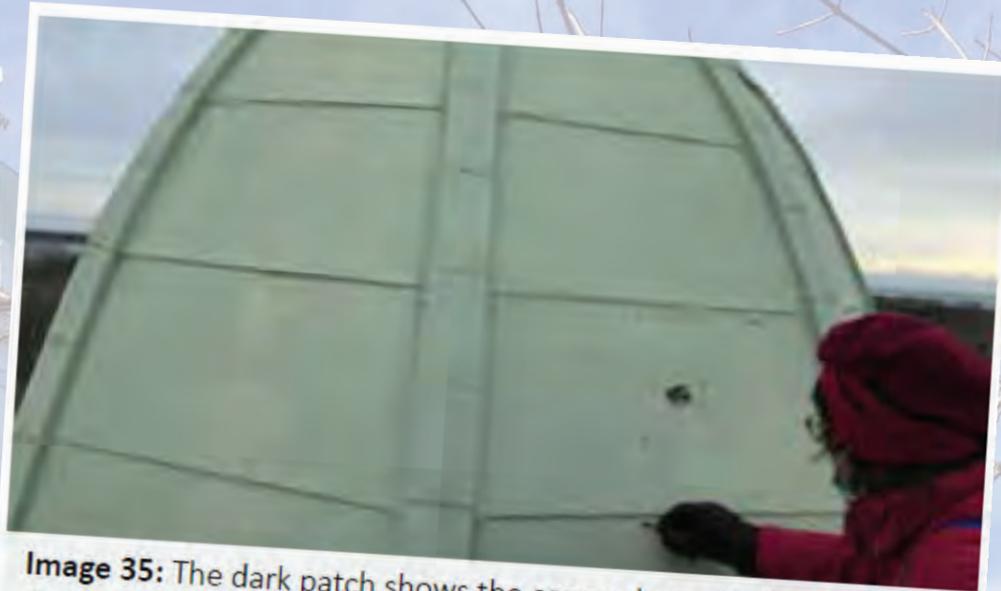
**Image 35:** The dark patch shows the copper beneath the coating. Generally only one application of such coatings can be applied with any expectation of usefulness..

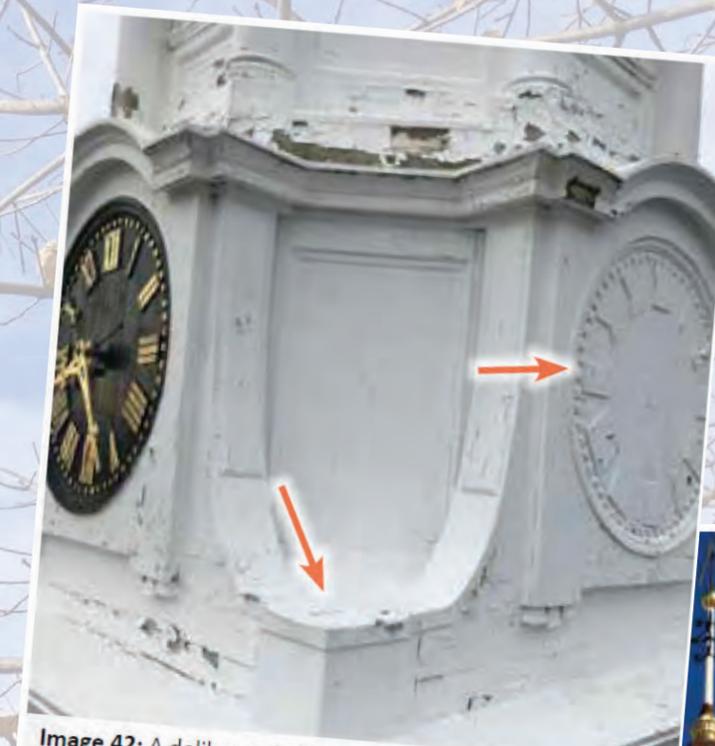
**Image 42:** A deliberately-blank clockface faces the north, and a missing urn once sat on a square pedestal.

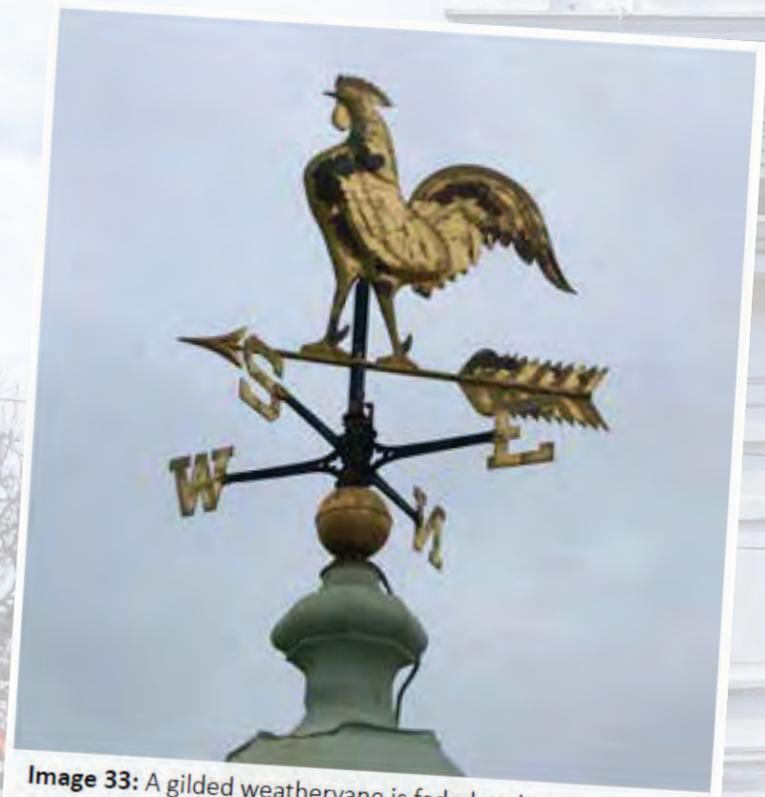
**Image 33:** A gilded weathervane is faded and worn.

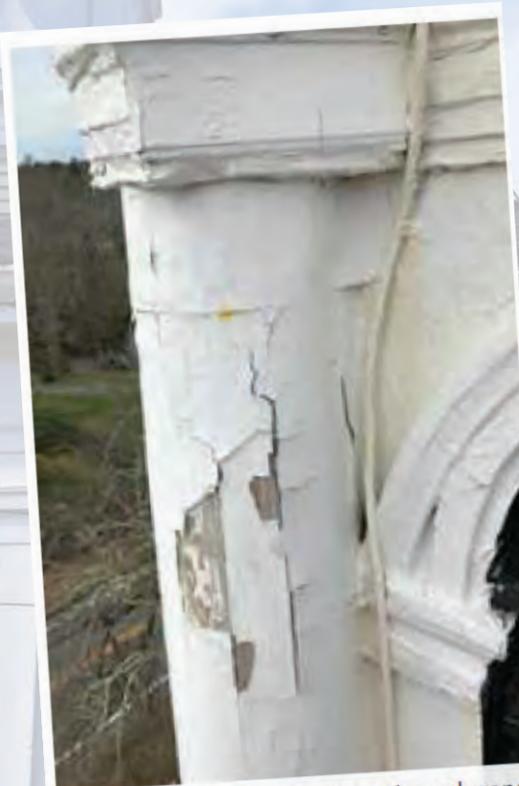
**Image 39:** Peeling paint on the columns require scraping, sanding, and new paint.

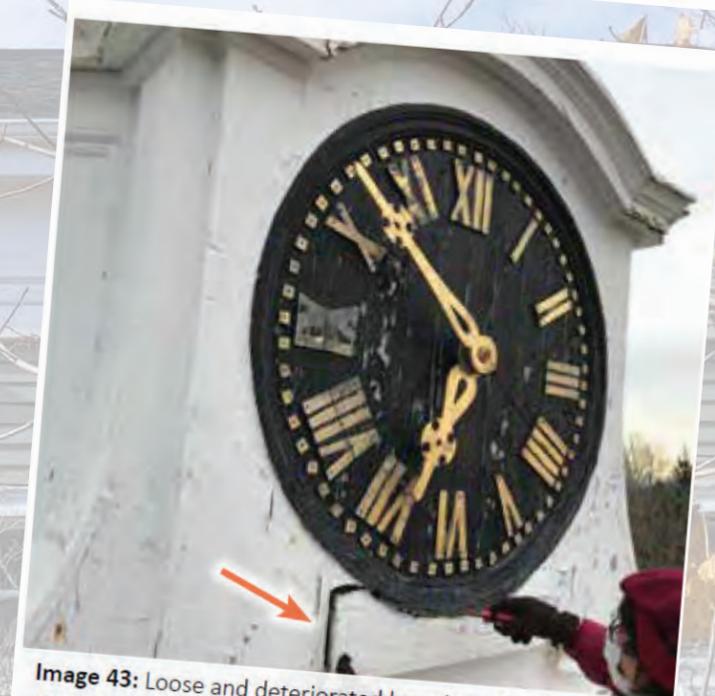
**Image 43:** Loose and deteriorated boards at the clock require repair and refastening.
