**BARNSTABLE HISTORICAL COMMISSION – JUNE 2<sup>ND</sup> MEETING MATERIALS**  
**Table of Contents**

<b>Page 85</b>	Letter from Massachusetts Historical Commission regarding 28 Falco Road Conservation Restriction Project

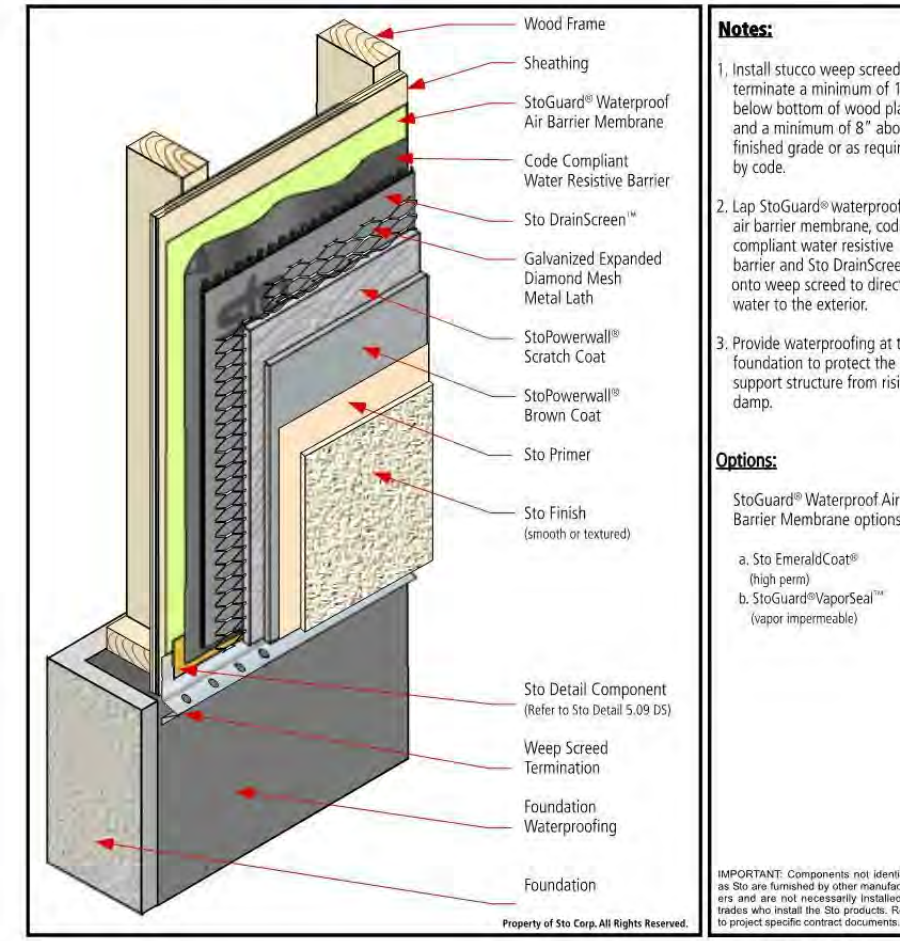
- Notes:**
- Install stoGuard waterproof air barrier membrane, code compliant water resistive barrier and Sto DrainScreen™ onto weep screws to direct water to the exterior.
  - Use StoGuard® waterproof air barrier membrane, code compliant water resistive barrier and Sto DrainScreen™ onto weep screws to direct water to the exterior.
  - Provide flashing at the foundation to protect the support structure from rising damp.
- Options:**
- Sto EmeraldCoat® High joint
  - StoGuard® VaporSeal™ (sealant)
- IMPORTANT:** Components not identified in this detail are to be installed by other trades. Sto and its affiliates are not responsible for the proper installation of these components. Refer to the manufacturer's instructions for proper installation.

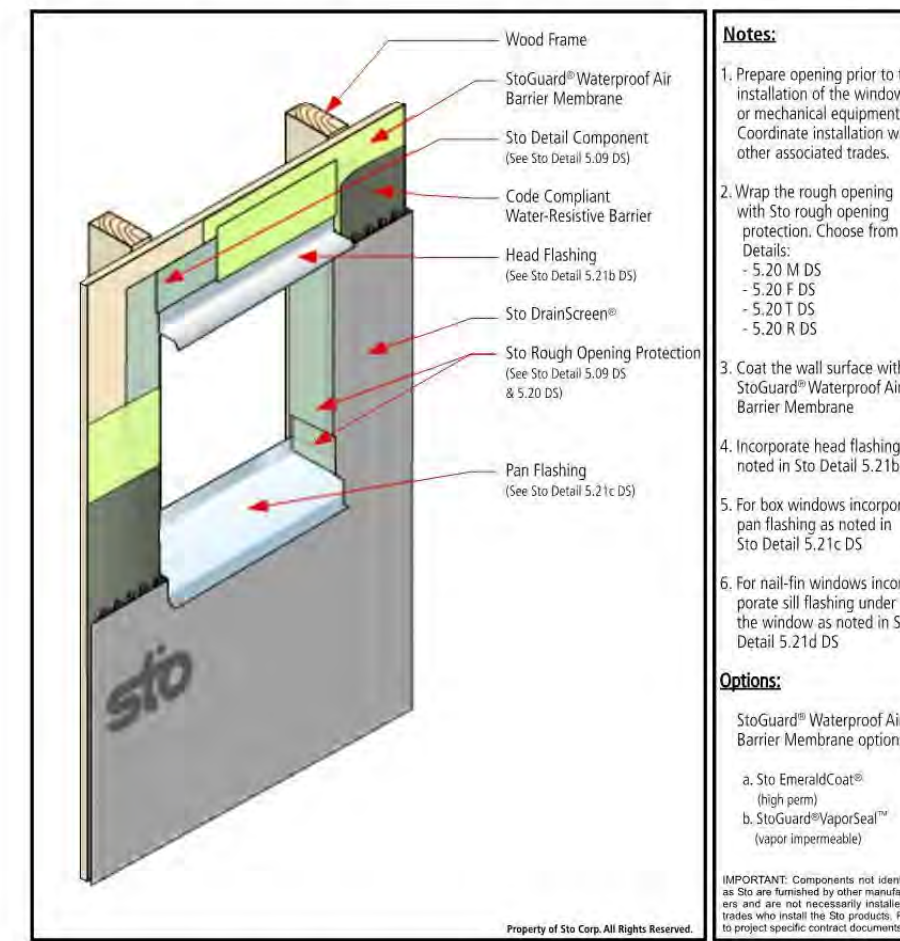
- Notes:**
- Prepare opening prior to the installation of the window or mechanical equipment. Coordinate insulation with other associated trades.
  - Wrap the rough opening with Sto rough opening protection. Choose from Sto Details 5.20 DS, 5.20 F DS, 5.20 T DS, 5.20 R DS.

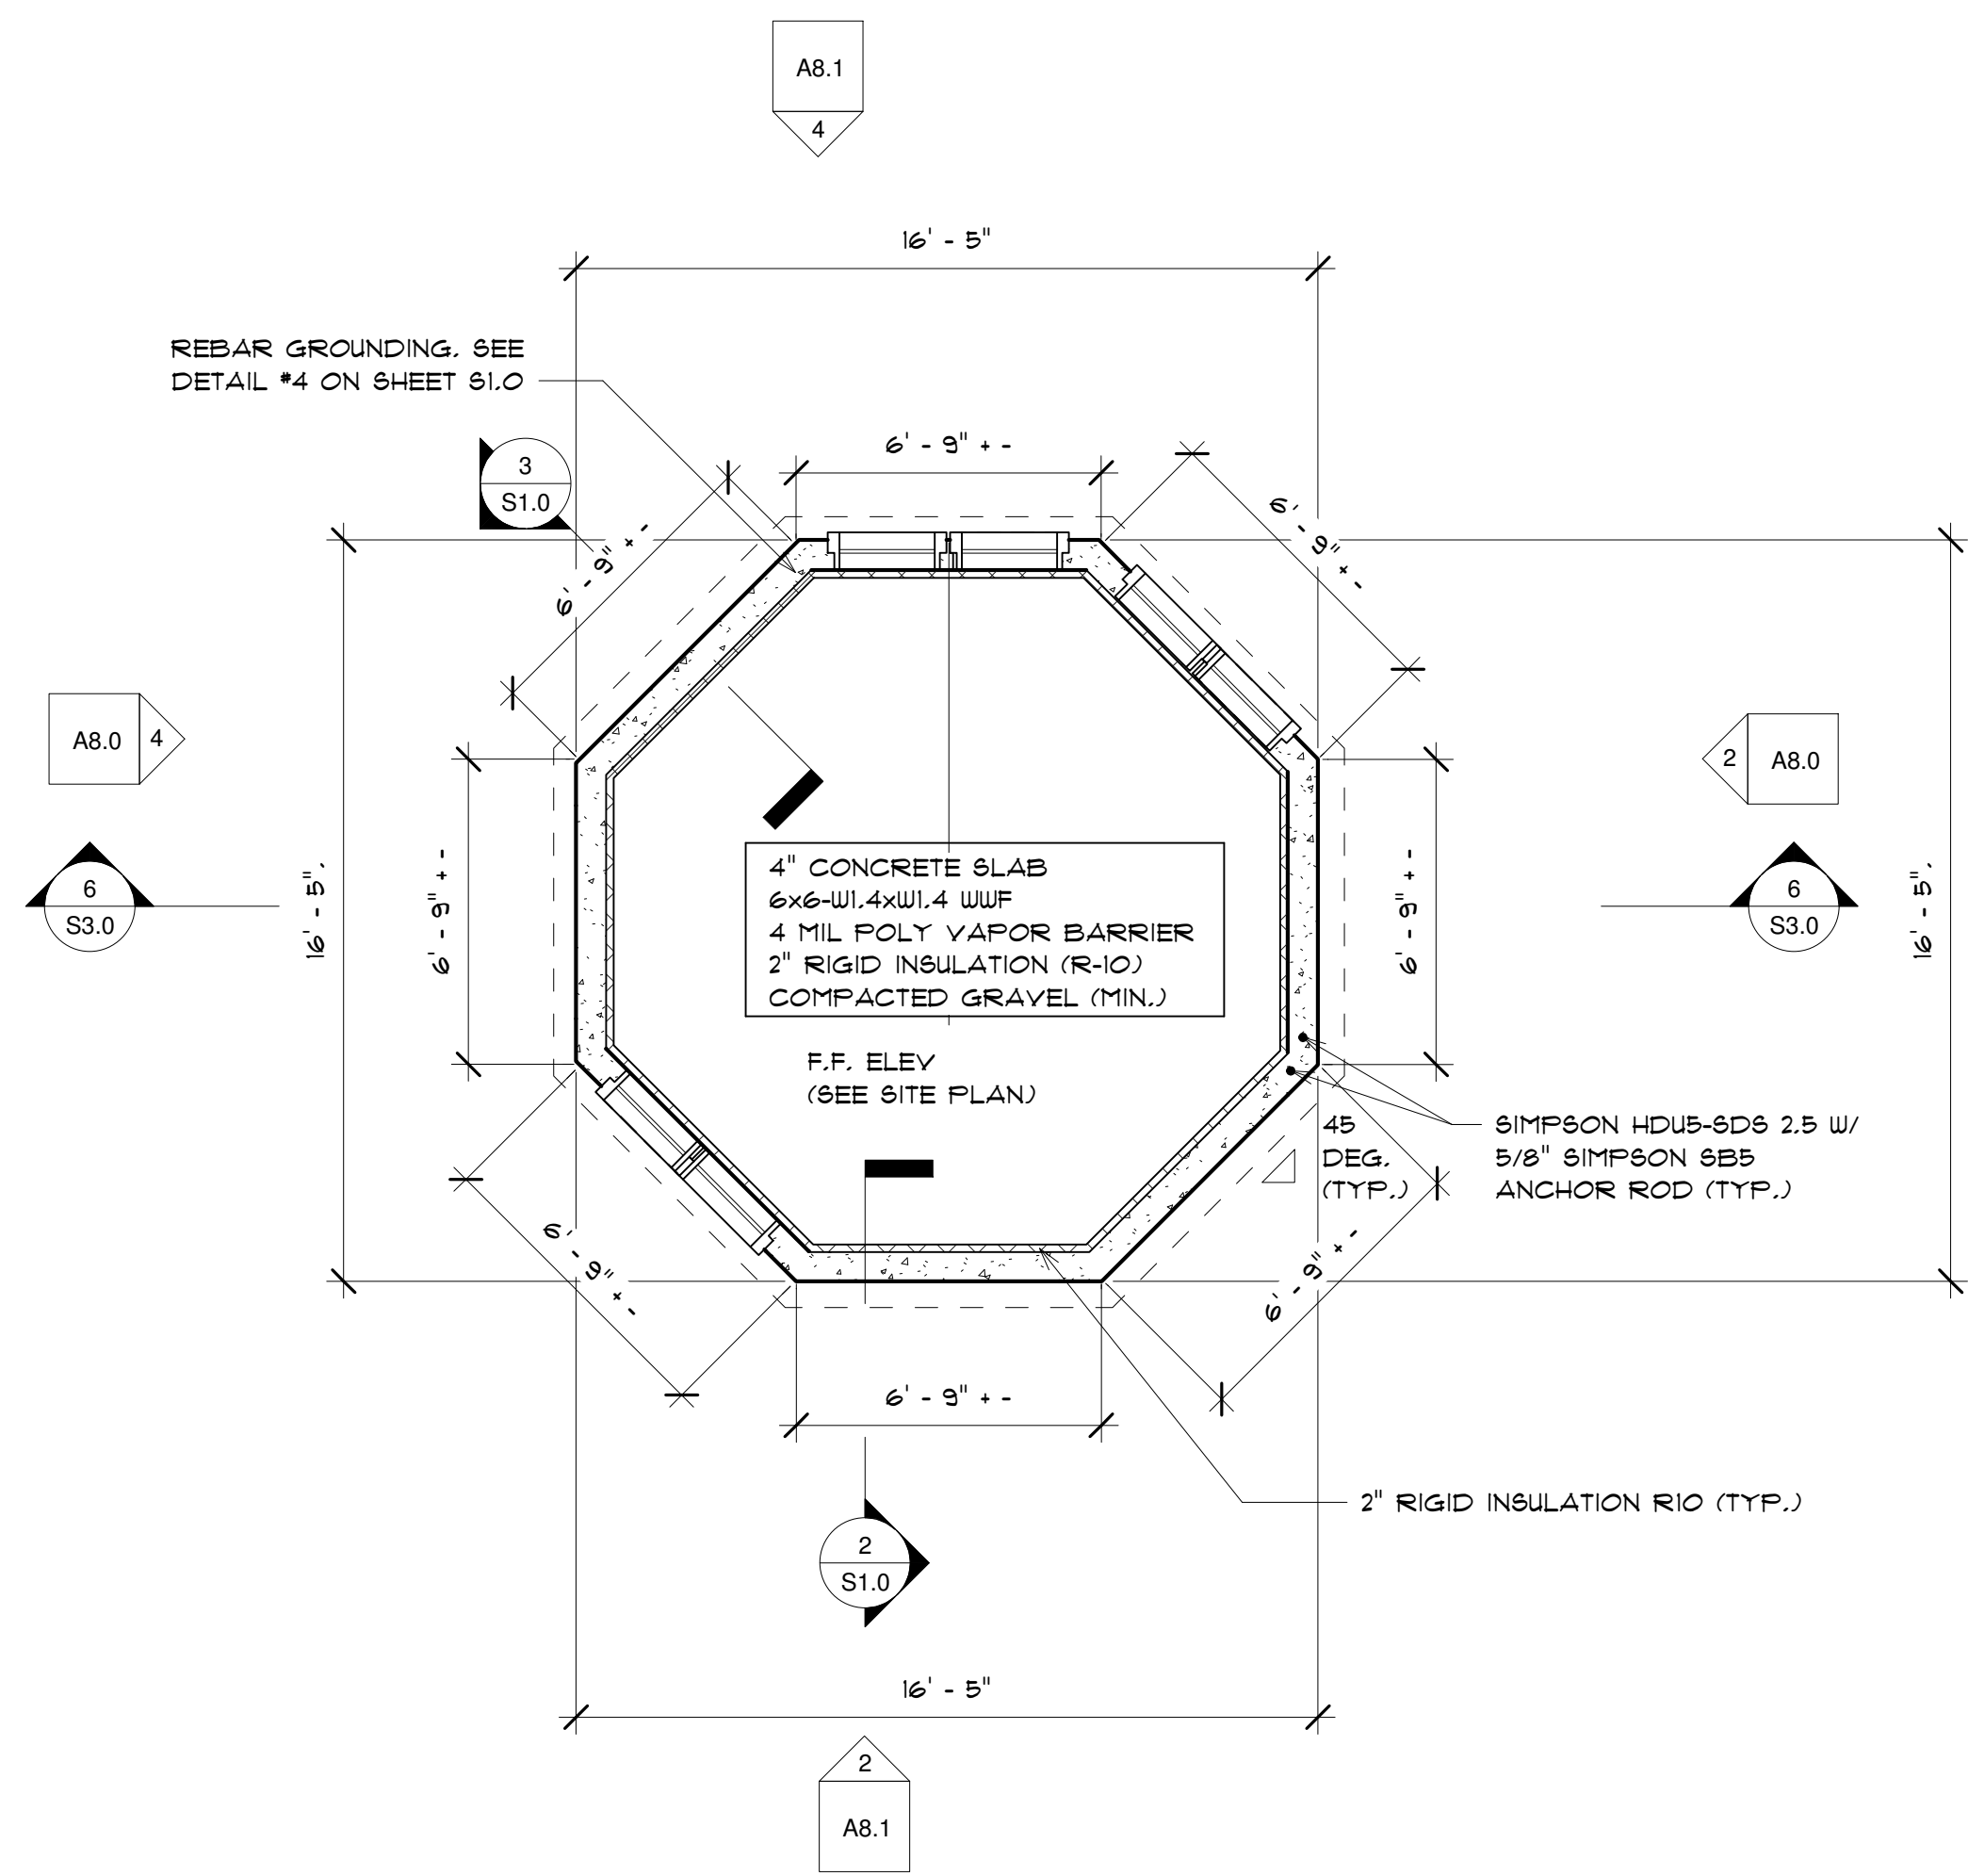
**1 FOUNDATION PLAN**  
1/4" = 1'-0"

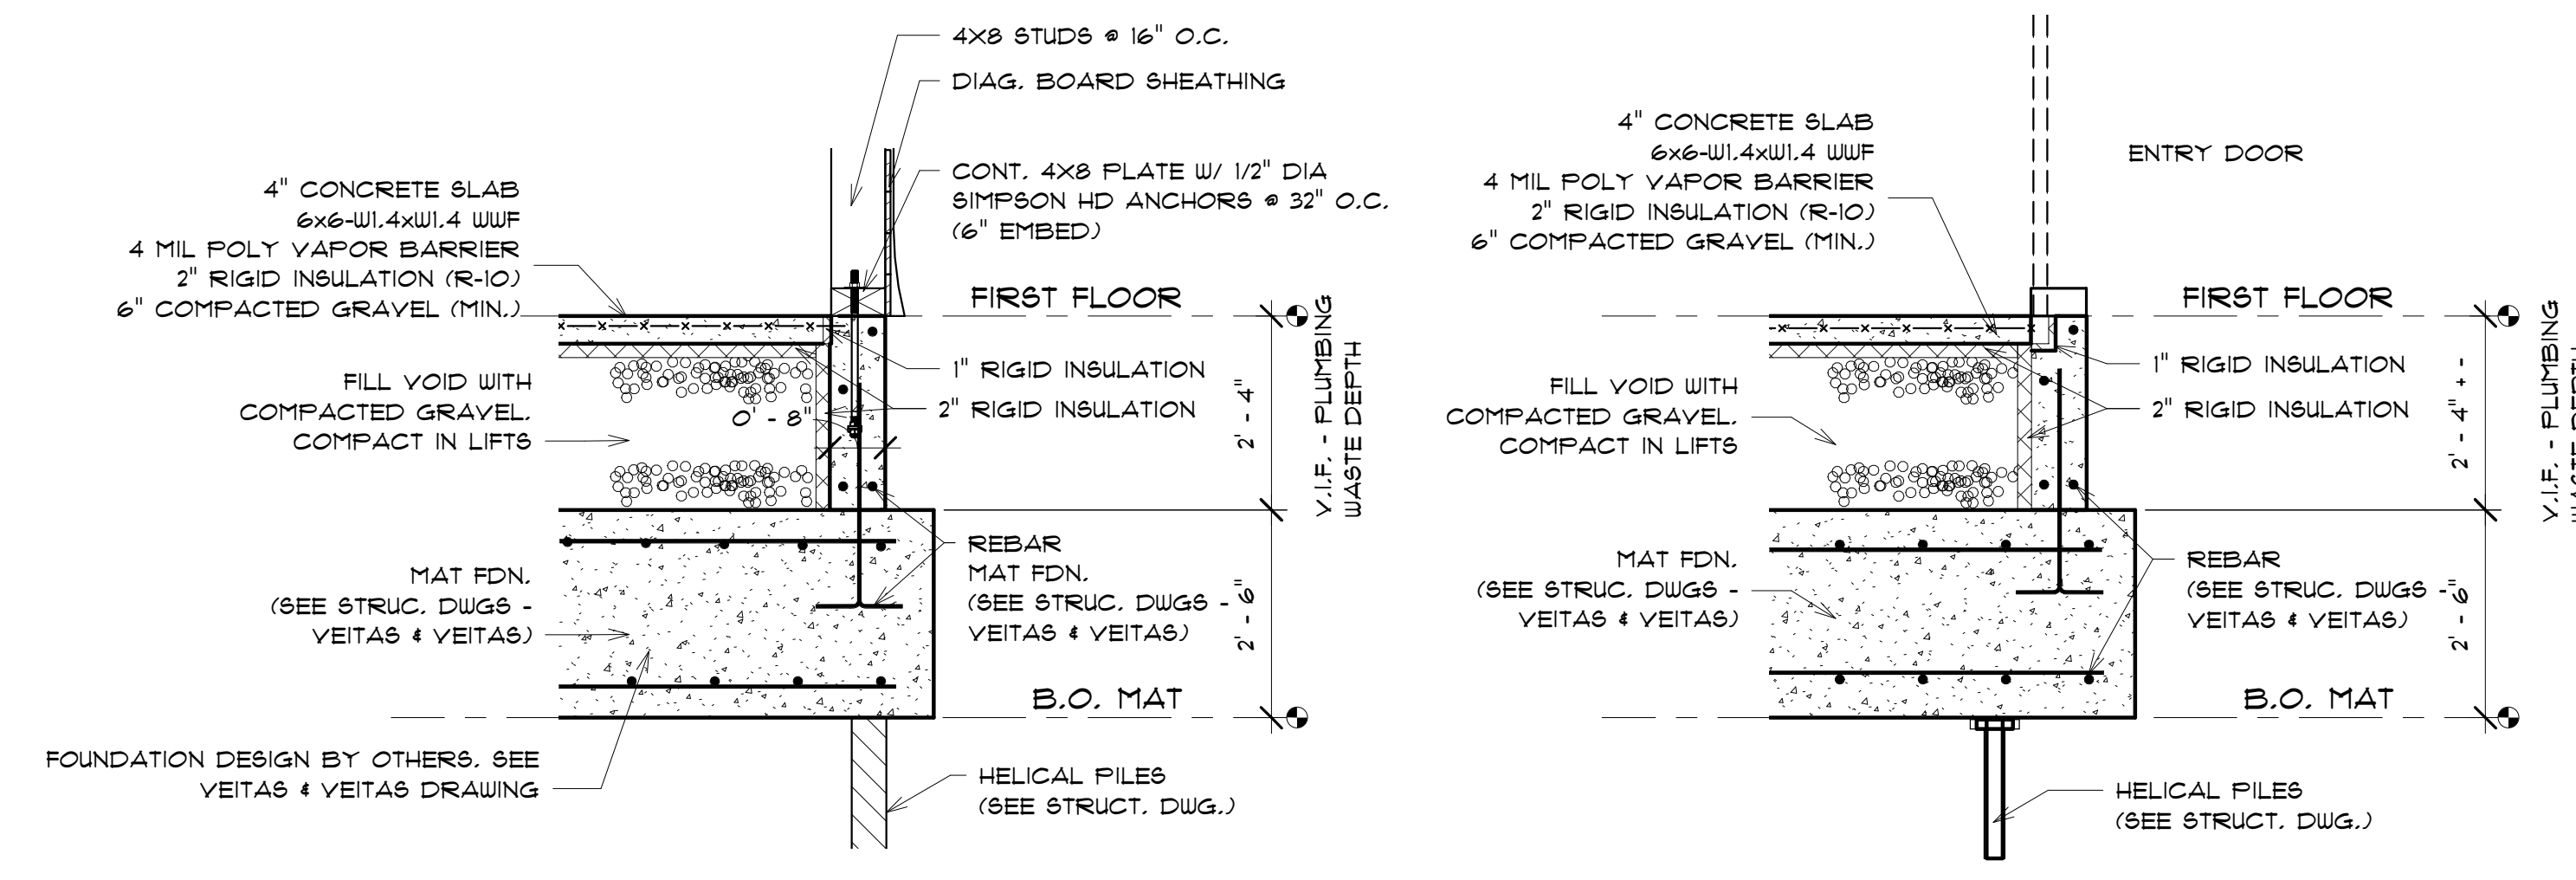
**2 FDN DETAIL #1**  
1/2" = 1'-0"

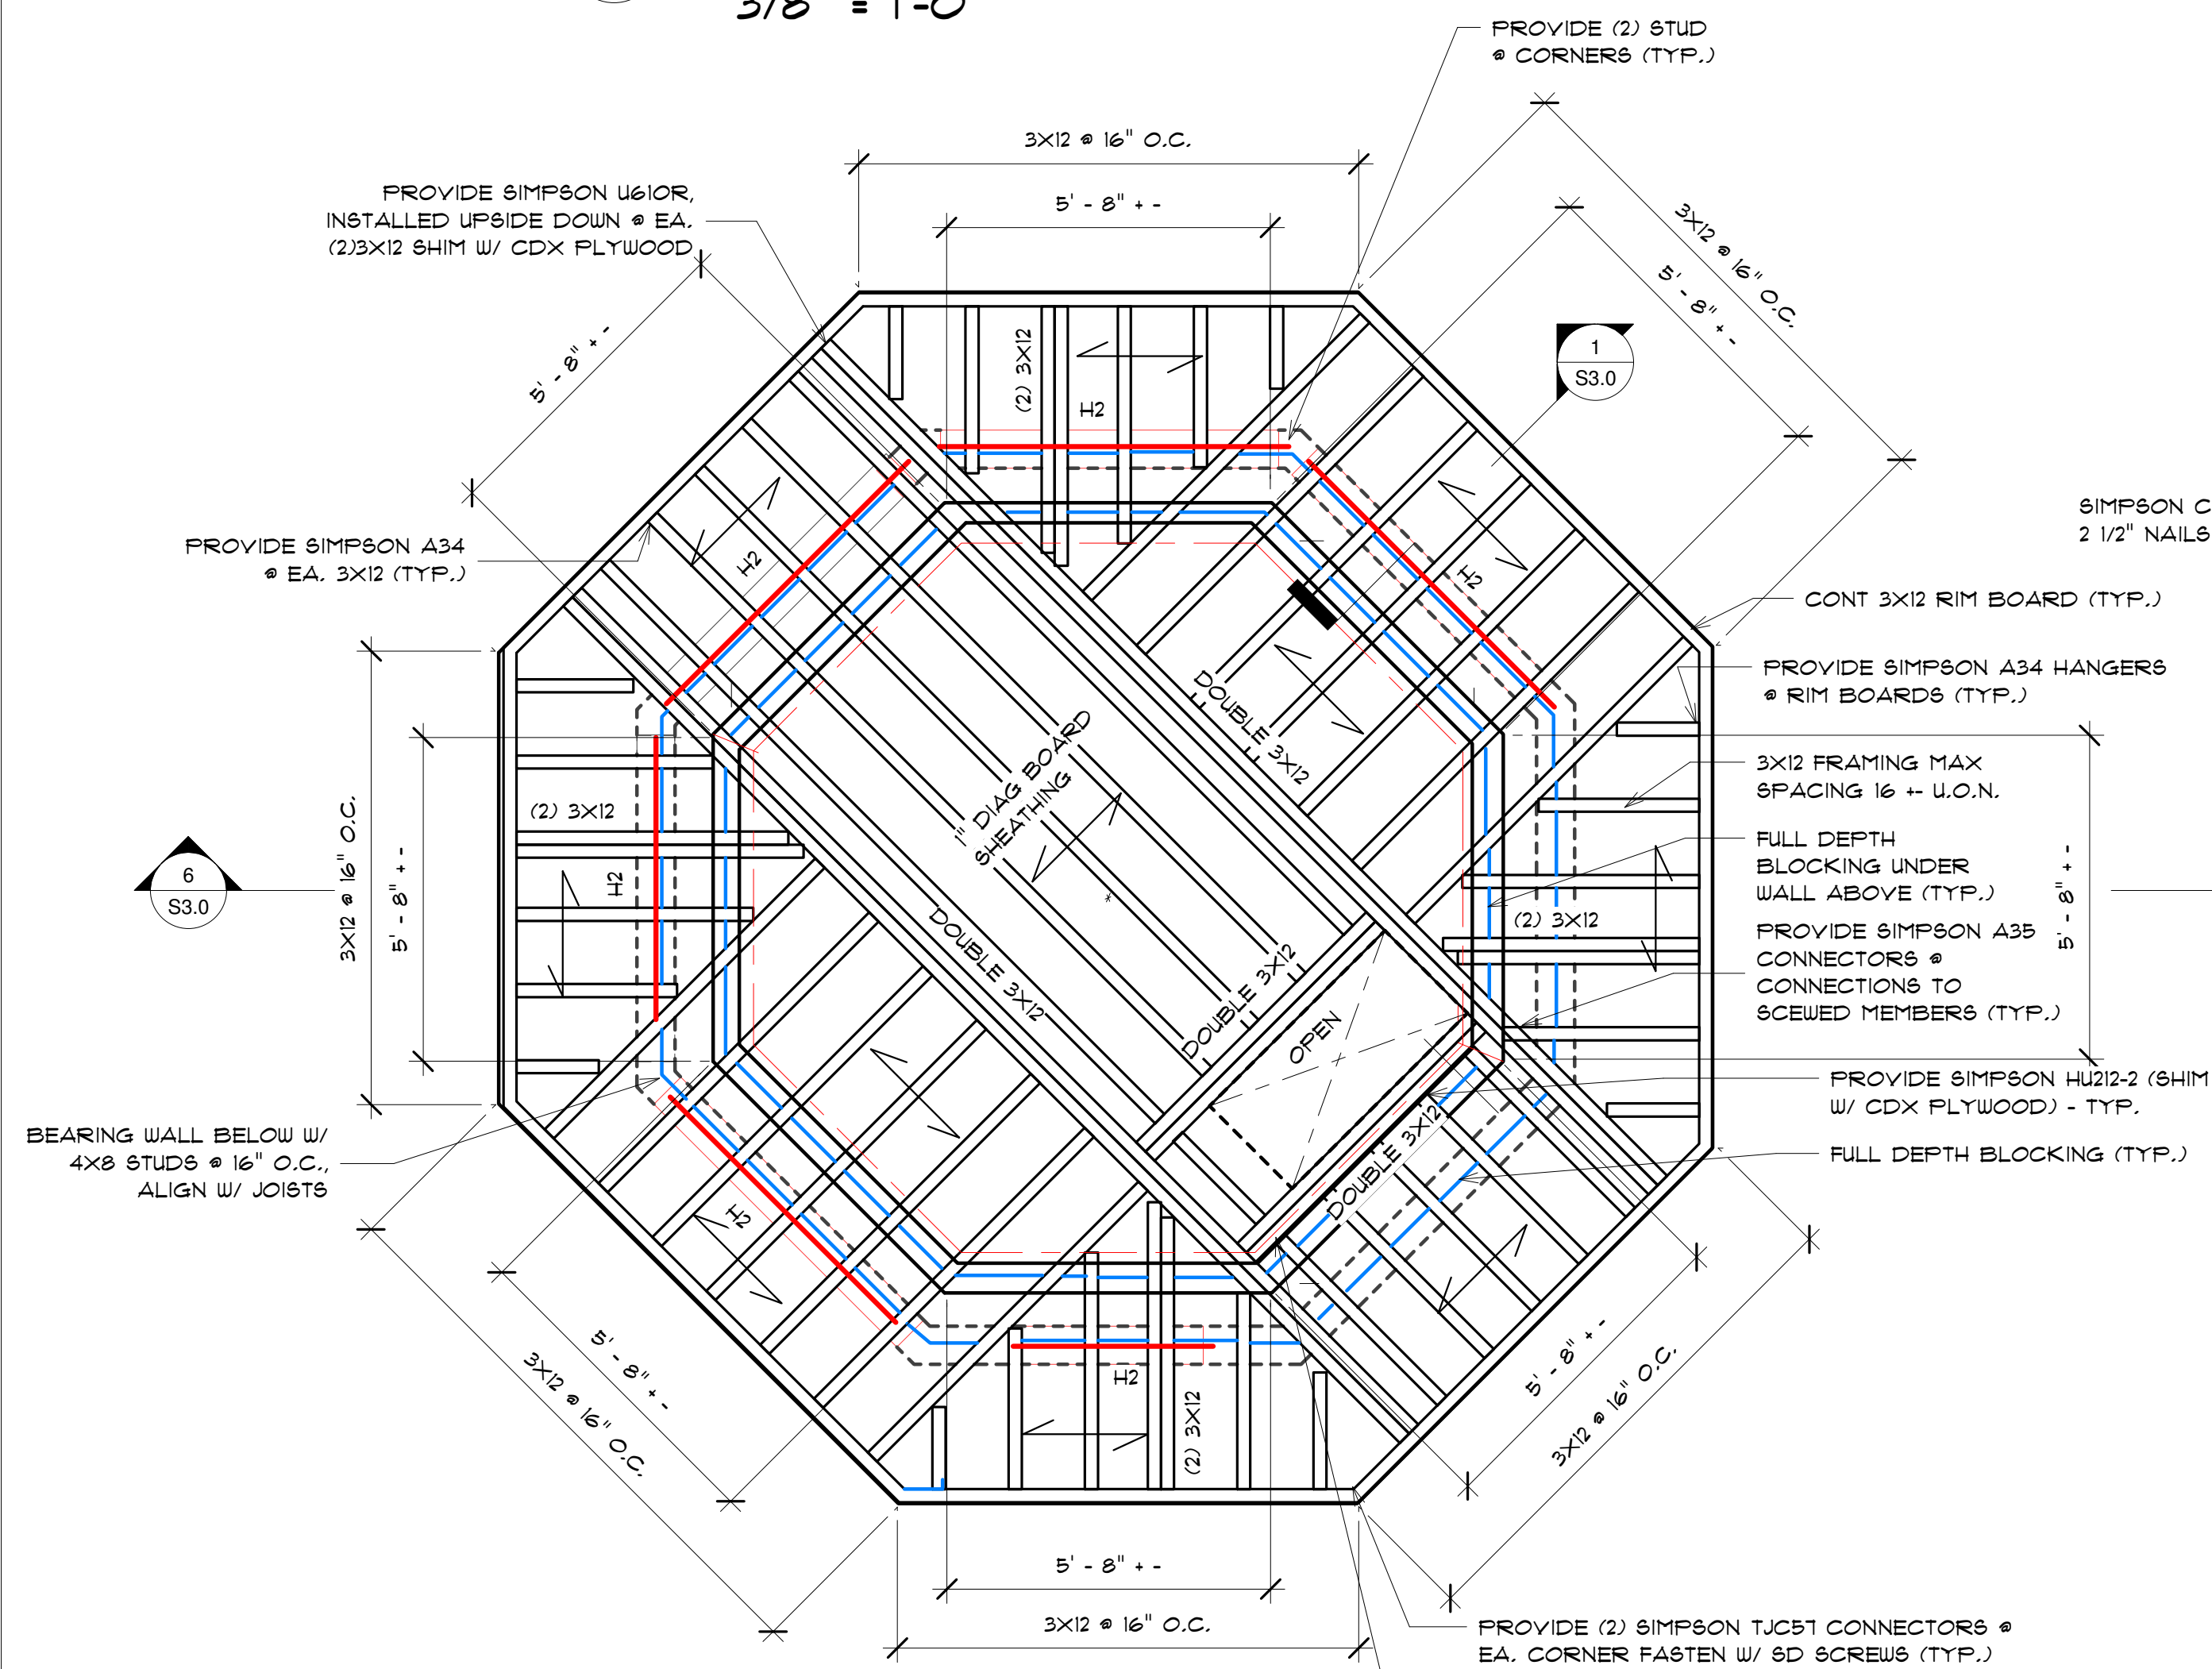
**1 FRAMING - SECOND FLOOR**  
3/8" = 1'-0"

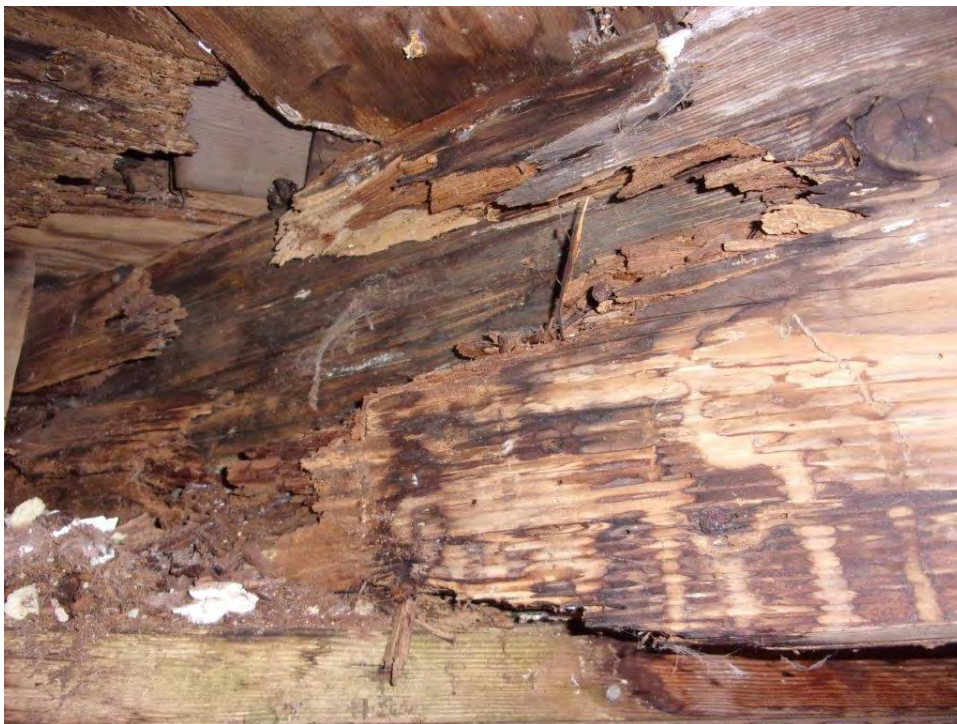
**Typical deteriorated/rotted end of second floor support beam  
at first floor exterior wall top plate**

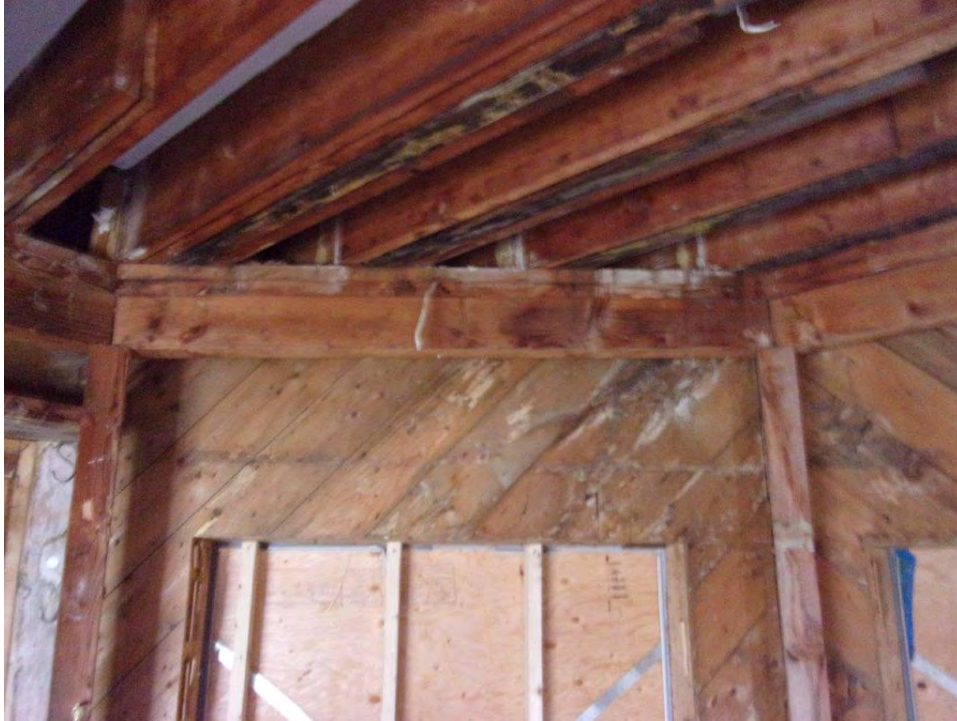
**Typical second floor supplemental support framing with sporadically fastened, sistered floor beams; no mechanical fasteners connecting supplement interior framing**

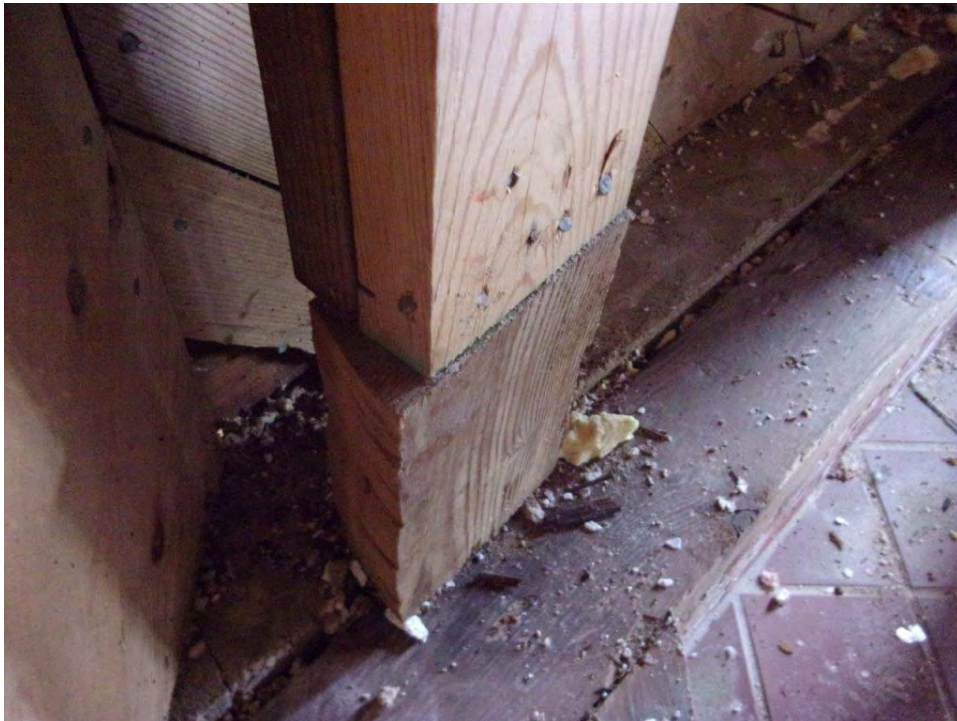
**First floor supplemental framing with discontinuous column framing; no mechanical fasteners securing column base to foundation**

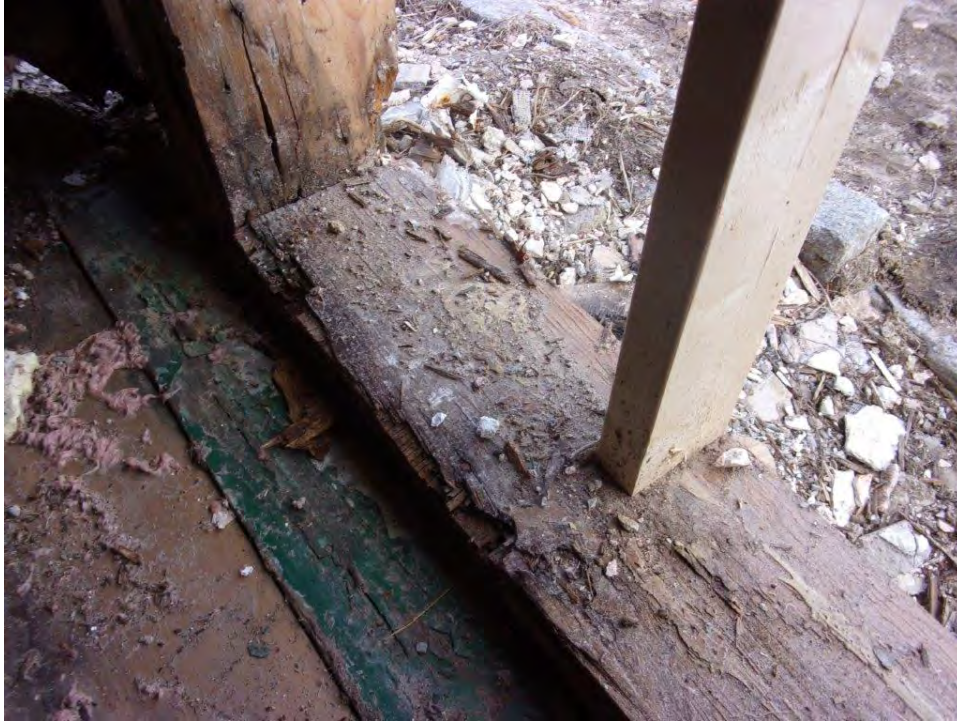
**Typical deteriorated first floor sole plate at exterior wall (in contact with foundation);  
no mechanical fasteners connecting sole plate to foundation**

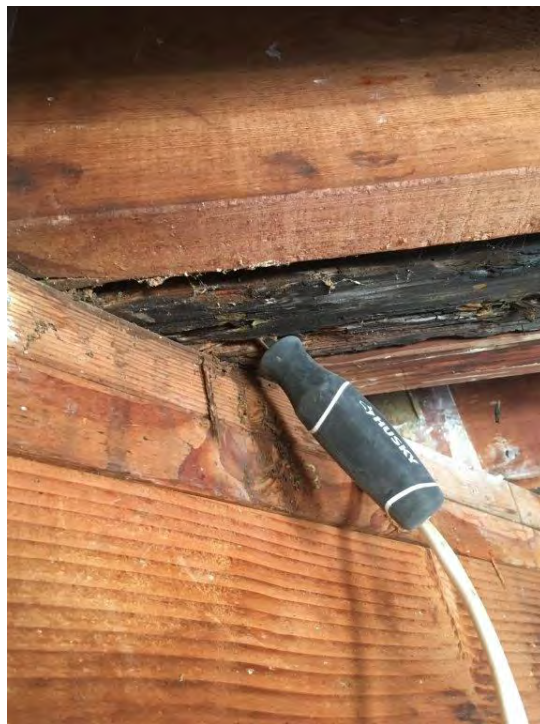
**Typical deteriorated second floor beam end  
supported on supplemental interior framing**

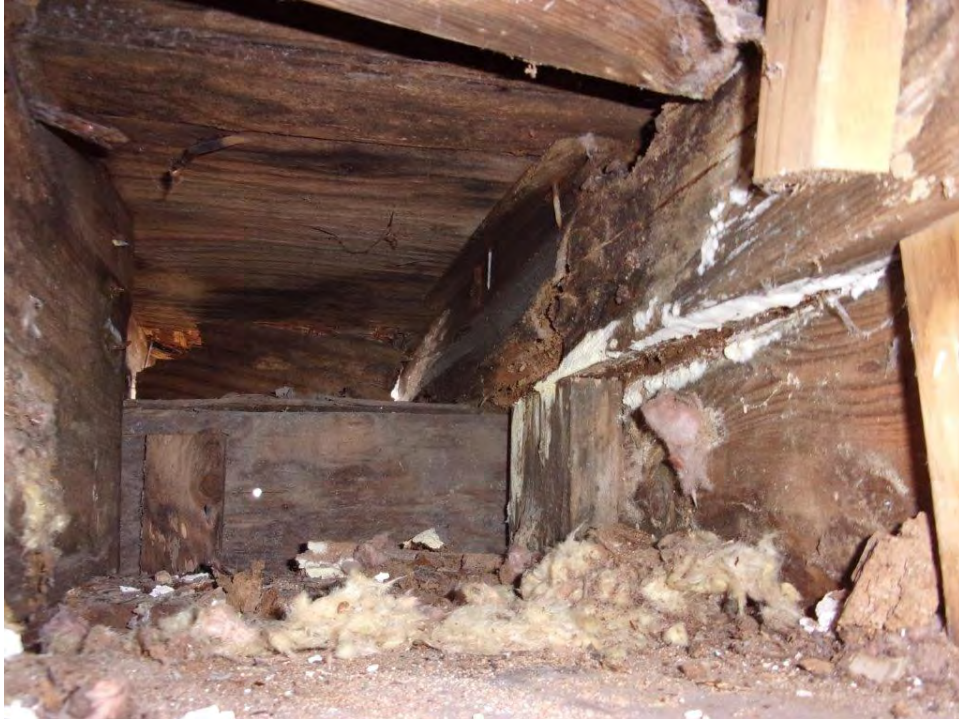
**Typical deteriorated cantilever support beam for wrap-around exterior balcony at first floor exterior wall top plate (underside)**

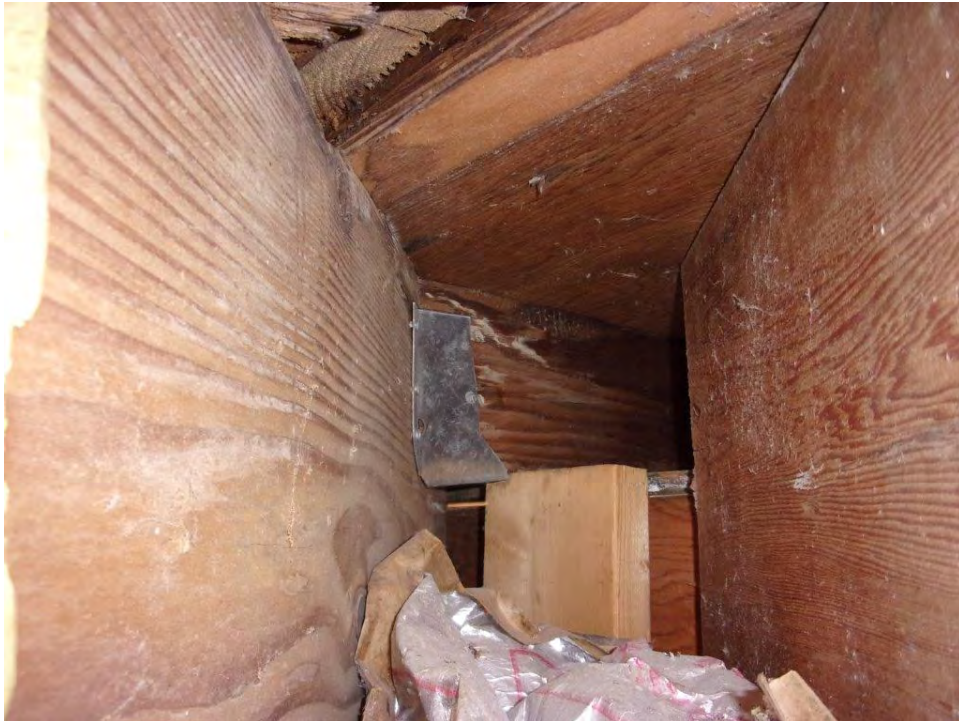
**Typical second floor balcony supplemental cantilever framing attachment and support**

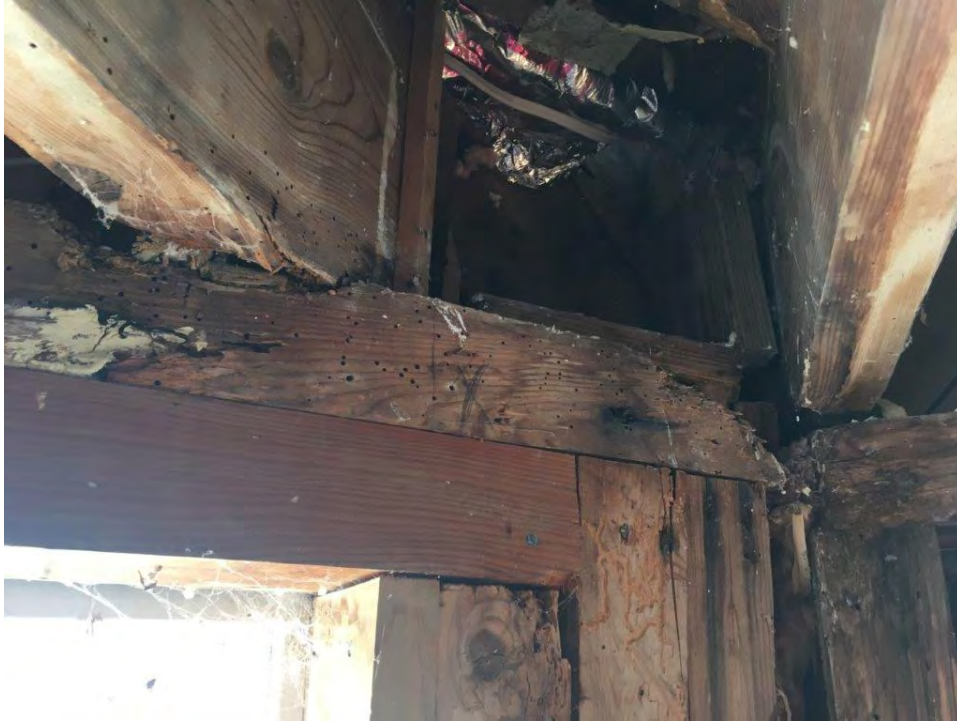
**Third floor beam with evidence of insect infestation and bearing failure at second floor exterior wall top plate; deterioration/rotting visible along top plates**

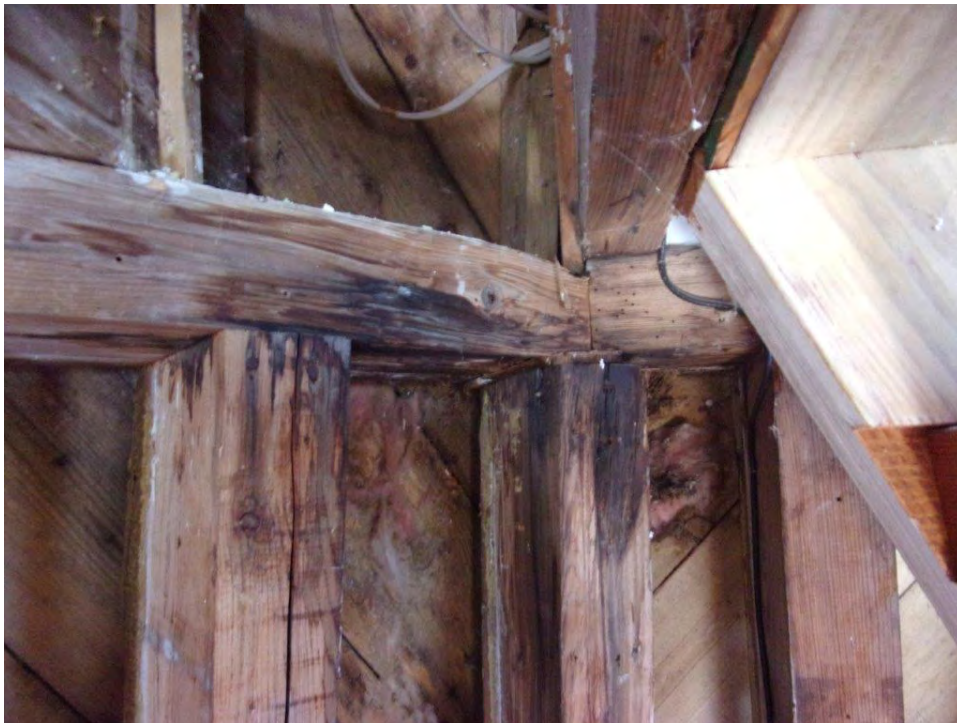
**Second floor exterior wall framing with visible water staining, rot & crushing of top plate**

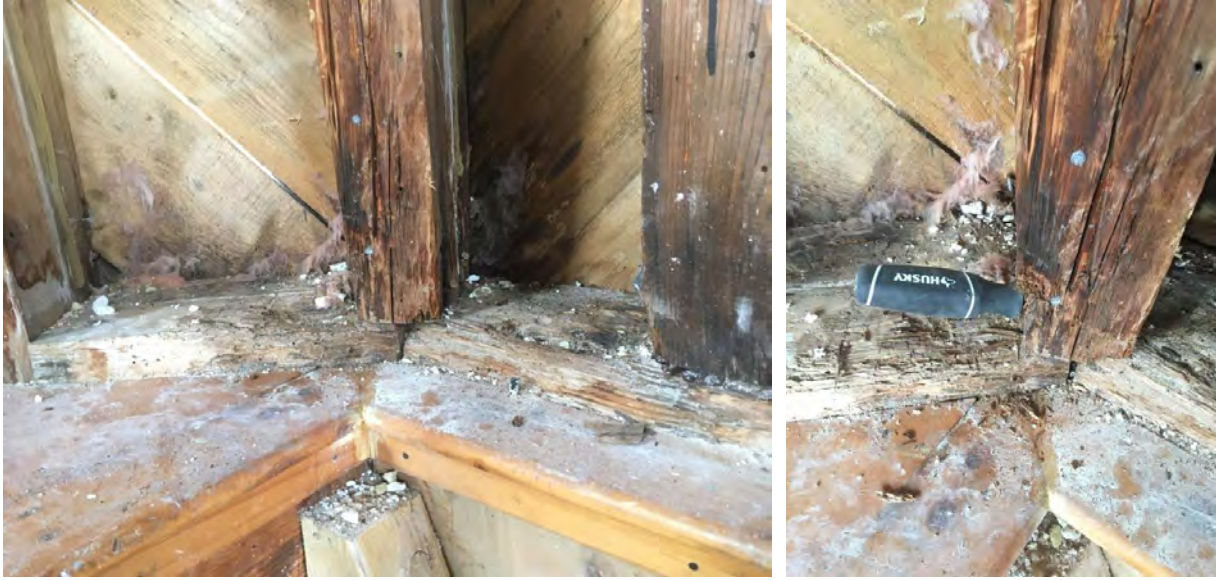
**Typical second floor exterior wall stud rot/deterioration  
at sole plate of second floor exterior wall**

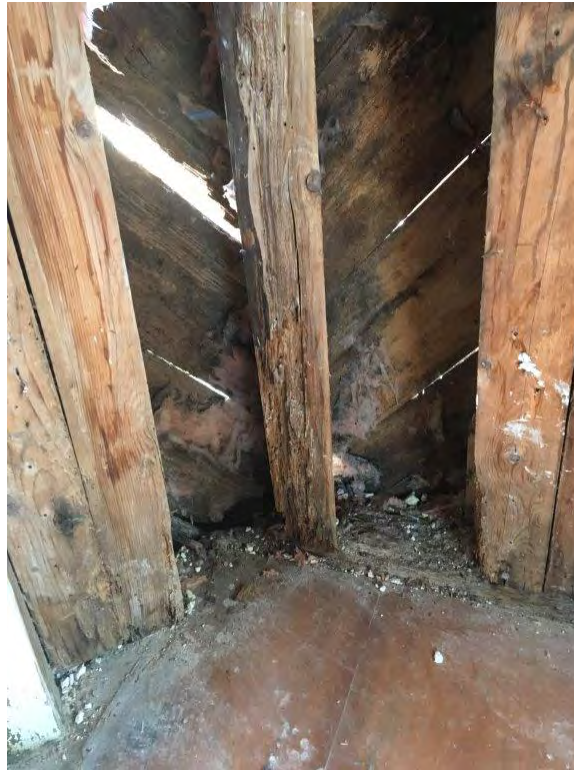
**Typical second floor exterior wall stud and wall board  
with evidence of staining and deterioration**

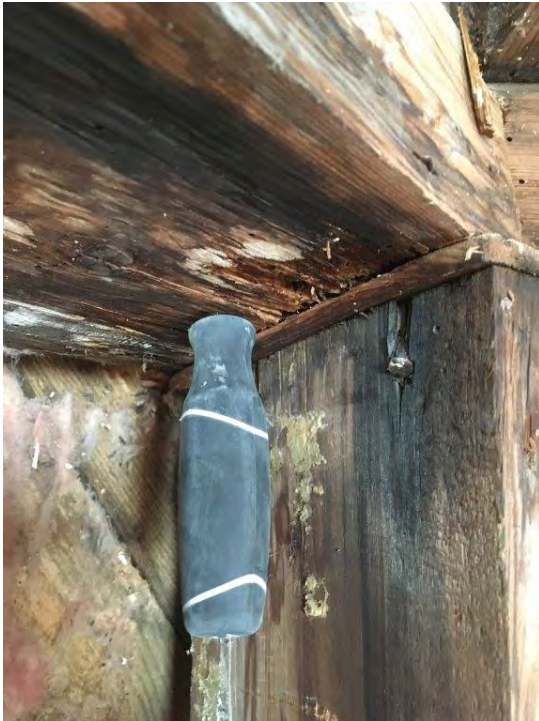
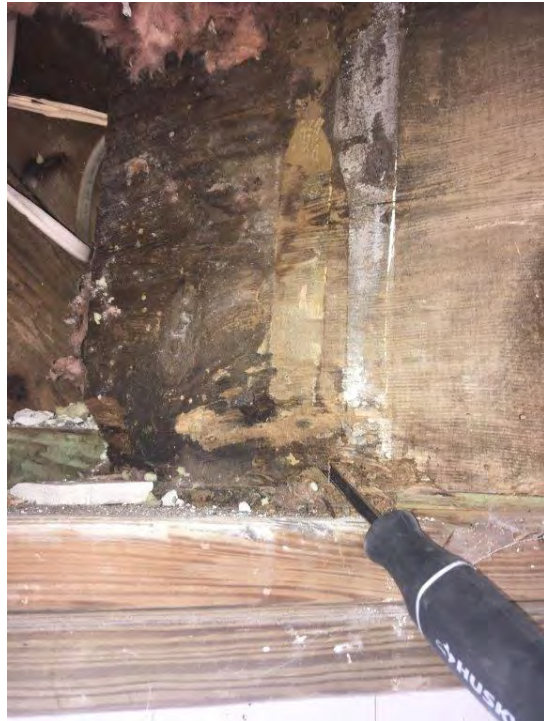
**Typical second floor wall top plate & third floor beam with rot/deterioration at exterior wall support top plate; no mechanical fasteners observed or no longer engaging framing**

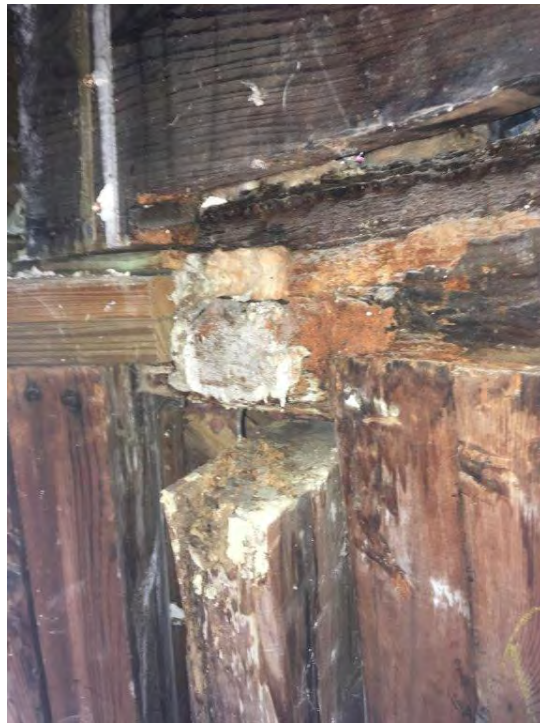
**Typical second floor wall stud fully separated top plate; no longer providing support to gravity load resisting system**

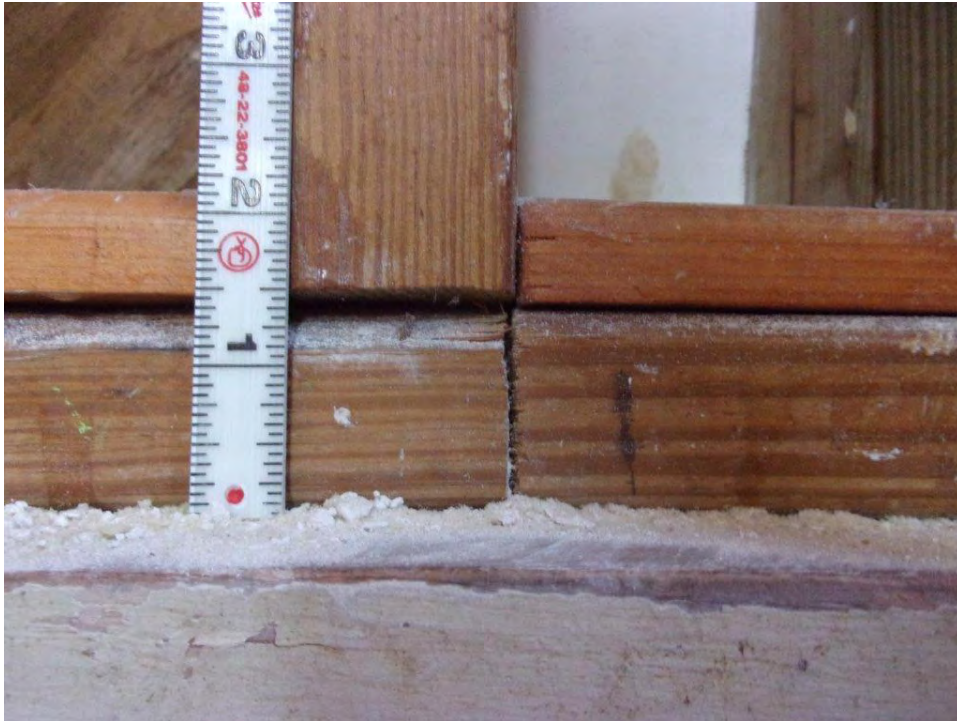
**Typical discontinuous second floor exterior wall sole plate joint with no mechanical attachment observed**

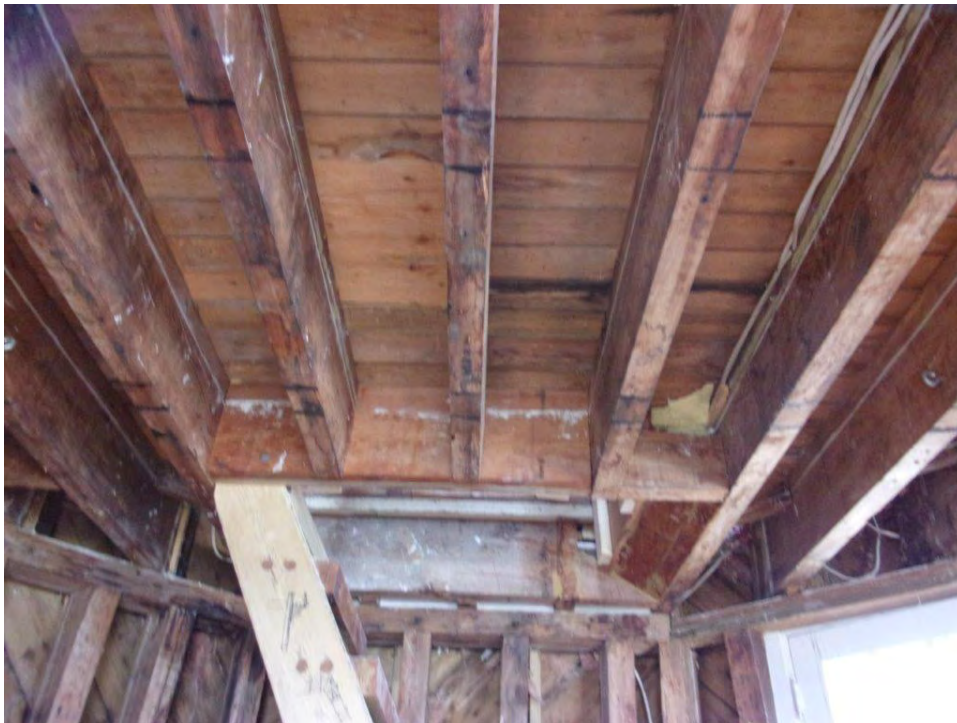
**Typical third floor support framing with discontinuous header at stair opening framing at third floor**

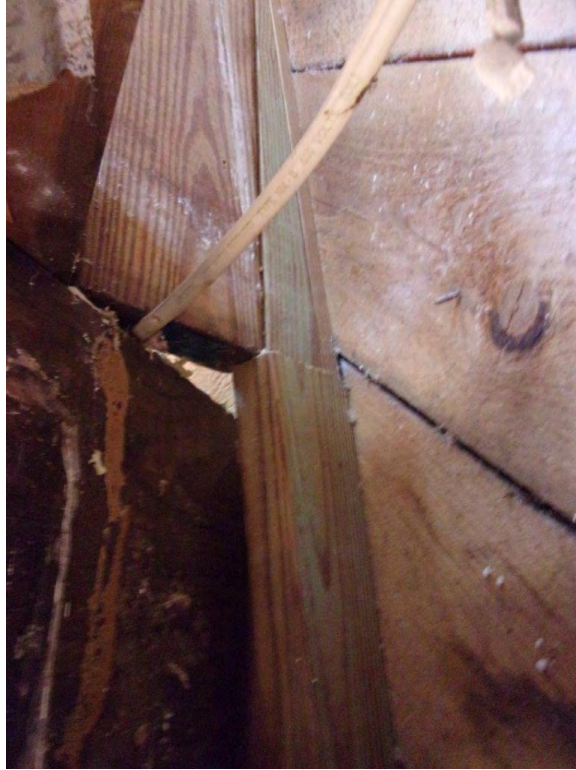
**Typical third floor exterior wall stud and “wedge” not fully supported;  
mechanical fastening of wedges to studs not observed**

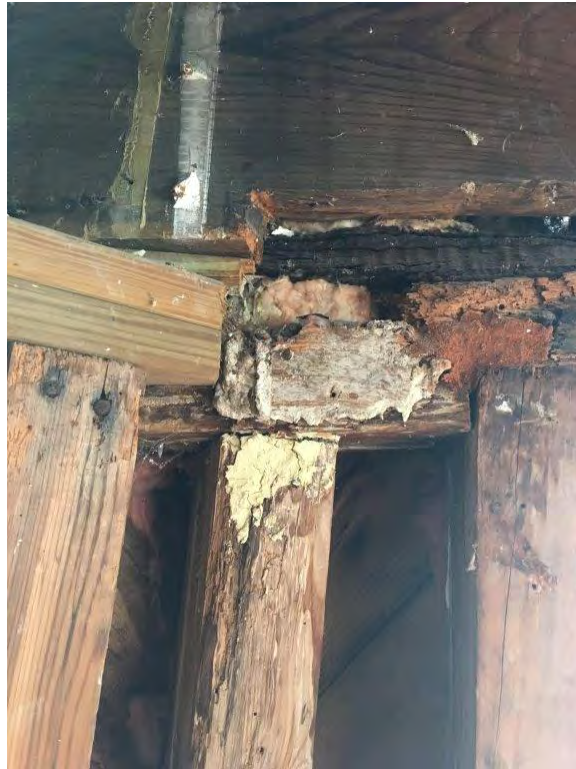
**Rotted/deteriorated steel plate and wood top plate installed at second floor exterior wall**
