**BARNSTABLE HISTORICAL COMMISSION – JUNE 2<sup>ND</sup> MEETING MATERIALS**  
**Table of Contents**

<b>Page 85</b>	Letter from Massachusetts Historical Commission regarding 28 Falco Road Conservation Restriction Project

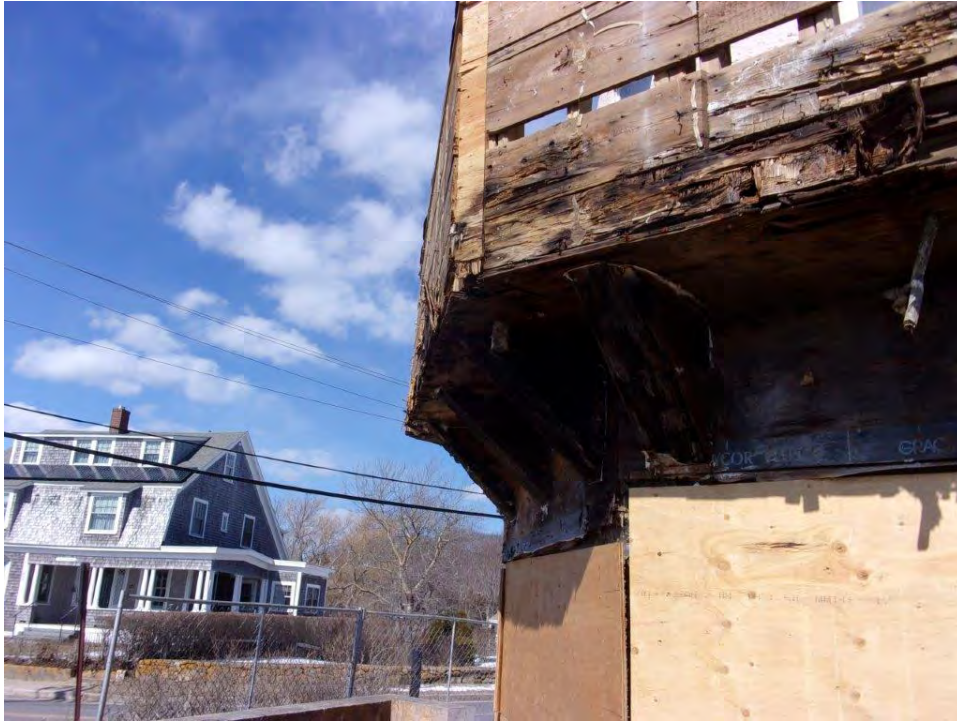
**Typical second floor wrap-around balcony sheathing and supports;  
constructed with dimensional lumber**

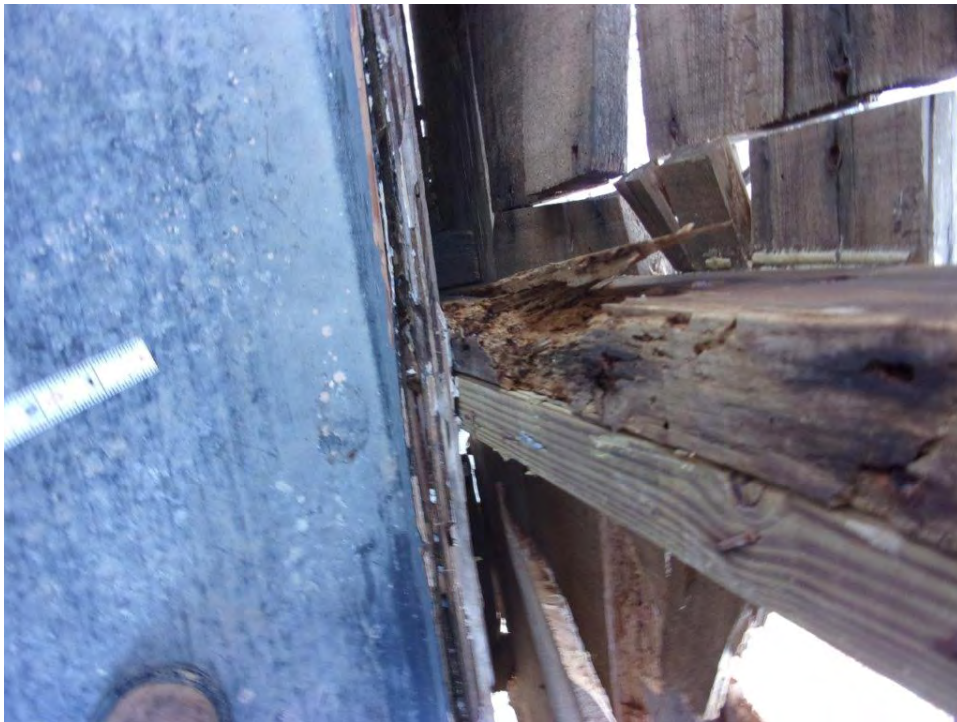
**Typical rotted/deteriorated second floor wrap-around balcony board sheathing  
and exterior railing post; constructed with dimensional lumber**

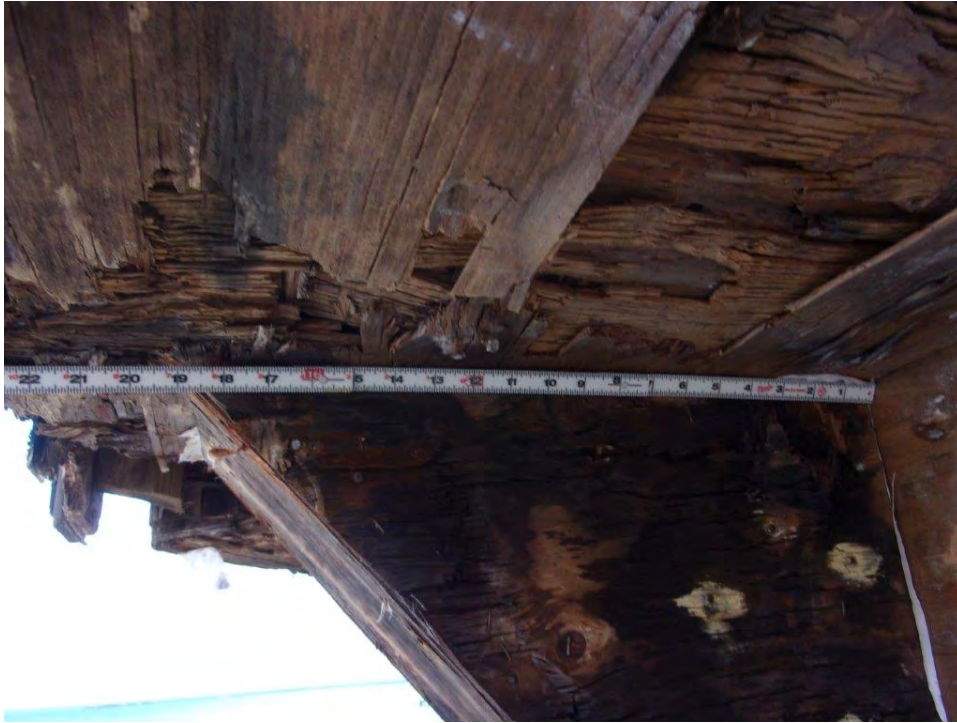
**Typical underside of second floor wrap-around balcony with failed sheathing (layers separating); constructed with dimensional lumber**

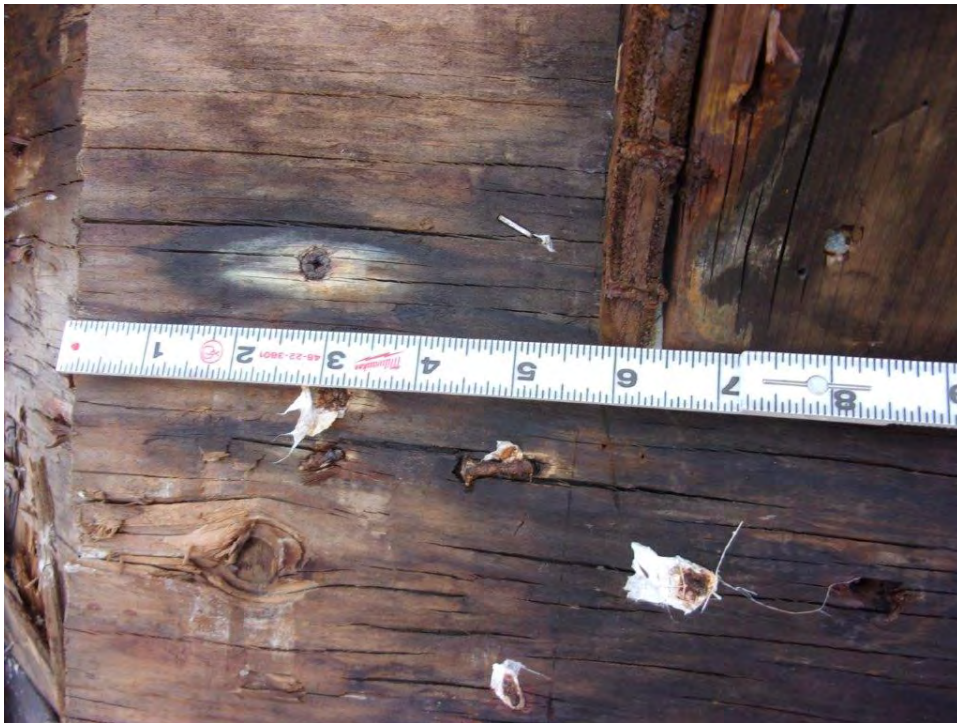
**Typical second floor wrap-around balcony with separation of sheathing from diagonal support; constructed with dimensional lumber**

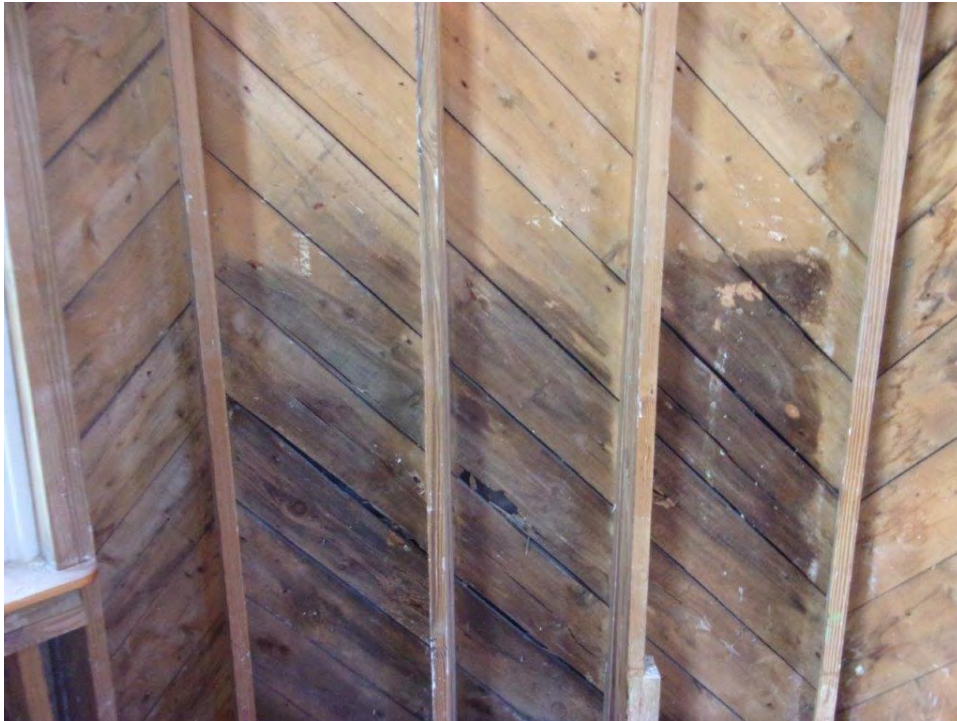
**Typical third floor board sheathing with visible water staining and deterioration; constructed with dimensional lumber**

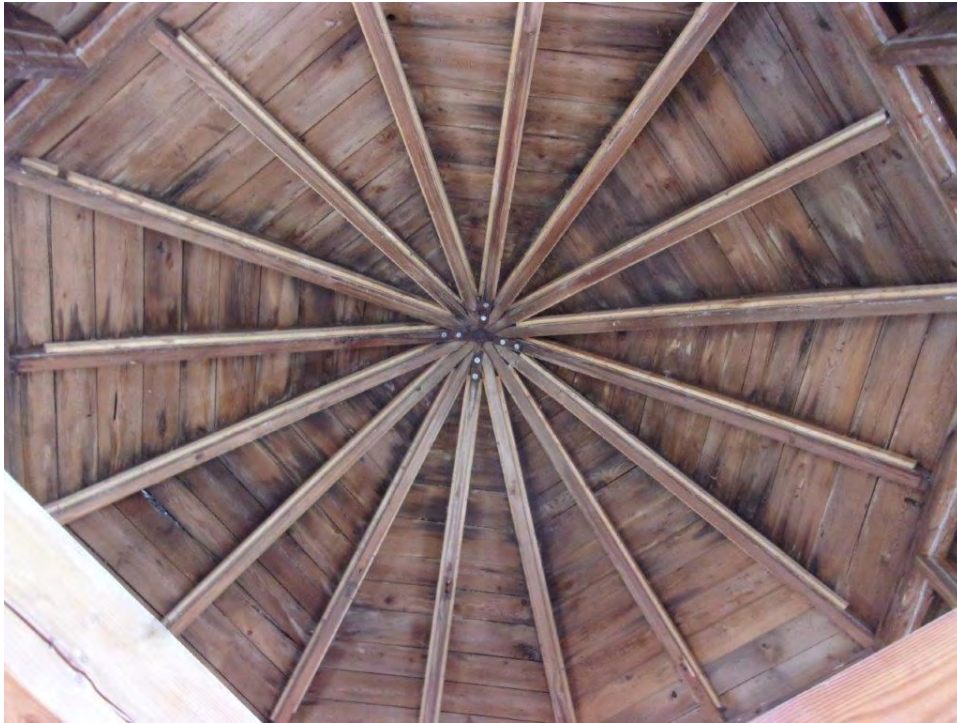
**Typical existing (original) dome roof framing with visible water staining at third floor**

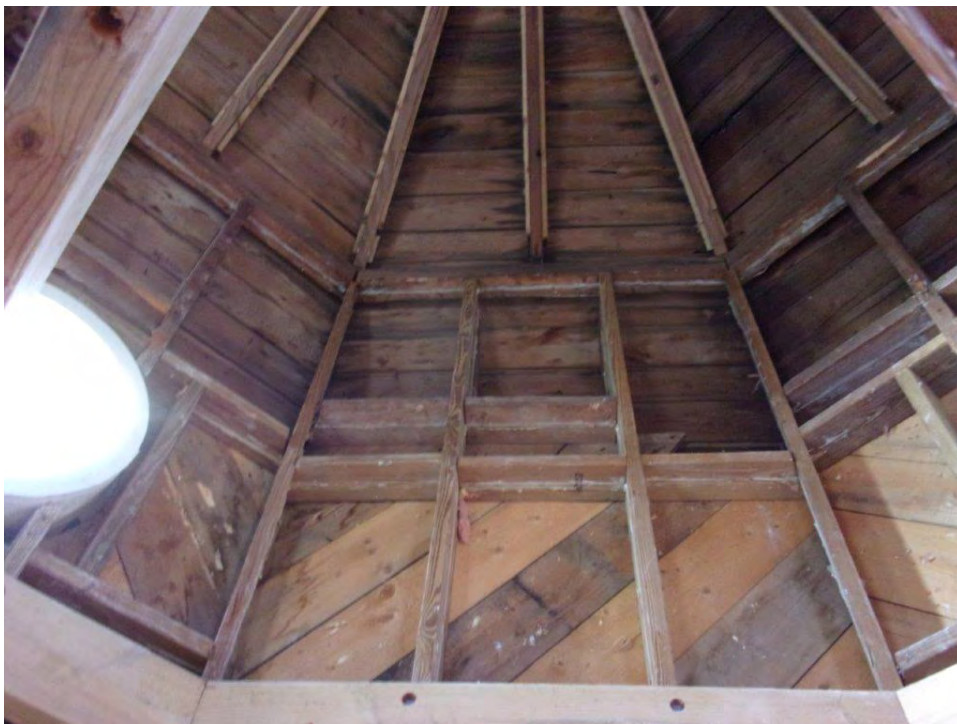
**Visible discontinuous bridging at dome roof eave at third floor exterior wall framing**

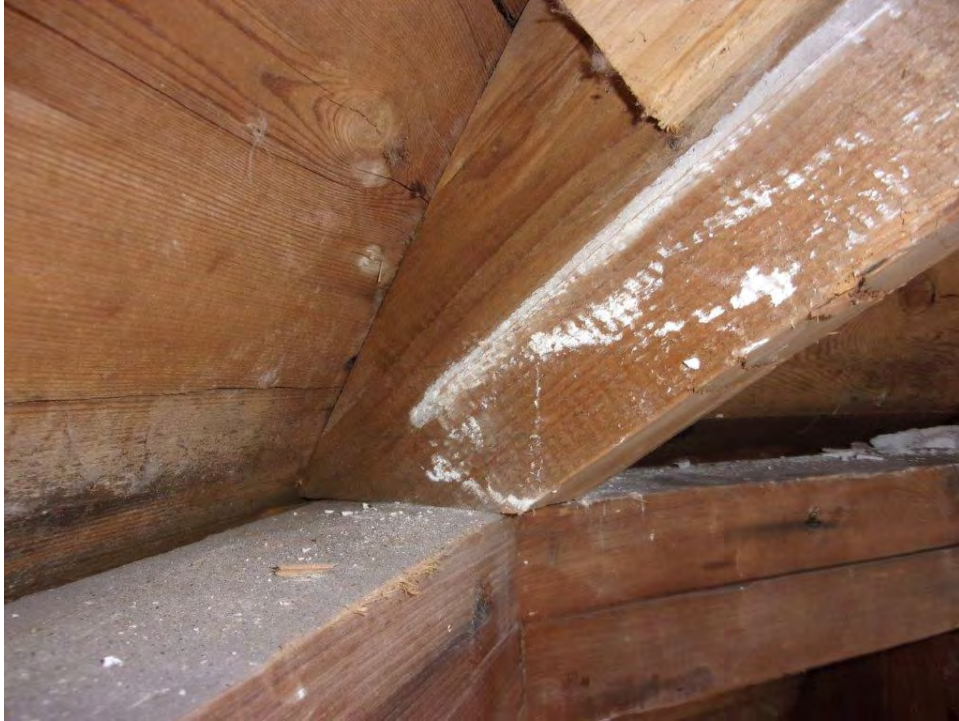
**Typical dome roof framing support at double top plate at third floor exterior wall;  
no mechanical fasteners observed**

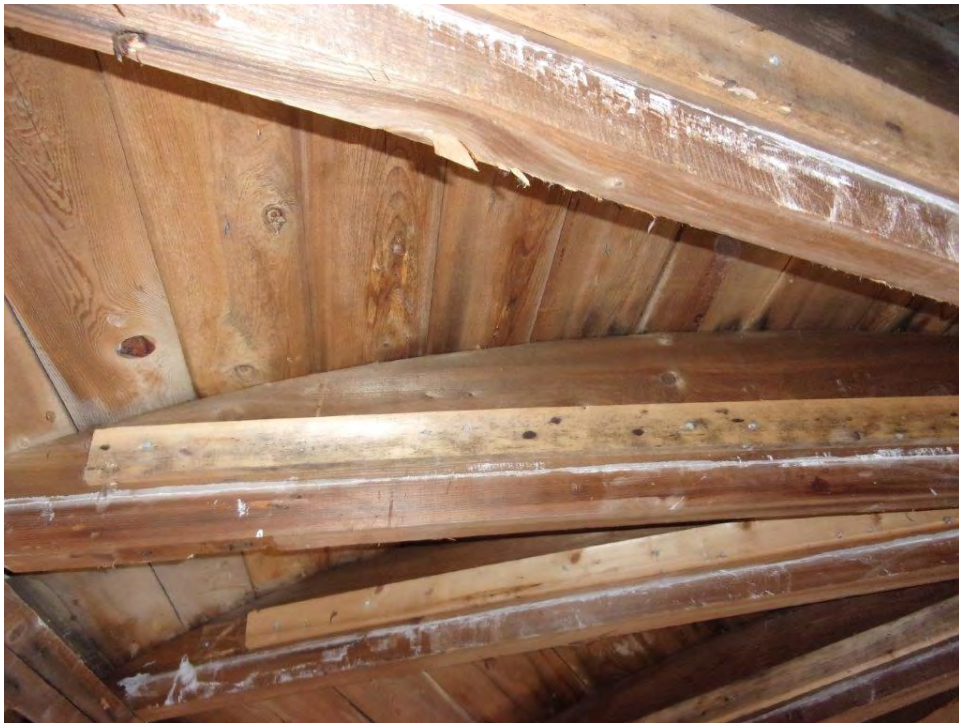
**Typical dome roof framing curvature and board sheathing  
with visible signs of water staining**

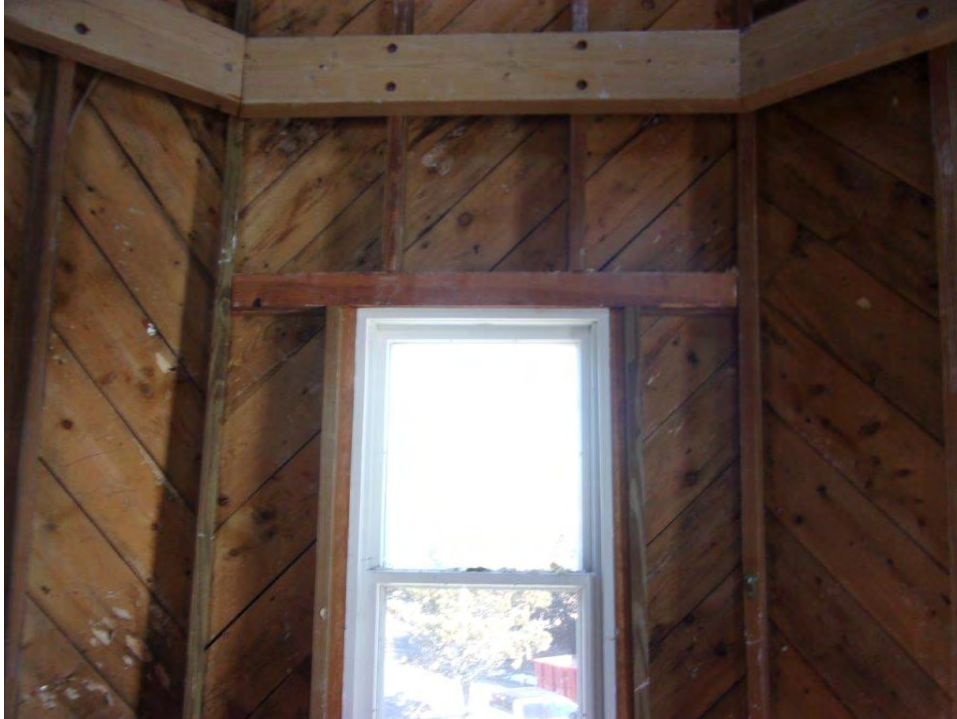
**Typical third floor window header and tension/compression ring wood framing;  
tension/compression ring framing secured with carbon steel fasteners**

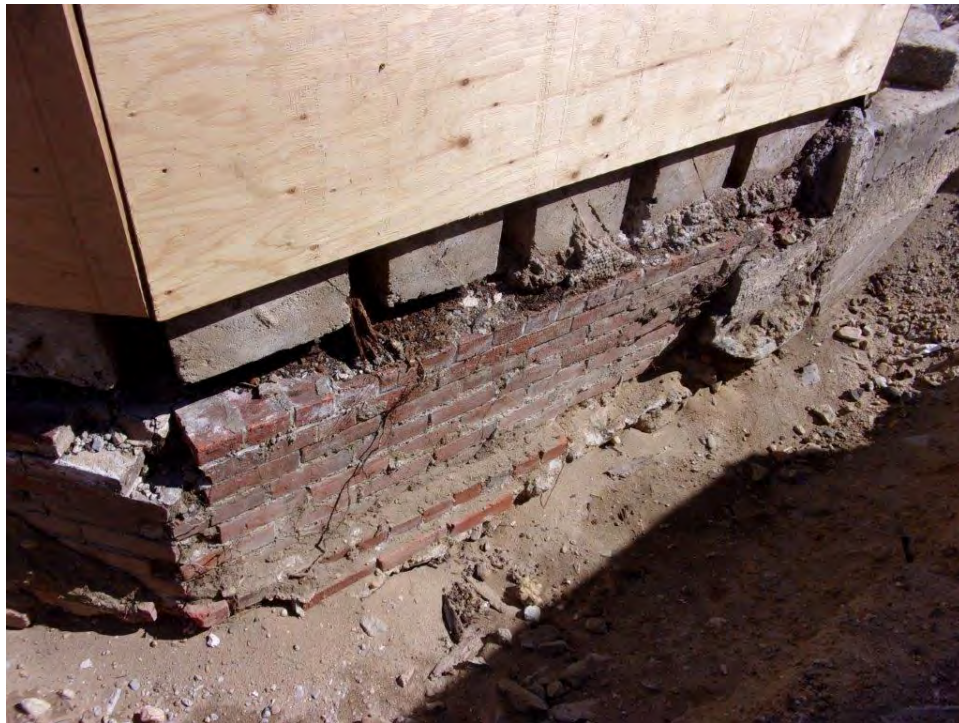
Typical building mass masonry and concrete foundation with concrete block installed between exterior wall studs; visible vegetative growth and deteriorated wood sole plate

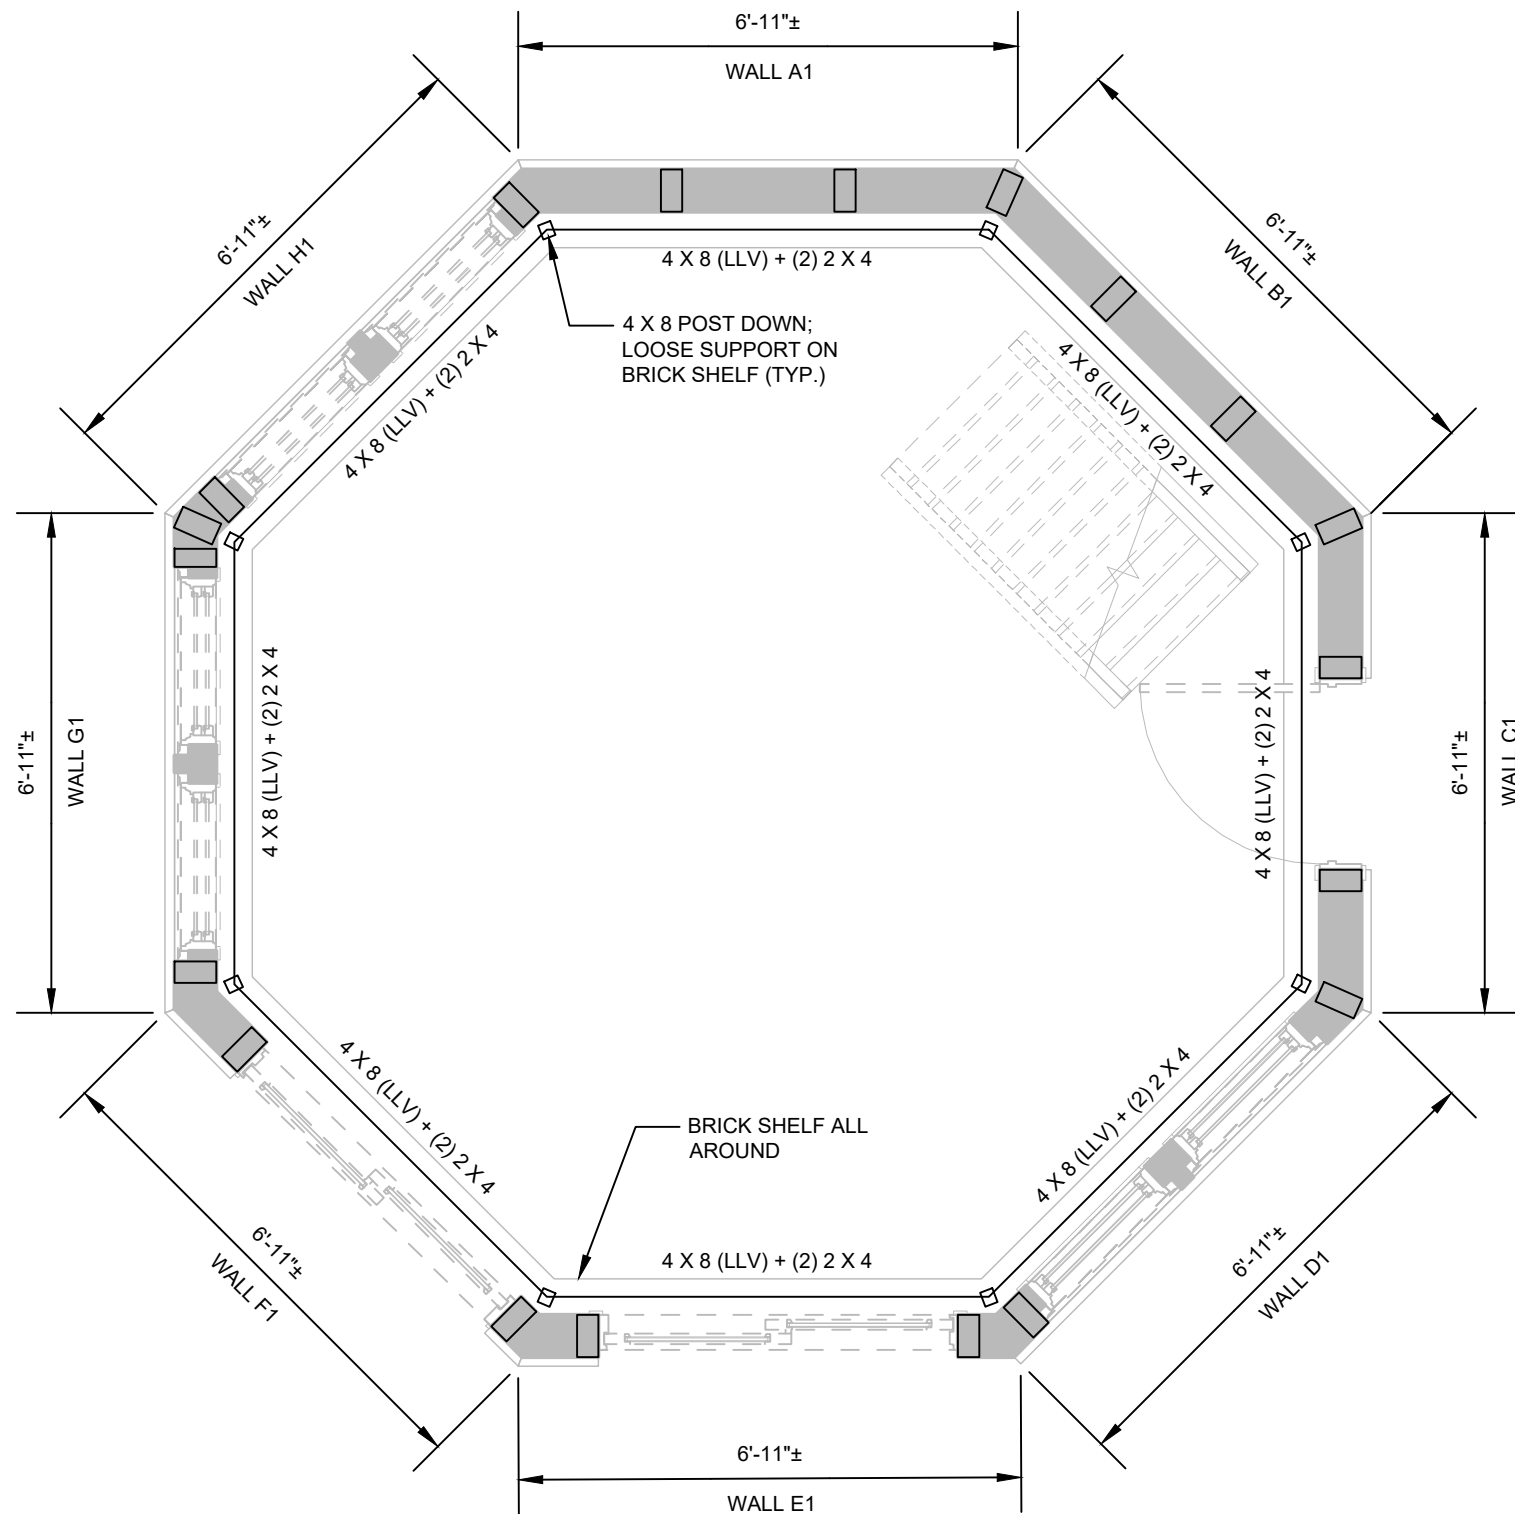
○ **PLAN: FIRST FLOOR AS-BUILT**  
SCALE: 3/8" = 1'-0"

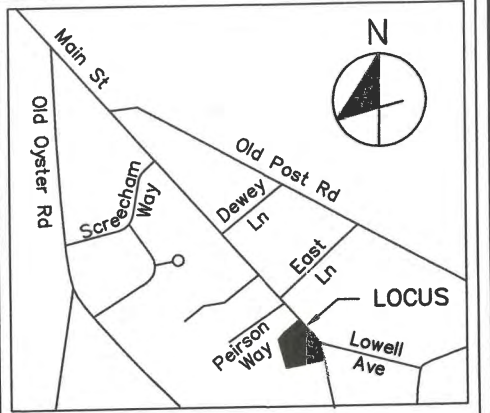
**FLOOD ZONE DESIGNATION**  
 FLOOD MAP 25001C0756J  
 EFFECTIVE 7/16/14  
 NON HAZARD-ZONE X

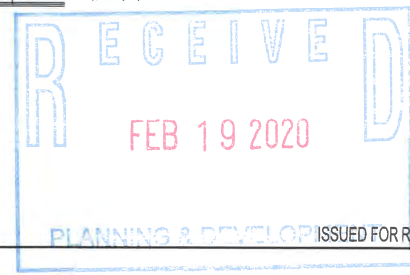
job no.:	1918
date:	11 FEBRUARY 2020
scale:	AS NOTED
drawn:	ELC, JAL
rev.:	
rev.:	
<b>A-3</b>	
sht	of

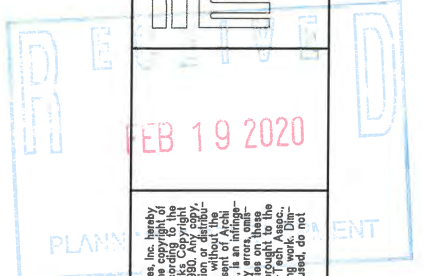
Architect-Tech Associates, Inc. hereby expressly reserves the copyright of these drawings. No part of these drawings may be reproduced, stored in a retrieval system, or transmitted in any form or by any means, electronic, mechanical, photocopying, recording, or by any information storage and retrieval system, without the prior written consent of Architect-Tech Associates, Inc. Any violation of this agreement shall constitute an infringement of the copyright laws of the United States of America. All dimensions and notes are to be taken from the drawings.

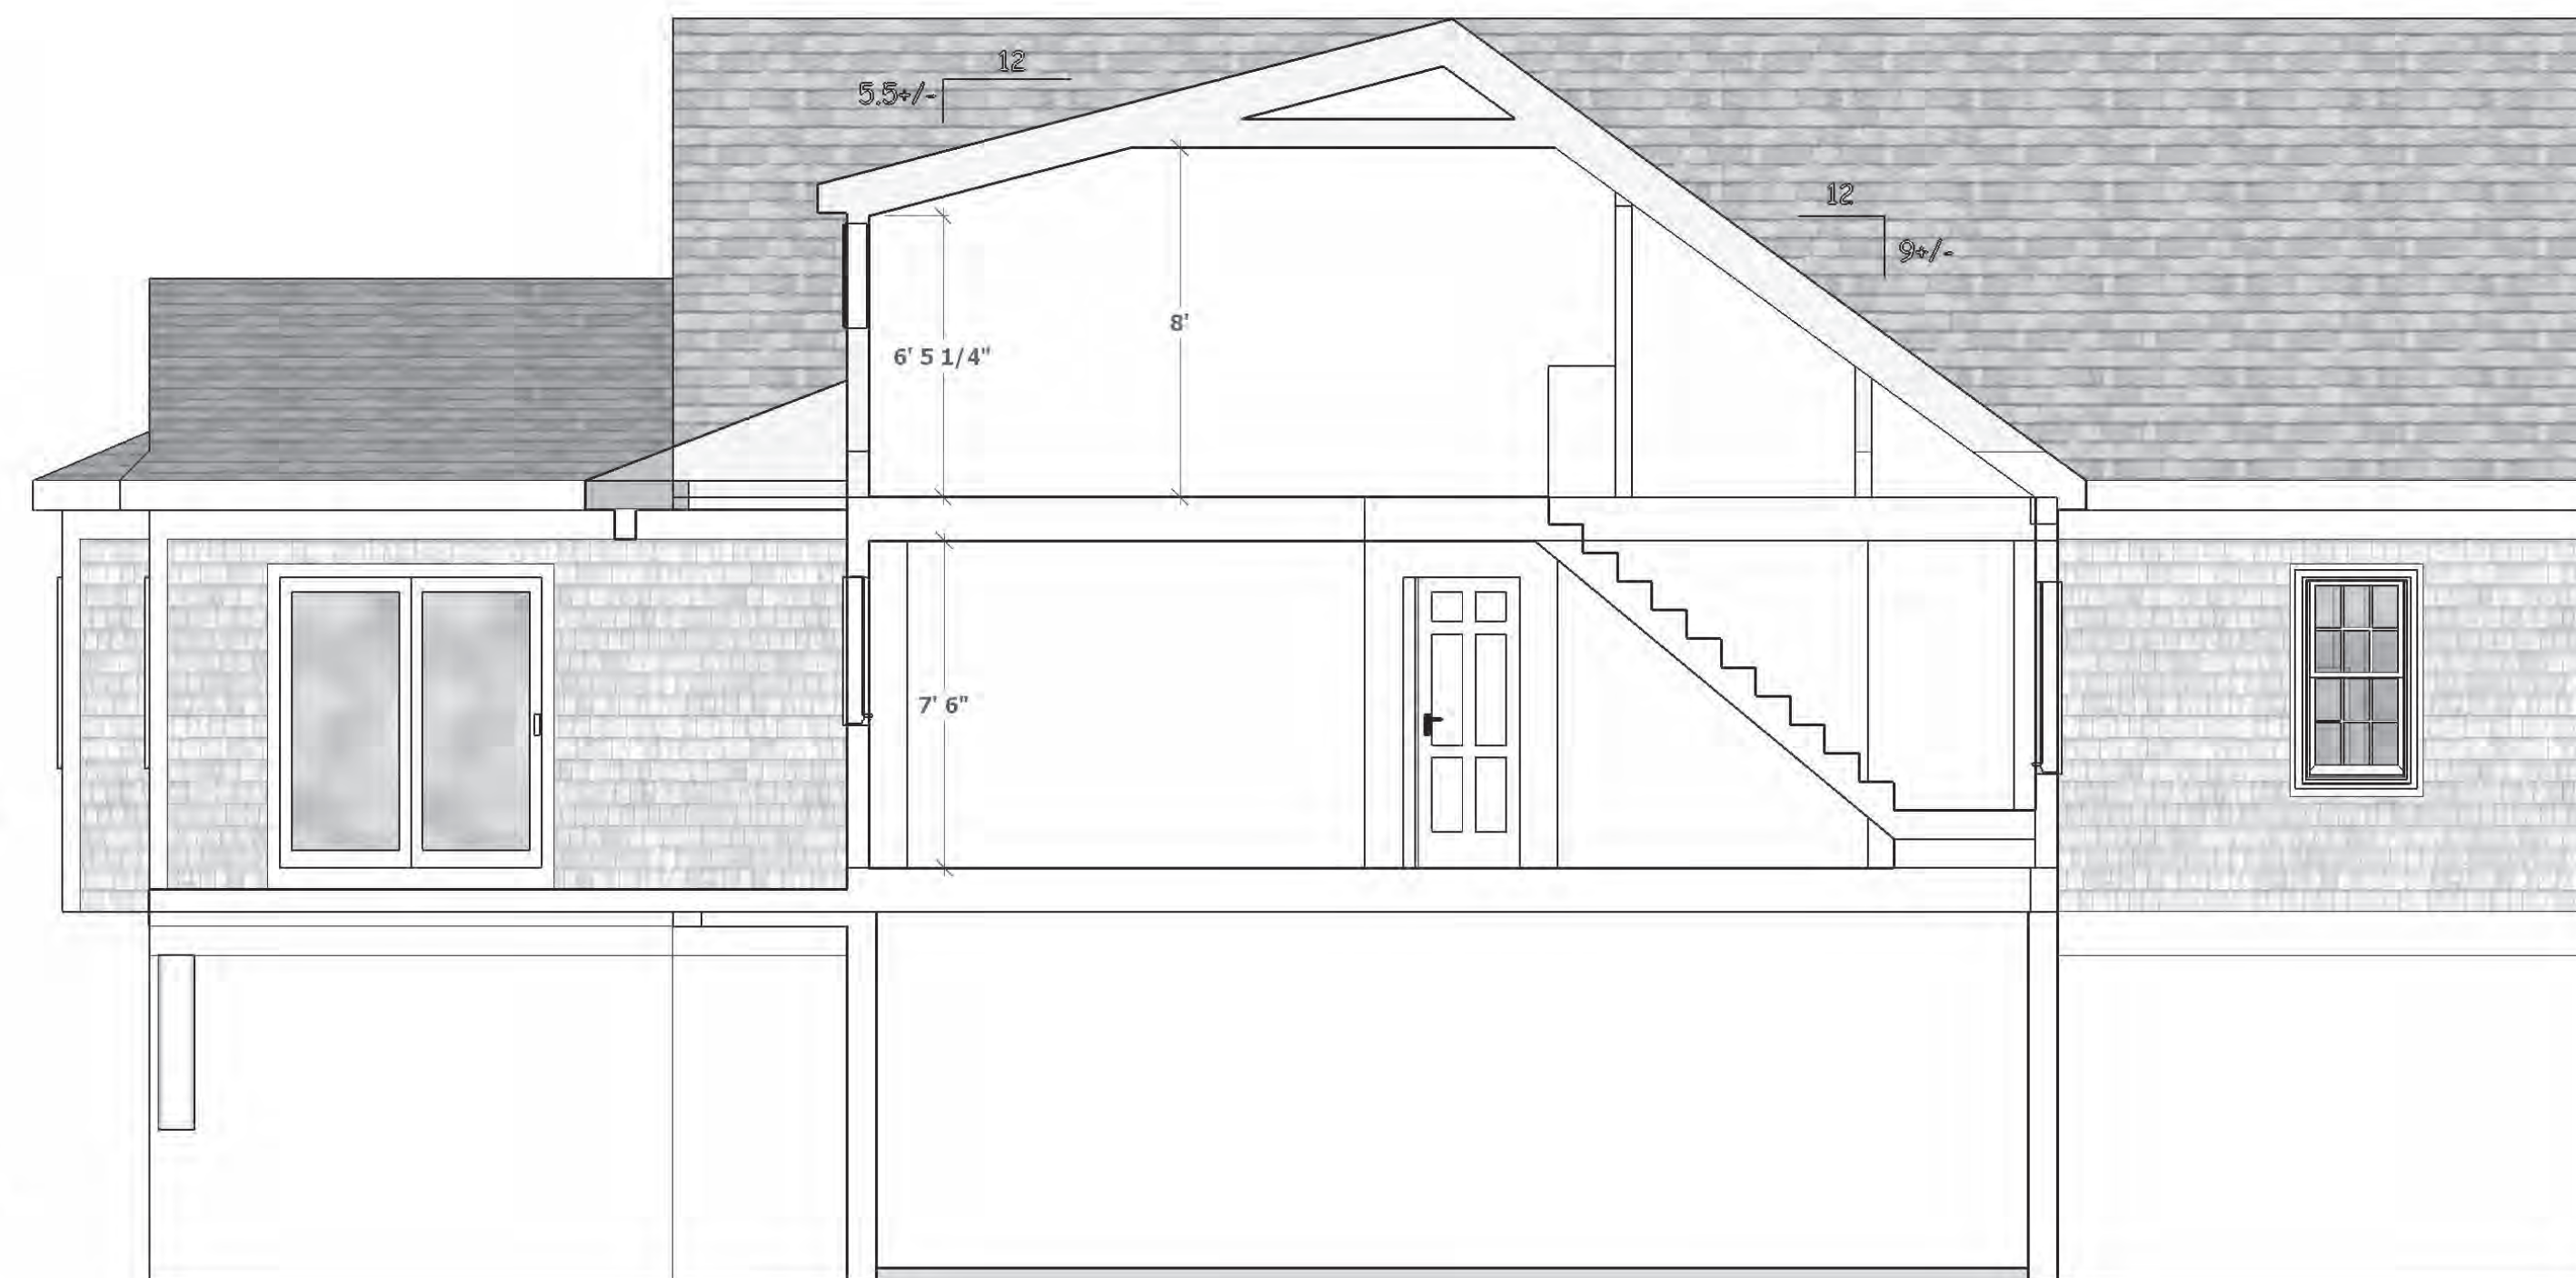
KITCHEN/BEDROOM CROSS SECTION
