# Veterans Beach, Playground and **Bathhouse**

Town of Barnstable **ADA Transition Plan**

September 2021

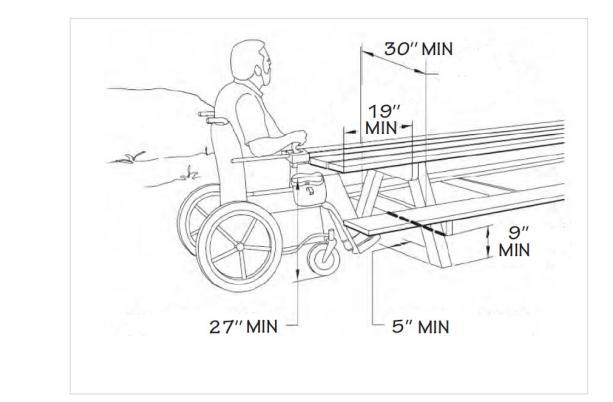
**Note:** The picnic area has newer picnic tables but they lack the required 19" knee clearance. See fig. below.
