Comfort Station at 249 North Street

ADA Transition Plan

October 2021

**Town of Barnstable
Comfort Station at 249 North Street**

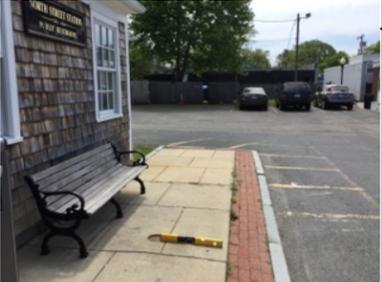
ID	Location	Floor	Room	Element	Type	Photo	Issues	Current Measure	Recommendations	Quantity	Price	Cost Estimation
Approach and Entrance												
Exterior Access Route												
1	Walkway Near Toilet Rooms	Ext.		Exterior Access Route	Walkway

Cross slope > 1:50 (2.00%)	5.7%	Reduce cross slope to be no steeper than 1:50 (2.00%).	1	-	\$0
2	Towards Toilet Rooms	Ext.		Exterior Access Route	Exterior

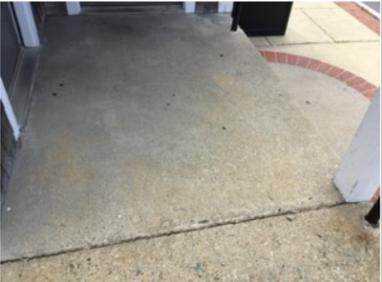
Level changes > 1/4"	0.75"	Alter change in level to be 1/4" high max. (Cost for a 4'x4' concrete patch.)	1	256	\$256
3	Walkway Near Parking Lot	Ext		Exterior Access Route	Walkway

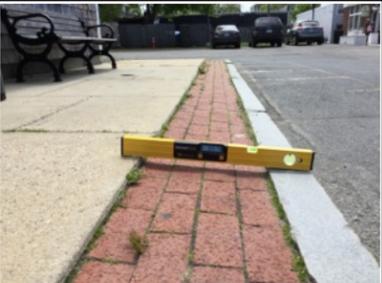
Level changes > 1/4"	0.75"	Alter change in level to be 1/4" high max.	1	-	\$0
4	Walkway Near Parking Lot	Ext		Exterior Access Route	Exterior

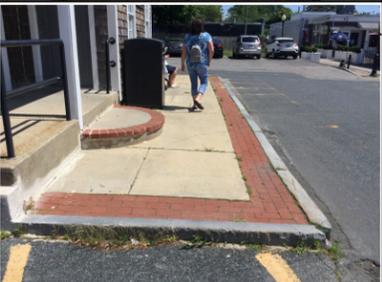
Accessible route not provided	-	Provide a curb ramp to ensure an accessible route is provided to the bench and trash container.	1	2800	\$2800
Access to Goods and Services

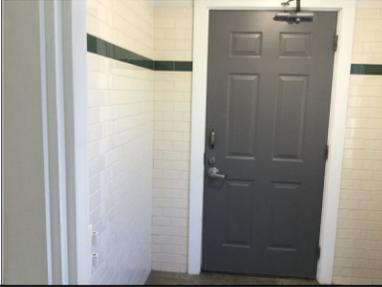
ID	Location	Floor	Room	Element	Type	Photo	Issues	Current Measure	Recommendations	Quantity	Price	Cost Estimation
Doors, Doorways, & Gates												
5	Women's Toilet Room	1		Doors, Doorways, & Gates	Toilet Room

Maneuvering clearance(s) not provided	15.9"	Provide an automatic door opener.	1	3060	\$3060
Ramps												
6	Exterior Ramp to Comfort Station	Ext.		Ramps	Exterior

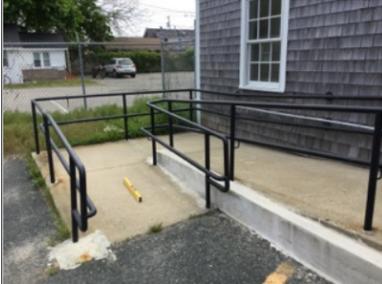
Edge protection < 4" high	-	Provide edge protection that prevents the passage of a 4" diameter sphere, where any portion of the sphere is within 4" of the finished floor or ground surface.	1	1260	\$1260
Signage												
7	Men and Women's Toilet Rooms	Ext.		Signage	Designation

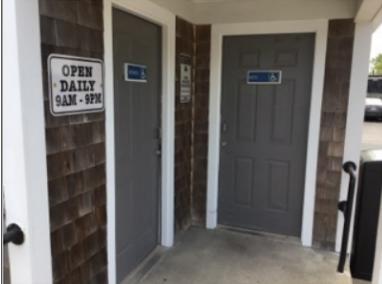
Raised characters not provided Braille not provided Sign not located on the latch side of the door	- - -	Provide text with raised characters duplicated in braille. Mount signs so that the baseline of the lowest tactile character is 48" min. above the finished floor and the baseline of the highest tactile character is 60" max. above the finished floor. Locate signs alongside the door on the latch side.	2	232	\$464

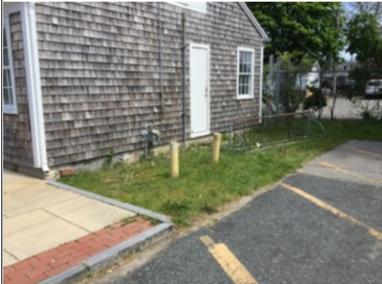
Bike Racks												
8	Parking Lot to Sidewalk	Ext.		Bike Racks	N/A

Not connected to an accessible route	-	Ensure bike racks are connected to an accessible route.	1	Labor	\$0
Toilet & Bathing Rooms

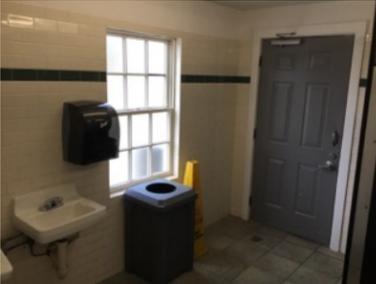
Audible and visible alarms not provided	-	When fire system is updated, ensure that a visible and audible fire alarm is installed.	1	-	\$0
10	Women's Toilet Room	1		Overall Access

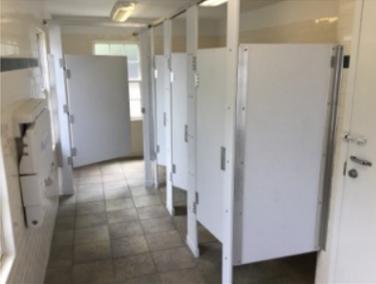
Audible and visible alarms not provided		When fire system is updated, ensure that a visible and audible fire alarm is installed.	1	-	\$0
Toilet Compartment												
11	Men's Toilet Room	1		Toilet Compartment	Accessible Compartment

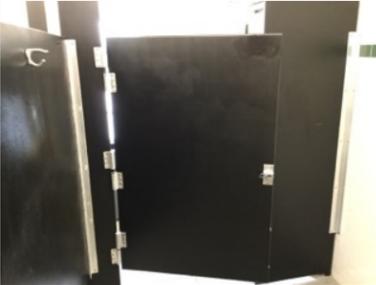
Door with malfunctioning self-closing hinge Coat hook > 48" Door pull not provided	- 65.5" -	Repair hinge. Lower coat hook so that it is no higher than 48". Provide a door pull on both sides of the door near the latch.	1	220	\$220
12	Women's Toilet Room	1		Toilet Compartment	Accessible Compartment

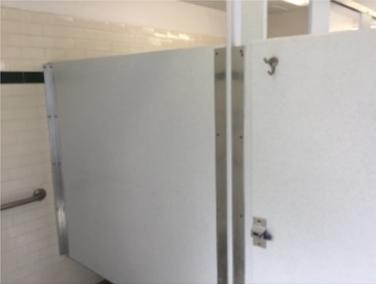
Door with malfunctioning self-closing hinge Coat hook > 48" Door pull not provided	- 64.5" -	Repair hinge. Lower coat hook so that it is no higher than 48". Provide a door pull on both sides of the door near the latch.	1	220	\$220

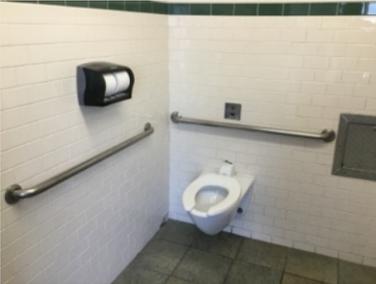
13	Men's Toilet Room	1		Toilet Compartment	Accessible Compartment

Non-compliant toilet paper dispenser	-	Relocate toilet paper so that it is located under the grab bar and higher than 15" above the finished floor; and between 7" and 9" from the front of the toilet.	1	353	\$353

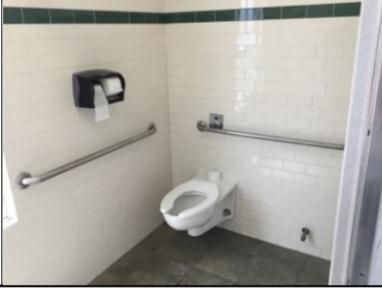
ID	Location	Floor	Room	Element	Type	Photo	Issues	Current Measure	Recommendations	Quantity	Price	Cost Estimation
14	Women's Toilet Room	1		Toilet Compartment	Accessible Compartment

Non-compliant toilet paper dispenser	-	Relocate toilet paper so that it is located under the grab bar and higher than 15" above the finished floor; and between 7" and 9" from the front of the toilet.	1	353	\$353
Best Practice												
Lavatories												
15	Women's Toilet Room	1		Lavatories	N/A

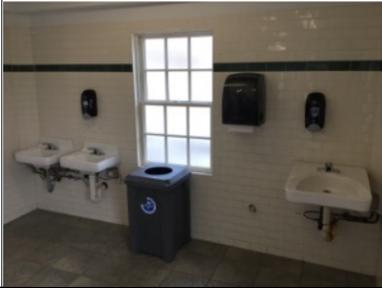
Recommend insulating pipes at all lavatories.	1	-	\$0
Signage												
16	Landing to Toilet Rooms	Ext.		Signage	N/A

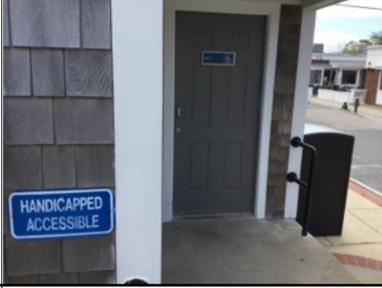
Recommend replacing the sign with one that says "Accessible Toilet Rooms".	1	-	\$0
17	Walkway Near Toilet Rooms	Ext.		Signage	N/A

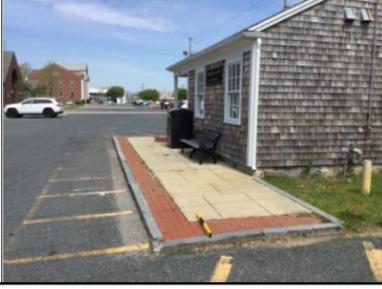
Recommend providing a directional sign at this location.	1	-	\$0
