**Stewart's Creek
Planning Document**

February 2021

Prepared for:
Town of Barnstable
230 South Street
Hyannis, MA 02601

Prepared by:
Woods Hole Group
A CLS Company
107 Waterhouse Road
Bourne, MA 02532 USA
(508) 540-8080

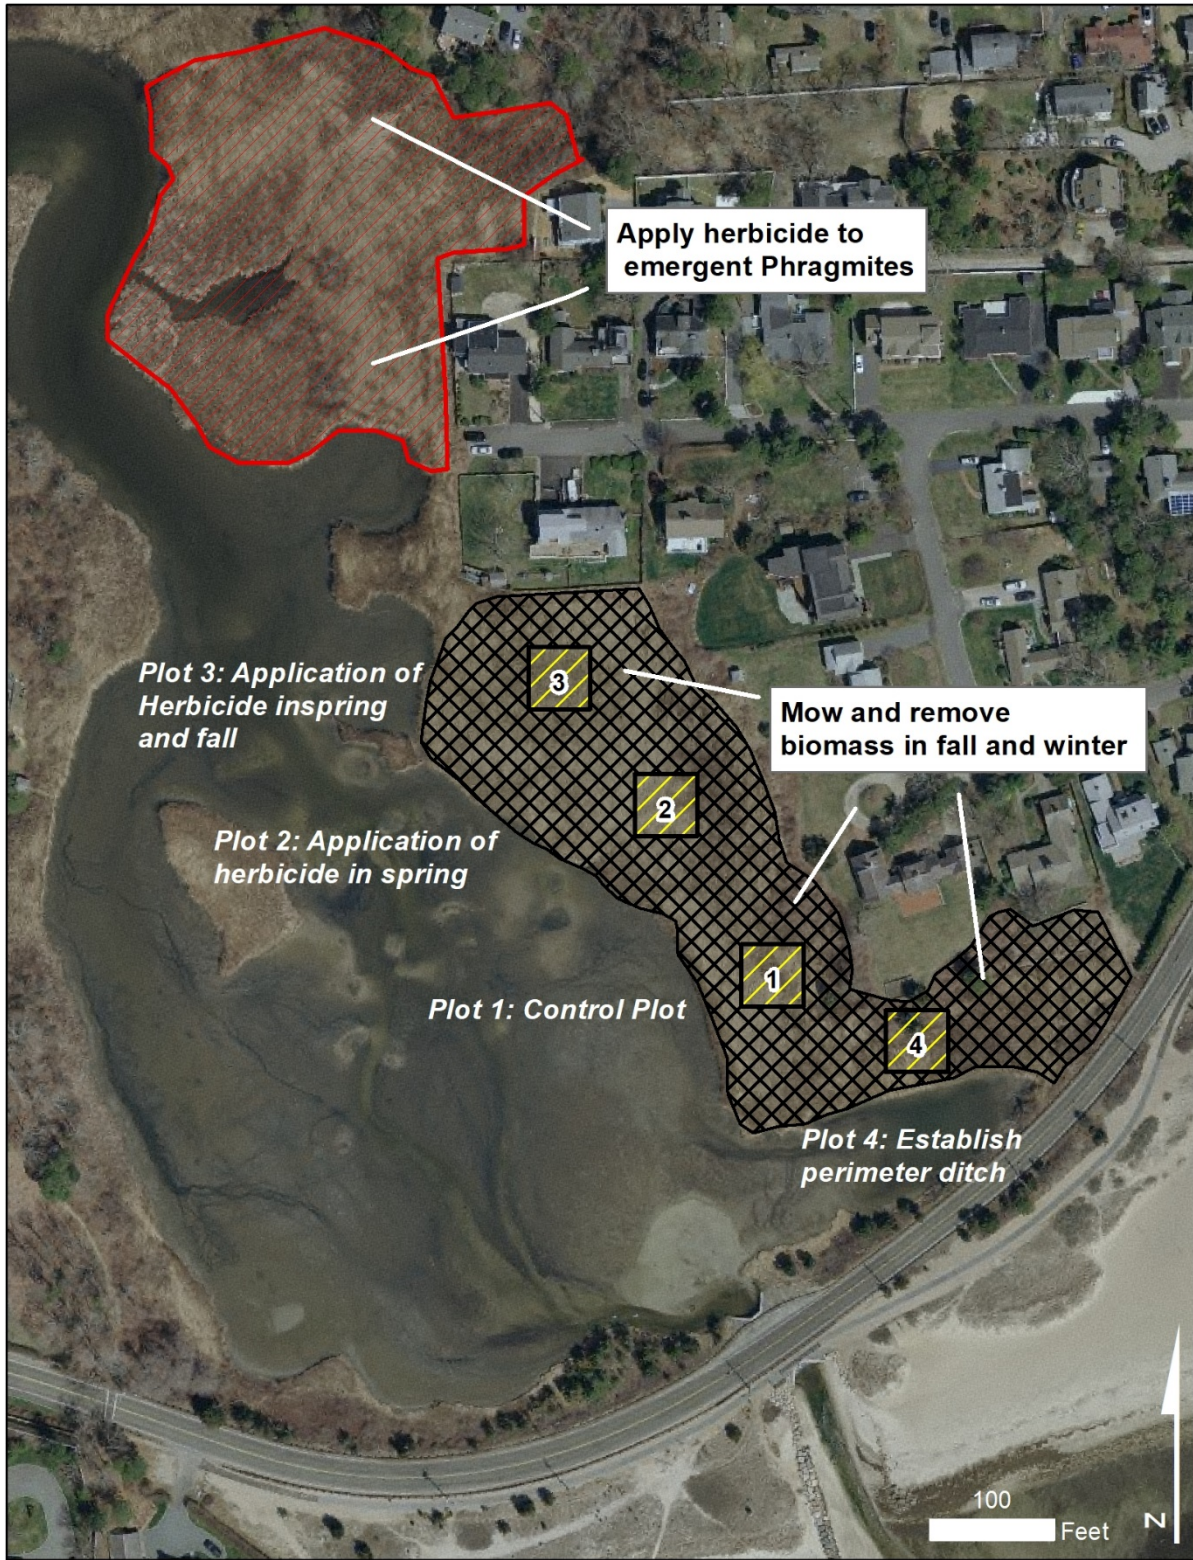
Figure 1. Stewart's Creek proposed draft Action Plan for Phragmite mitigation.

1. Mow, remove biomass, and aggressively apply wetland-approved herbicides to emergent *Phragmites* where previously established freshwater vegetation is transitioning as indicated by the red outline in Figure 1 (e.g., end of Stetson Lane)

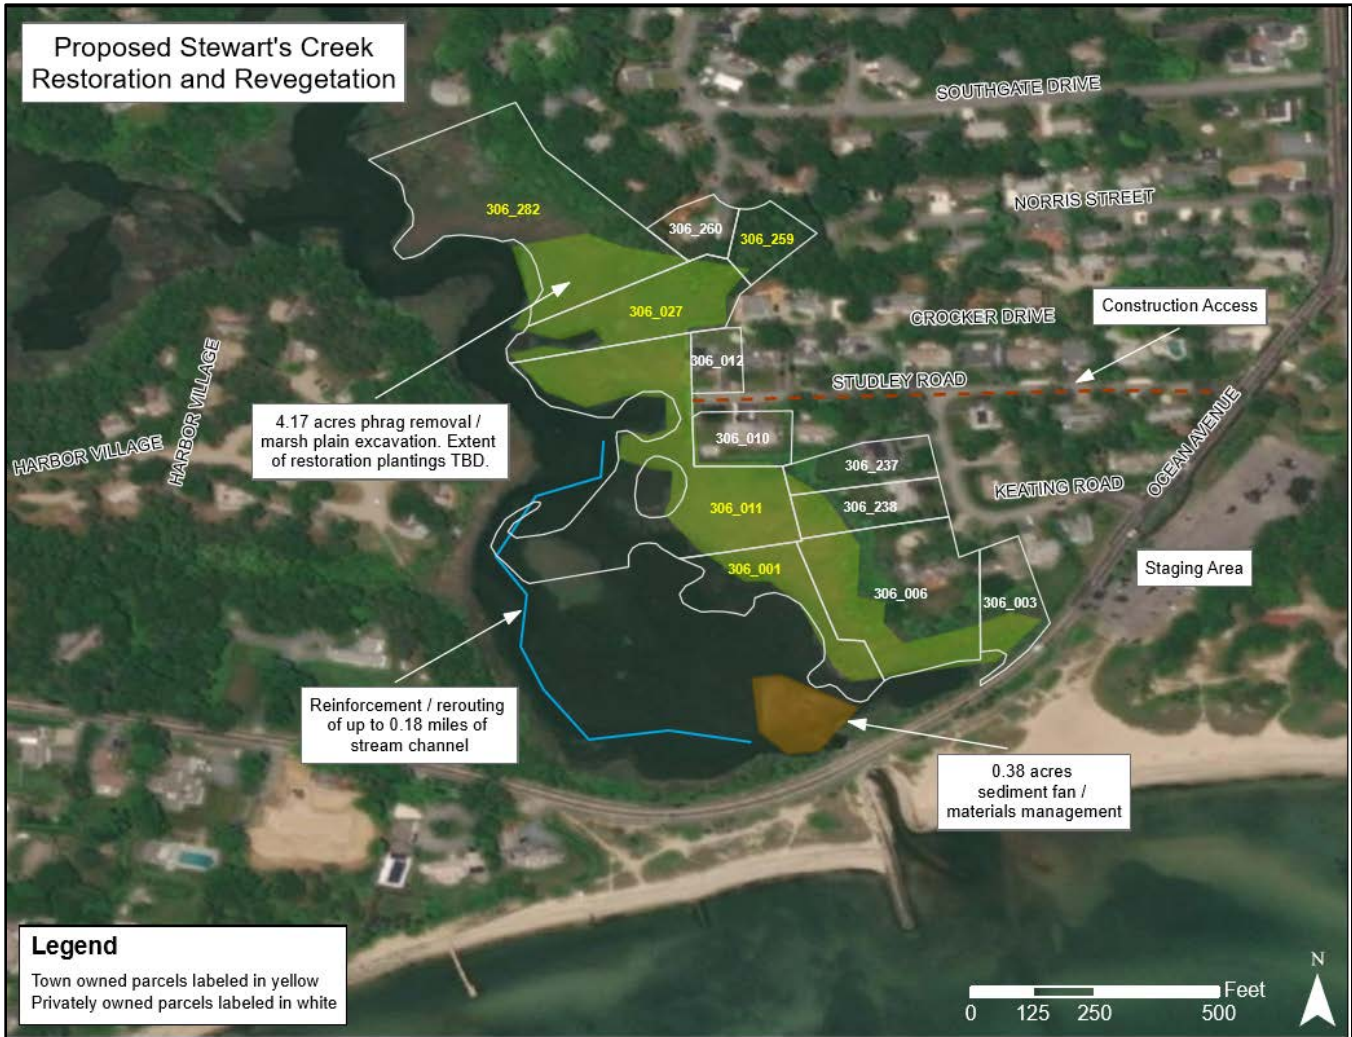
Figure 1 – Proposed project components, parcel ownership, construction access, and staging area for improvements to Stewart’s Creek.

The costs estimated herein outline the first step in the process – excavation of the *Phragmites* and restoration of the marsh plain. As we evaluated costs for managing the upstream tidal shoal and re-routing the channel, it became clear that preliminary design plans and specifications would be needed to accurately estimate the costs of those steps in the process. To review, an outline of the proposed components of the project, construction access, and staging areas are outlined in Figure 1.

It is important to note that the proposed improvements may extend onto several private parcels shown in white text in Figure 1 (Parcel no. (306_012), (306_010), (306_237), (306_238), (306_006), (306_003) moving from north-south). Town-owned parcels are shown in yellow text in Figure 1 (Parcel no. (306_

282), (306_259), (306_027), (306_011), (306_001) moving from north-south). The adjacent, privately-owned parcels may receive some ancillary benefits (invasive species treatment, improved storm damage protection, etc.) resulting from the project. It will be important for the Town to approach said owners to discuss any necessary easements prior to designing and constructing the project.
