# BARNSTABLE HISTORICAL COMMISSION

**November 17, 2020**

<b>2</b>	Agenda
<b>4</b>	NOID – 671 Old Post Road <i>Page 44 – Parcel Detail</i> <i>Page 51 – home inspection</i>
<b>133</b>	Correspondence – Planning Board, Regulatory Agreement
<b>174</b>	2021 Hearing & Deadline Schedule

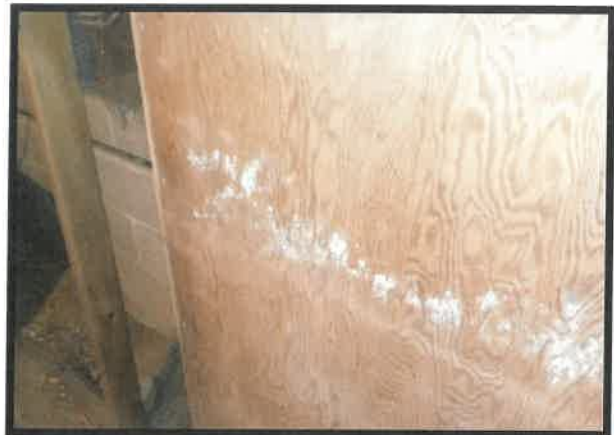
Visual Microbial Contamination (VMC) located on plywood in the Basement.

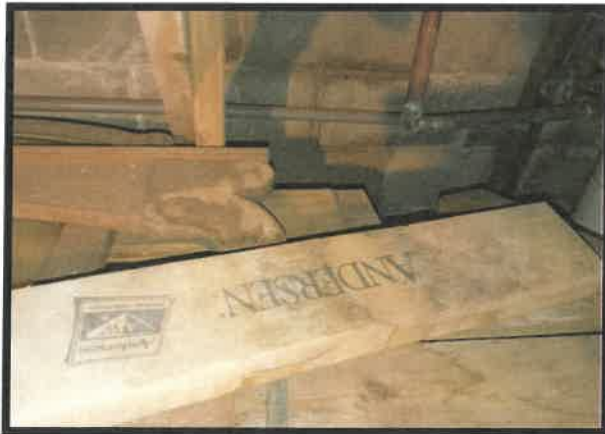
VMC located on cardboard contents in Basement.

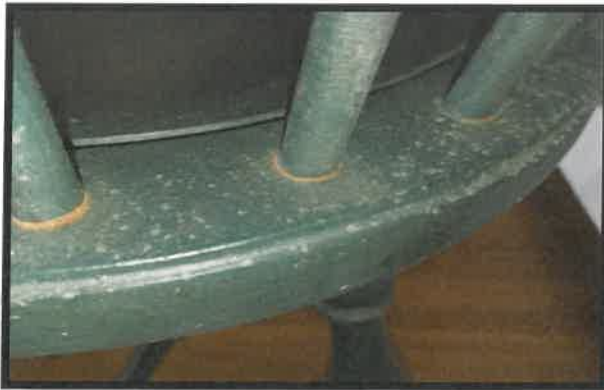
VMC located on wooden furniture in first floor living space.

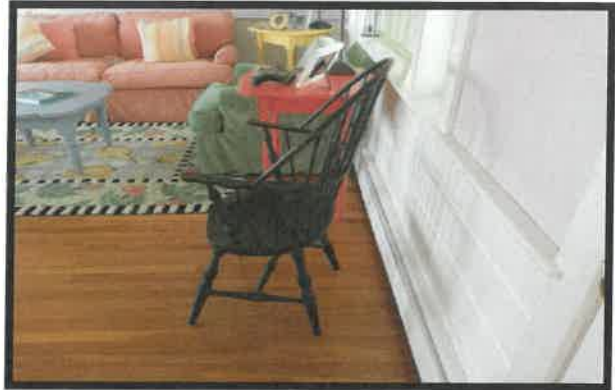
Wooden furniture where VMC was located.

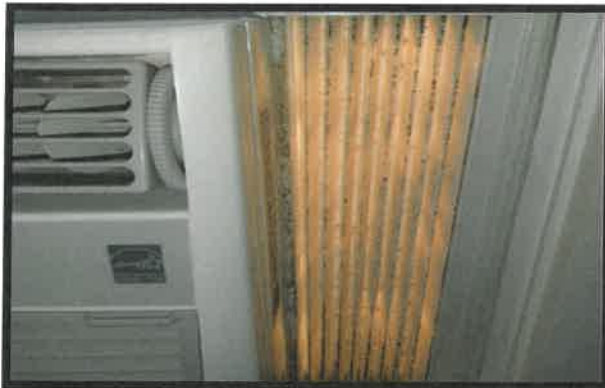
VMC located on window AC unit in Guest Room.

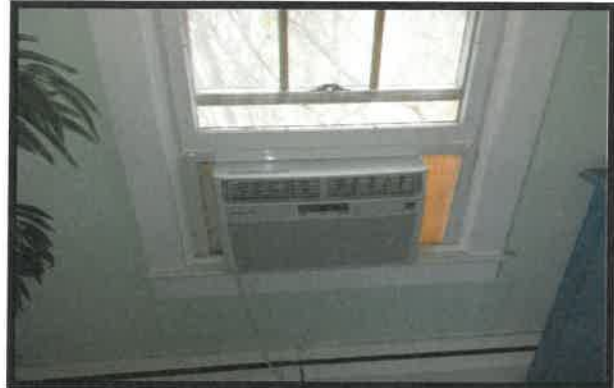
Location of window AC unit where VMC was identified.

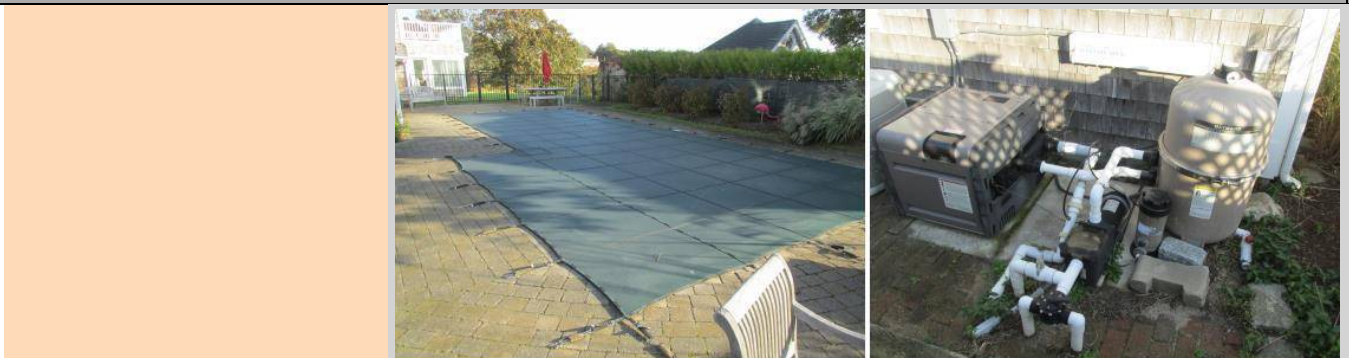
Observation: There is a swimming pool on the property. Analysis: Be advised that the inspection of swimming pools, attached mechanical systems, decks, pool houses, pool patio and ancillary equipment are expressly **EXCLUDED** from this inspection report per contract. Be advised that pool evaluation is undetermined as much of the piping and structure are hidden from view or the pool may be closed for the season. For safety, all pools should be protected by a five foot high fence with self-closing and self-latching gate hardware. Associated electrical equipment should have modern GFCI shock

protection. Recommendation: You should review all data and maintenance requirements with the owner prior to purchase. Other options include hiring a local pool company to perform further inspections or through your attorney you may set a sum of money in escrow until such time as the pool can be seasonally evaluated.

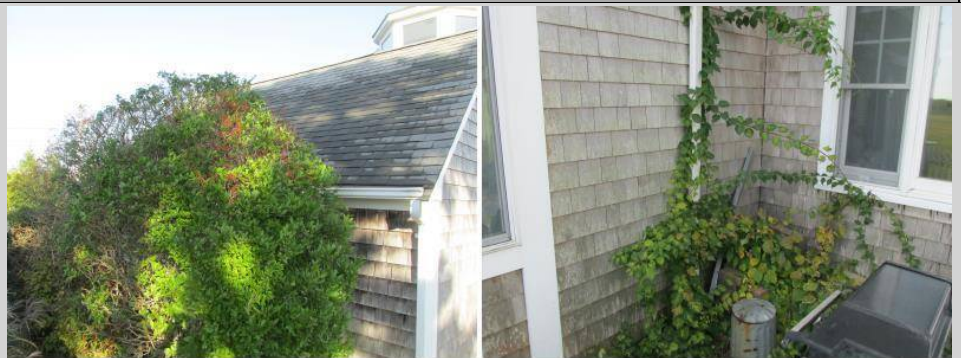
Observation: A few shrubs along parts of the perimeter of the foundation are overgrown and are in contact with the home. Analysis: Overgrown shrubs in contact with the home can prevent proper ventilation for the drying of wood siding & trim. Continuous damp conditions promote mildew, mold, damp rot and wood boring insect infestation.

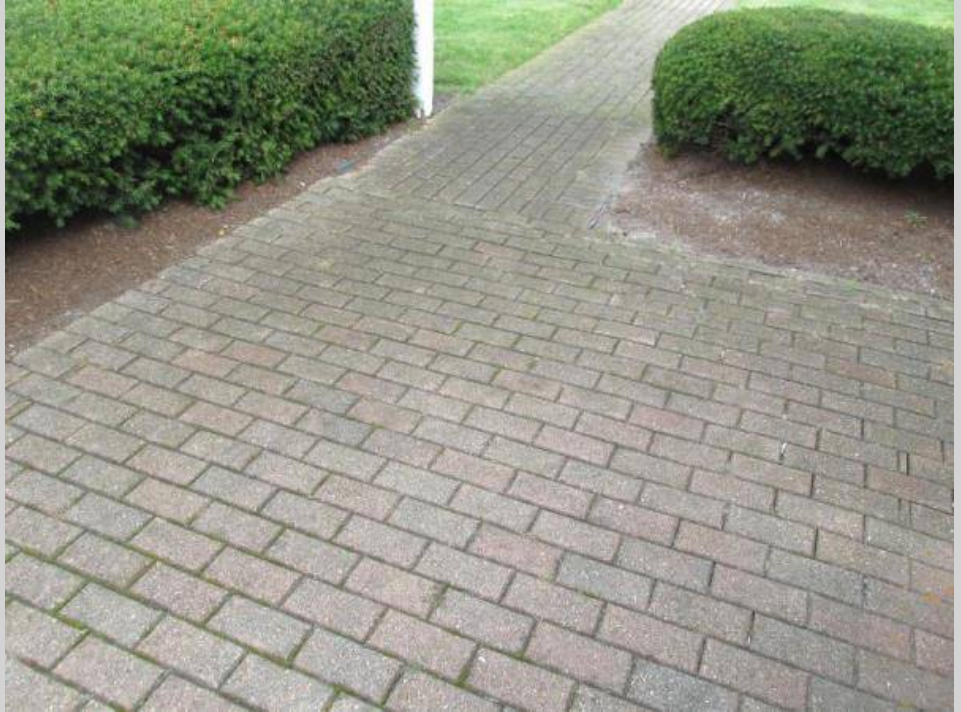
**WALK PROBLEMS:**

Observation: Inspection of the walks revealed the following problems:

\*\* Mildew growth on walkway. The moss growth is slippery when wet. Clean off the moss as a safety upgrade.

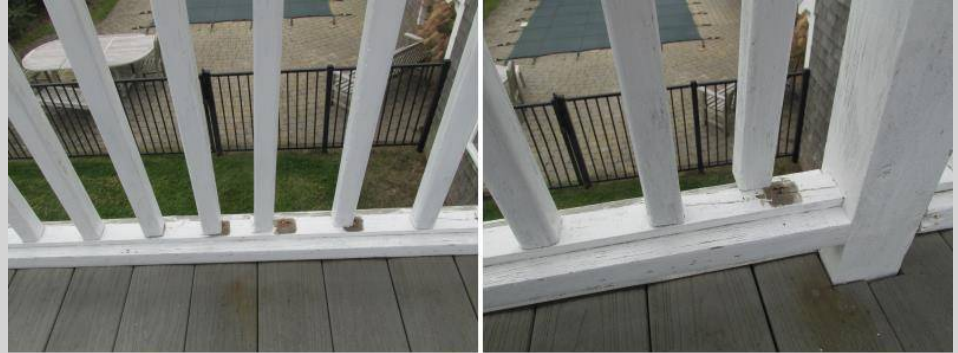
VISIBLE DECK PROBLEMS:

Observation: Inspection of the deck revealed the following defects. (LISTED BELOW)

Analysis: Deck defects are common, but should not be taken lightly, as they may present a SAFETY HAZARD. Recommendation: Have a licensed contractor evaluate the deck and make repairs or upgrades as needed. The issues found which need repairs should include, but are not limited to the following:

- The Following Railing defects were noted: **The rail balusters are loose and are not properly secured, and are a SAFETY HAZARD.**

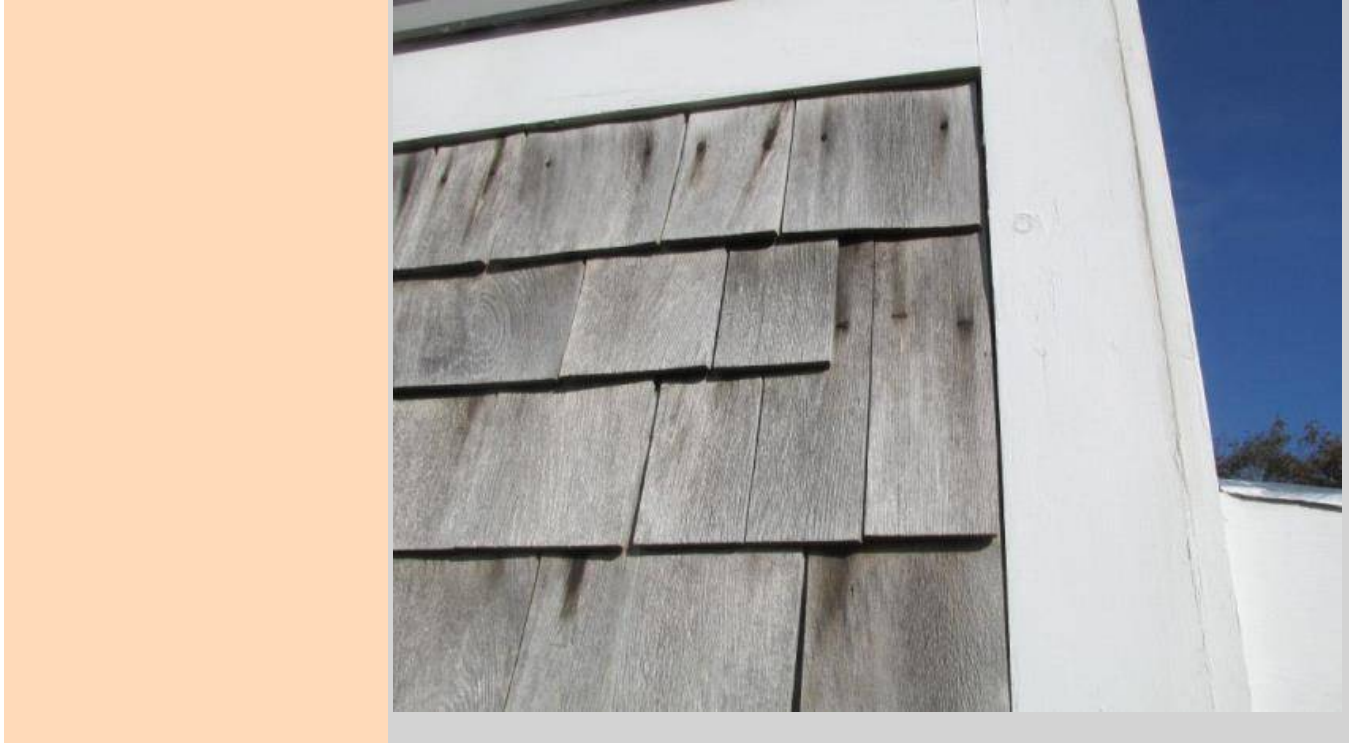
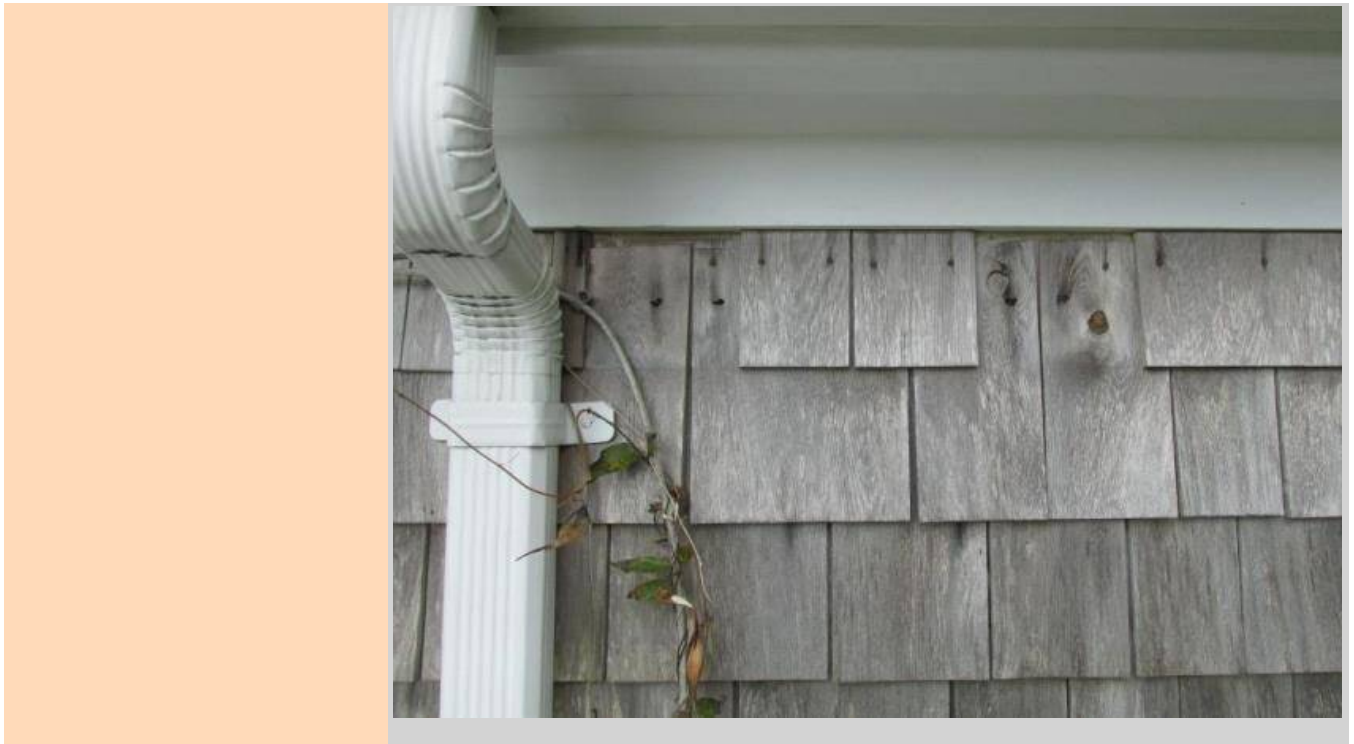
- Cracked shingles
- Missing shingles

Observation: The siding has areas of standard wear. Analysis: The issues will most likely continue and will eventually needed repair or replacement. Recommendation: No repairs needed at this time.

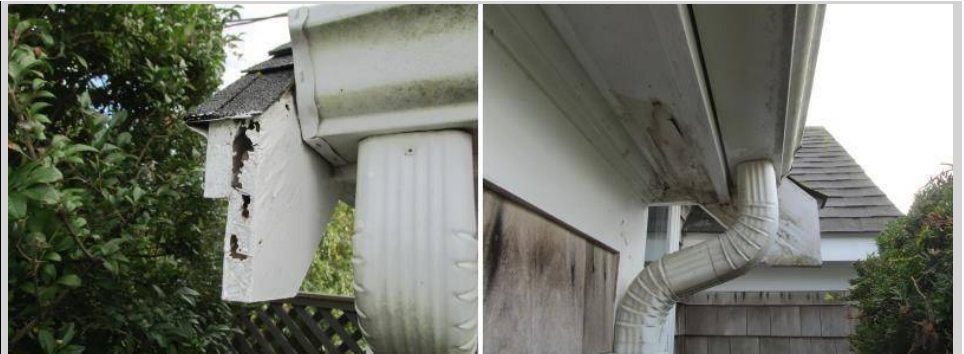
\*\* FUNCTIONAL with EXCEPTIONS:

Observation: Where accessible, areas of the wood trim components are decayed.

Analysis: Postponed finish maintenance or close ground proximity has allowed moisture to saturate the trim boards and cause decay. Note: As with all visible decay, there is a potential for concealed damage. Recommendation: Hire a carpenter to remove and replace all defective wood trim materials as needed to restore function. The areas of decay are:

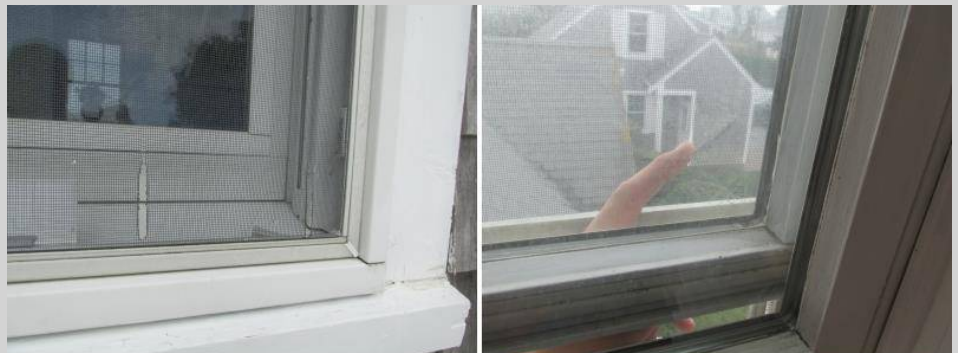
**PRIMARY WINDOW PROBLEMS:**

Observation: Inspection of a representative sample of the windows (at least one window per room) revealed the following problems:

**\*\* Damaged screens.**

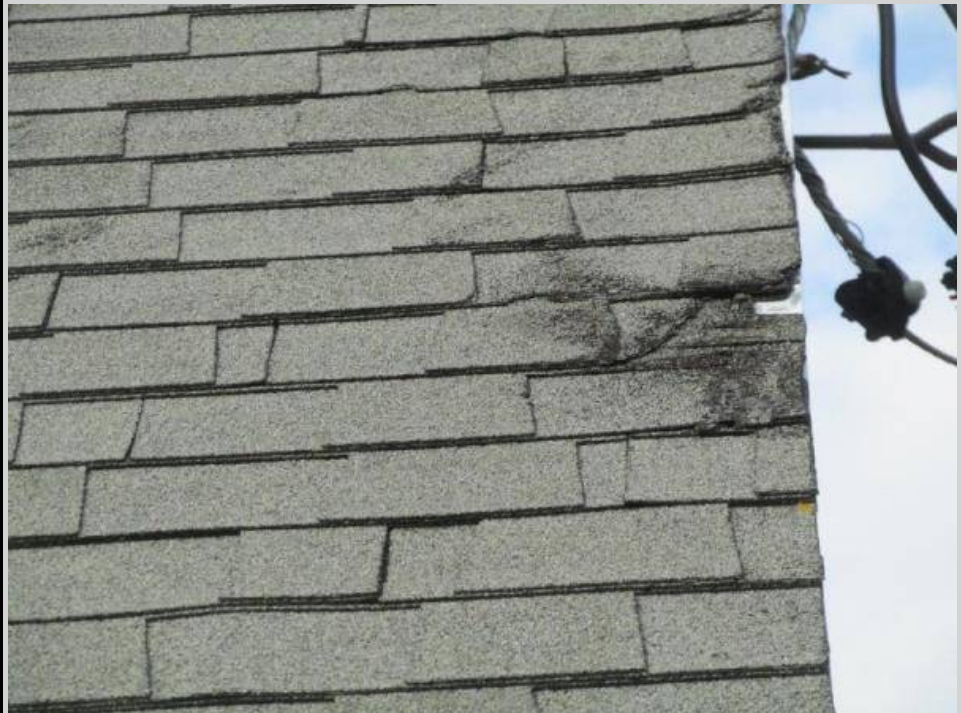
<i>VISIBLE PROBLEMS:</i>
--------------------------

Observation: By the method of access, inspection of the roof covering revealed the following defects:

- \*\* Worn granules.
- \*\* Moss, fungus or algae growth.
- \*\* A small area of damaged roof shingle noted (Minor repair needed)

Analysis: The above listed defects are part of the expected aging process for this roof covering. No repairs are required at this time. Recommendation: Monitor the roof during the remaining years of it's design life, then have it reappraised by a roofer for budgeted age replacement.

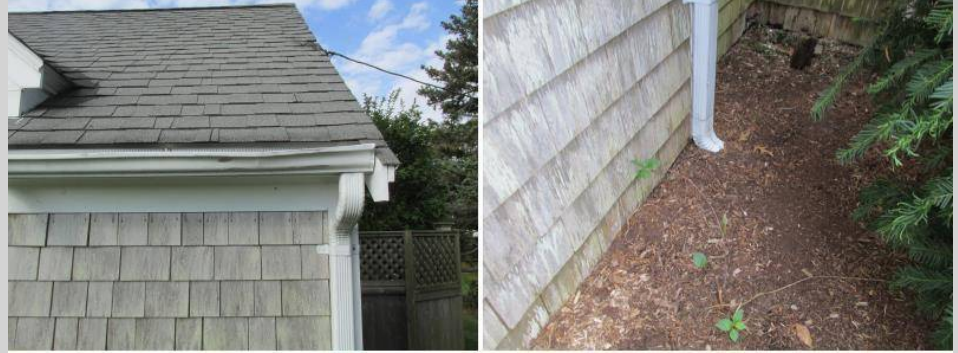
**GUTTER PROBLEMS:**

**Observation:** Inspection of the gutters revealed the following problems that require your consideration:

\*\* Dents and or other cosmetic issues noted at the gutters. These imperfections do not appear to be affecting the function. Replace as desired as a cosmetic upgrade

\* The base of the downspouts touch the ground.  
 \*\* The downspouts do not have splashblocks or extensions to help direct water far away from the foundation. Consider adding as an upgrade.

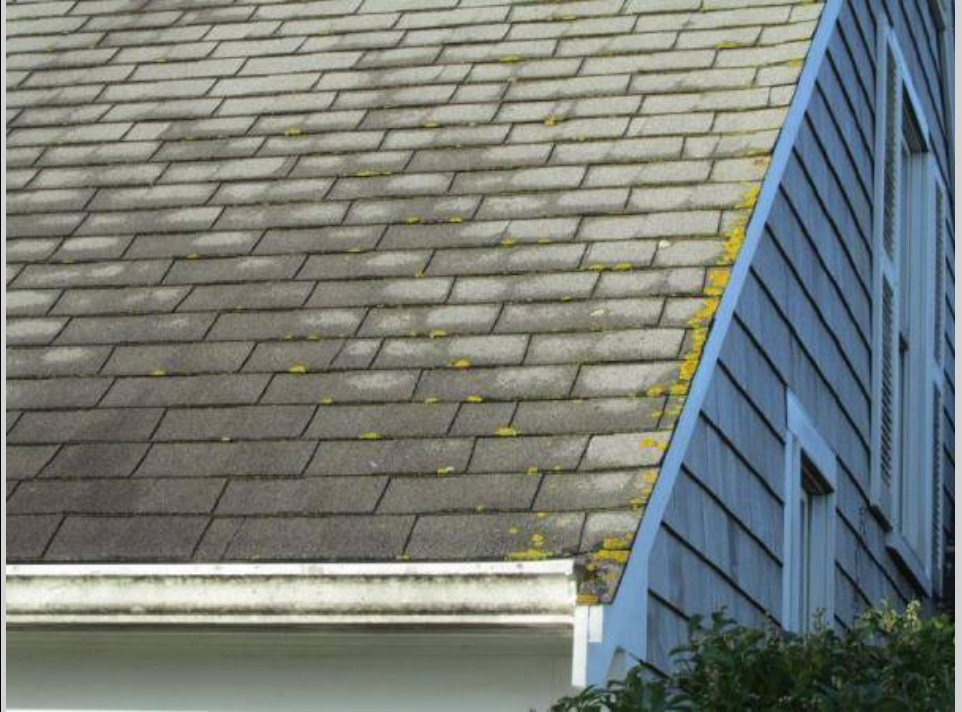
**ROOF CONDITION & PROBLEMS:**

**\*\* FUNCTIONAL condition with EXCEPTIONS noted:** Observation: Inspection of the garage roof covering revealed the following problems:

**\*\* Standard granular wear and some moss growth**  
Monitor. No repairs needed.

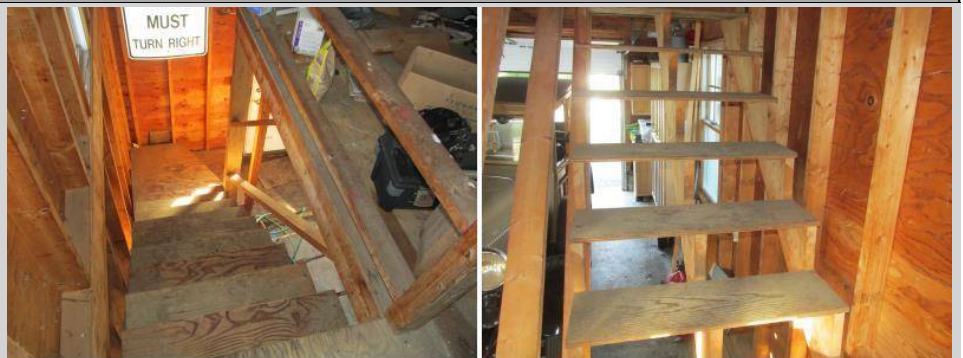
\*\* FUNCTIONAL with EXCEPTIONS noted:

The garage steps up to the attic space have NO handrail and no riser backer. Recommendation: Hire a carpenter to further evaluate and make safety upgrades to the steps.

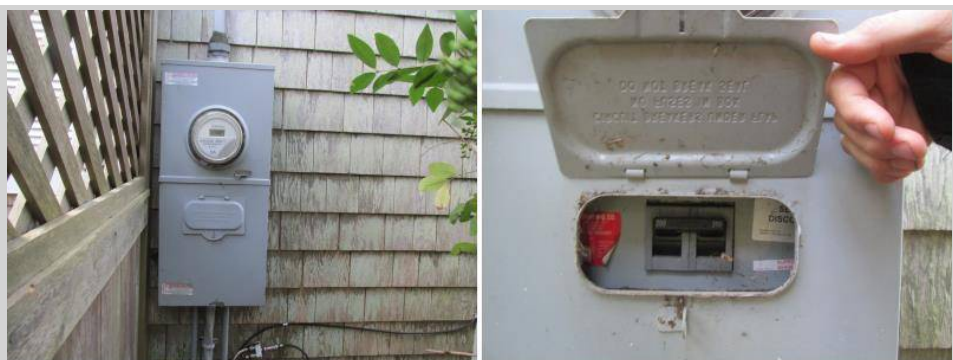
Observation: The main circuit breaker disconnect is located outside next to the electrical meter. (Note: The main disconnect was NOT tested during the home inspection so as to not disturb the owner's timers, appliances, computers and lifestyle. You should test the main disconnect when you move into the home.) Analysis: The above is an informative statement and not a problem. When the main breaker panel must be located greater than five feet from the meter, the main disconnect should be located at the meter.

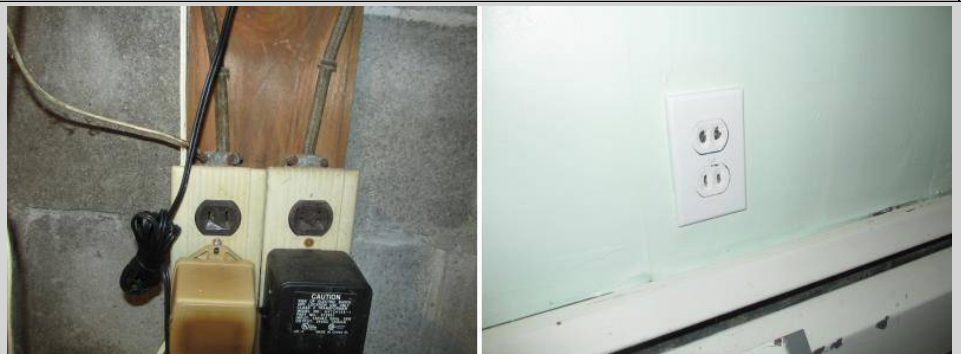
Observation: Random sampling, revealed the presence of a mixture of 3 hole receptacles and two slot receptacles (typical of homes built before 1960).  
NOTE: Some of the 3 hole receptacles were tested and found to be **UNGROUND**ED. (The third hole is there for "show" only and does not provide a grounding safety)

Analysis: **For your consideration, the Consumer Products Safety Commission has rated two slot receptacles as "POOR."** Be advised that 2 slot receptacles are no longer installed and may not be grounded. Grounding is a safety feature that provides protection in the event of a problem. While the outlets are pre-existing and no repairs are required unless remodeling is done, you should understand that newer receptacles have a third hole dedicated solely for grounding protection.

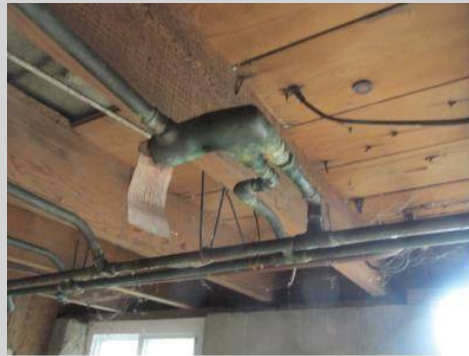
**PRESSURE PIPING PROBLEMS:**

Observation: Extensive Greenish liming and white corrosion was visible on the copper pressure pipes, fittings or valves. Analysis: Such corrosion is typically caused by the acidic nature of the water supply but also indicates that repairs may be needed in the future to prevent leakage. Recommendation: Ask a plumber to reappraise all of the pressure piping, valves and fittings; and to provide estimates for repair or replacement to prevent leakage.

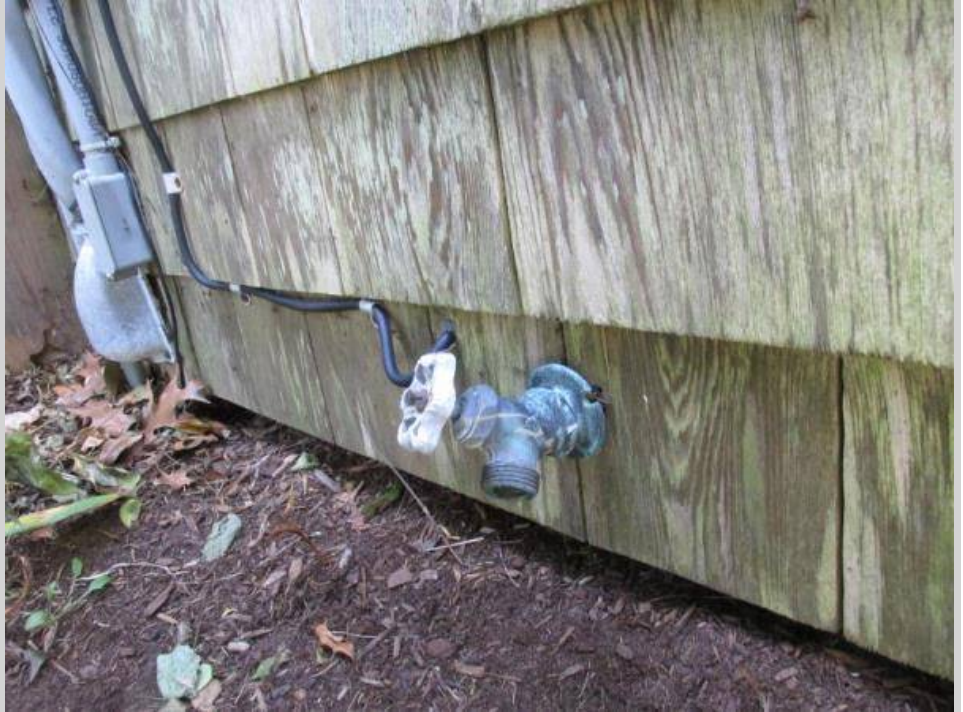
Observation: At time of inspection, the outside faucets and water pipes were drained and shut-down. Analysis: Home Inspectors are prohibited from operating secondary shut offs as they may be shut off due to a leakage issue inside the home. True operational condition is undetermined. Further investigation is needed.

Recommendation: Each outside faucet should be tested when the owner gets them up and running.

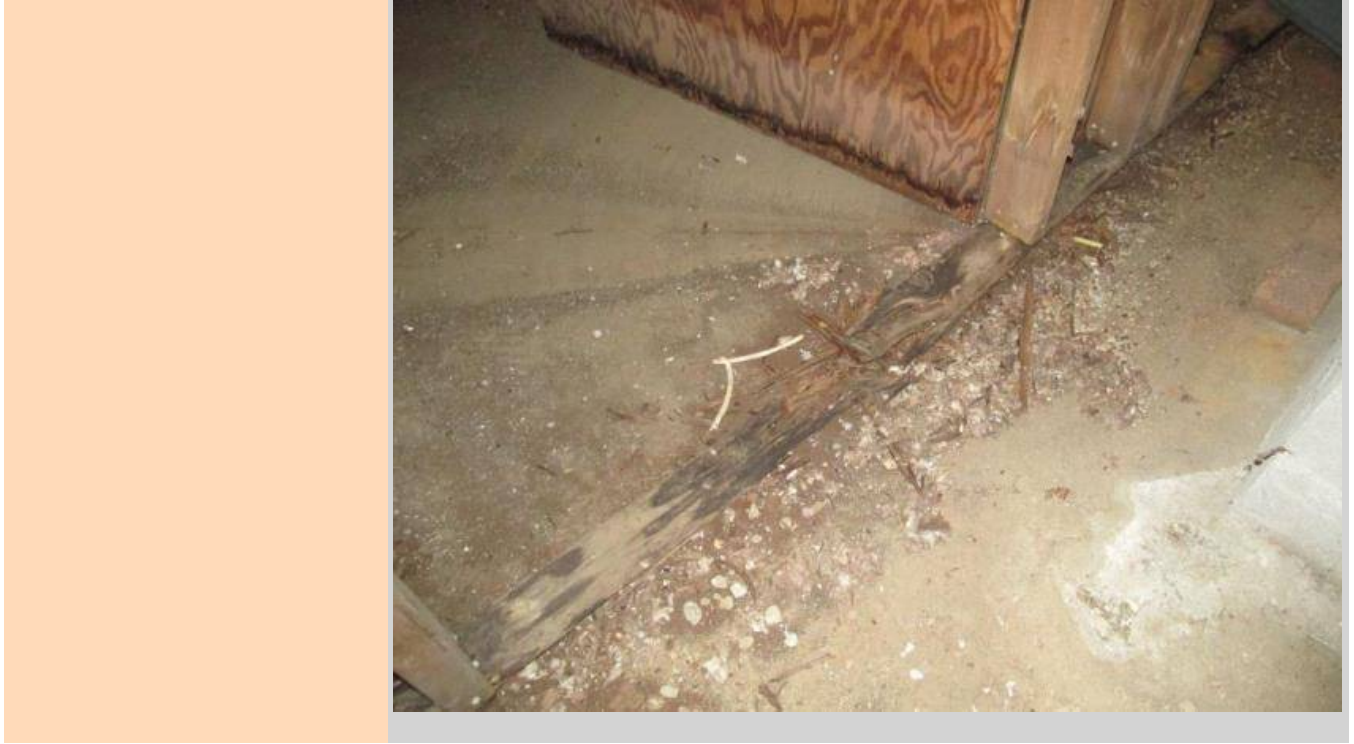
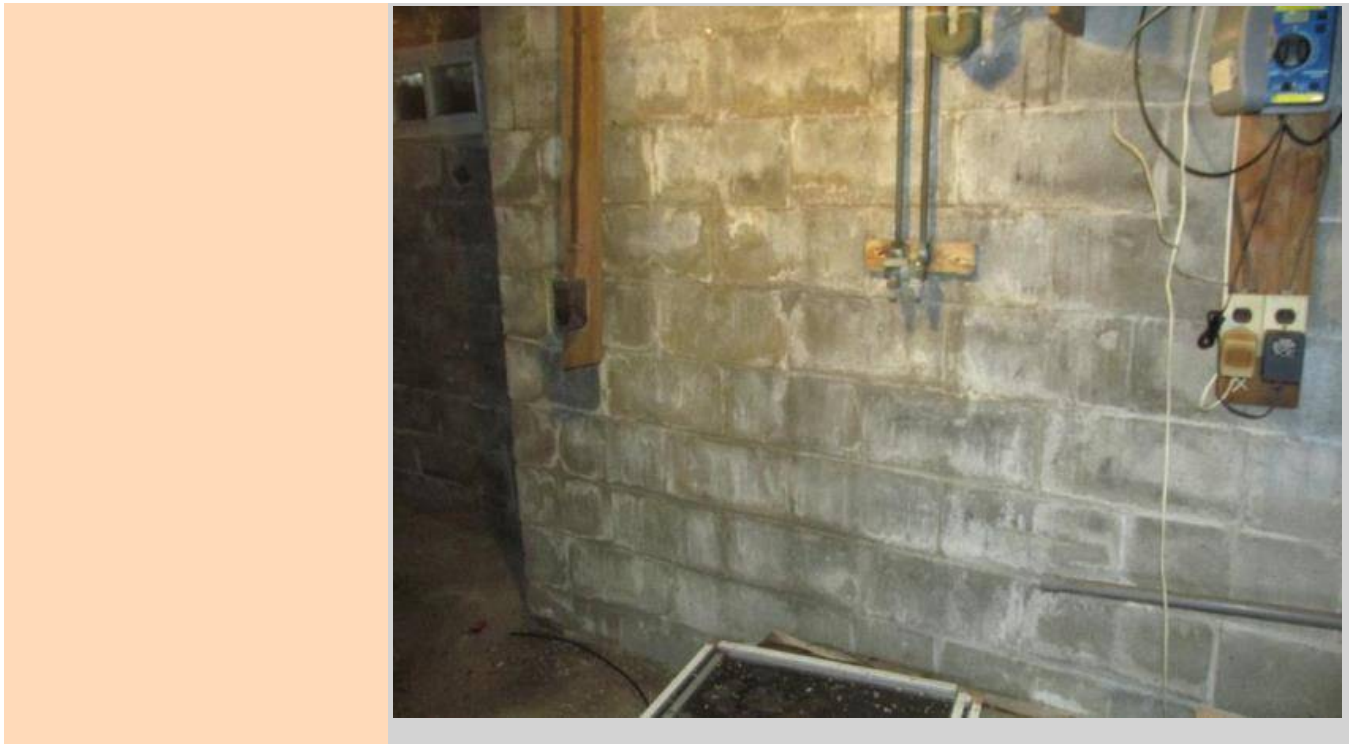
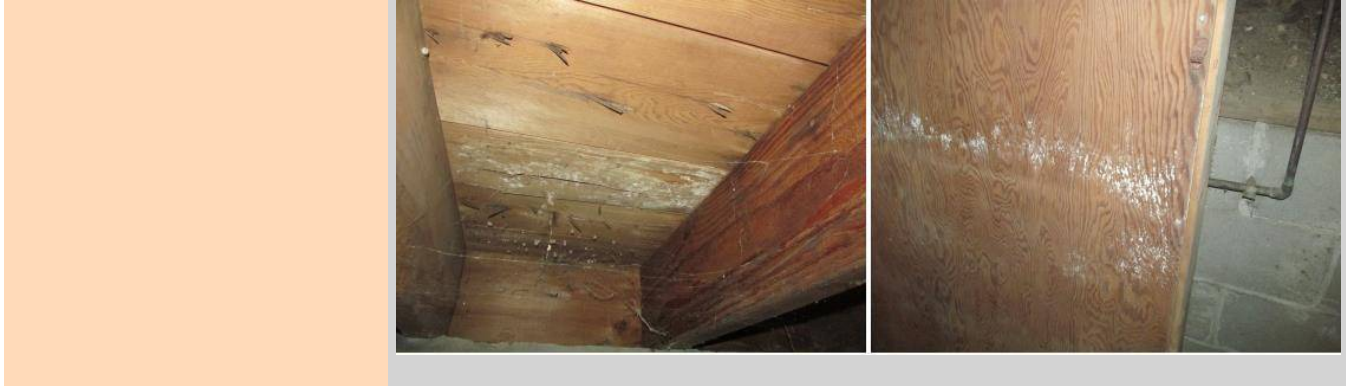
-----  
Observation: Inspection of the basement foundation walls revealed whitish colored powdery stains in some areas. Analysis: The white stains are called **efflorescence** stains. The stains are mineral salts that remain after moisture passes through masonry and then evaporates. At some point in the past, surface water and / or roof drainage has soaked into the ground near the foundation, exerting hydrostatic water pressure against the foundation with sufficient force to cause the efflorescence. The stains do not indicate flooding but do indicate a need to perform better exterior drainage control.

Recommendation: Identify and correct (if needed) any low grade areas near the foundation so that surface water is directed away from the home. Be sure also to keep gutters cleaned out and downspouts directing water away from the home. Monitor the stains.

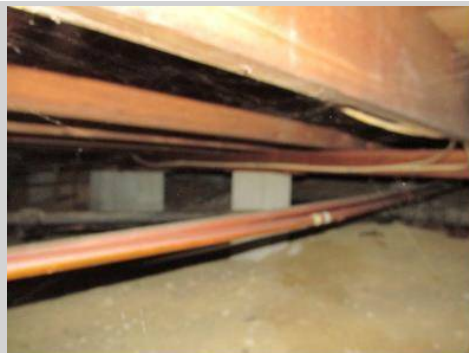
CRAWL SPACE PROBLEMS:

Observation: The crawl space has no vapor barrier on the soil.  
Analysis: A vapor barrier is required to control moisture migration. Humidity is constantly rising from the soil. Such humidity trapped within a crawl space may cause moisture problems such as wood rot, mold, mildew and pest activity.  
Recommendation: Add a vapor barrier of 4-6 mil plastic on the soil of the entire crawl space. ALSO, the crawl space area should have a means of cross ventilation OR a mechanical system that dehumidifys or exchanges the air in the crawl space.

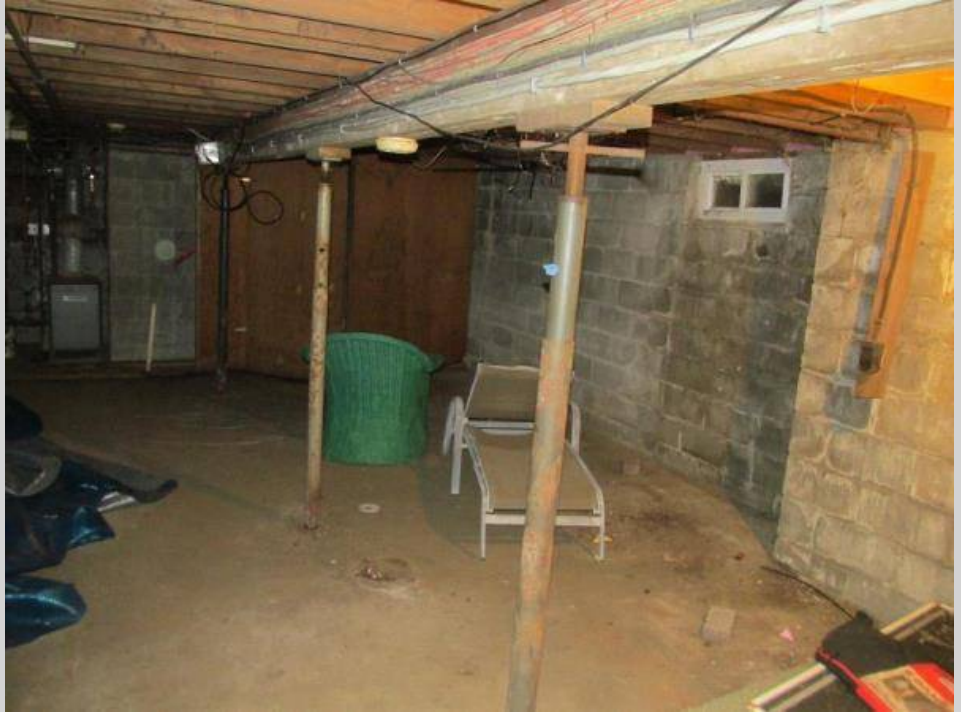
**COLUMN PROBLEMS:**

**Observation:** Inspection of the accessible columns that support the floor frame revealed the following problems:

**Observation:** Metal telescoping columns in use as primary columns. **Analysis:** Telescoping columns are intended by the manufacturer to be used for repair work only. **Recommendation:** Permanent steel columns are suggested as a structural upgrade.

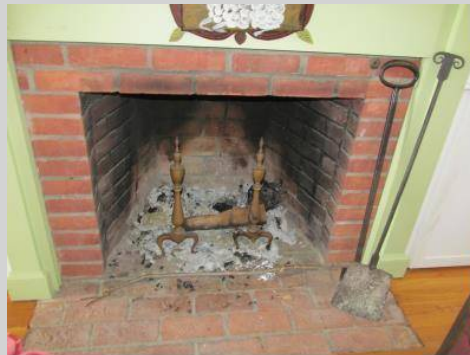
FIREPLACE PROBLEMS:

Observation: The fireplace damper handle is missing. Analysis: The damper will not open easily Recommendation: Do not use until a proper handle is added.

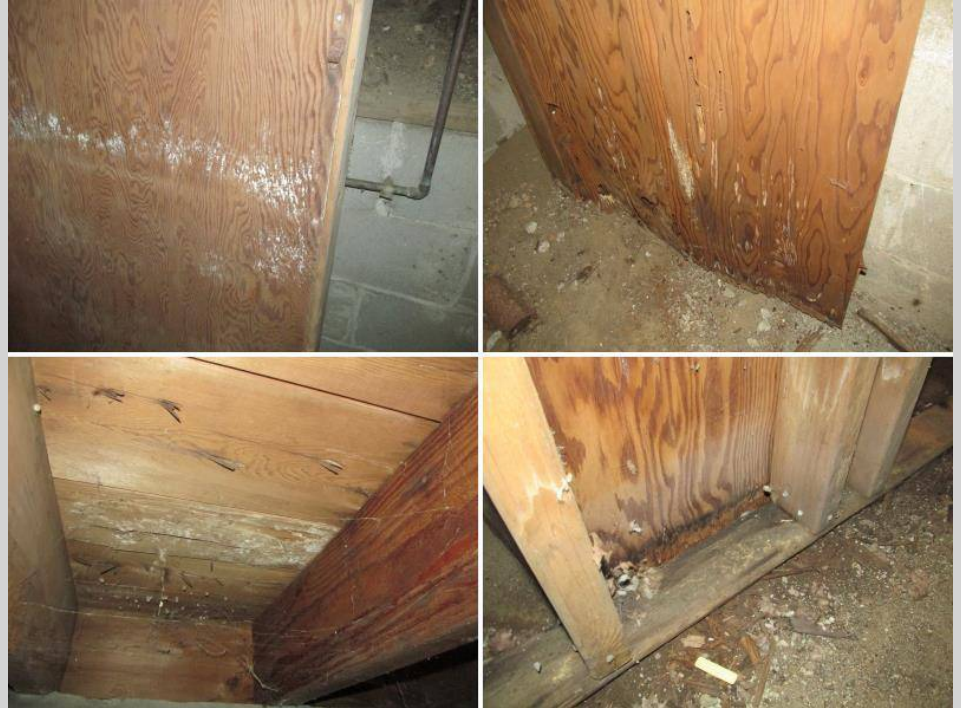
Signs of mold or other suspicious looking growth

Observation: Suspected mold was visible.

Analysis: Be advised that many homes have excessive moisture and poor ventilation issues which can lead to mold, especially a home close to large bodies of water and one that gets closed up for long periods of time.

Recommendation: Hire a field professional to further investigate and remediate the suspected mold.
