Meetinghouse Farm Barn

Town of Barnstable
ADA Transition Plan

September 2021

**Town of Barnstable
Meetinghouse Farm Barn**

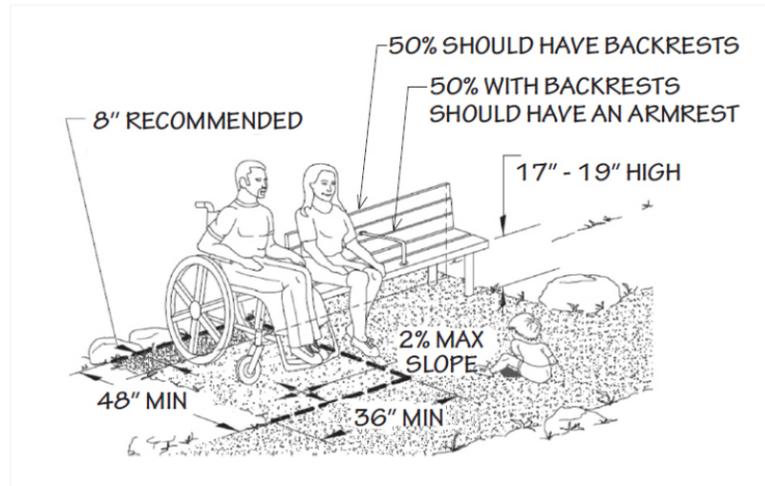
Figure 1: Illustrating recommended clear floor space at a bench.

- Lack of an accessible route to the bench by the entry to the path through the Rhododendron Forest.
- The threshold at the egress door from the second floor is higher than the maximum height allowed.
- The staircase to the second-floor entry and egress door has handrails on just one side. The one provided handrail is also mounted higher than the maximum height allowed and has a noncompliant cross section.

- Recommend providing a 36" by 48" firm, stable and slip-resistant area alongside the bench by the entry to the Rhododendron Forrest so that a person using a wheelchair or other mobility device is able to sit alongside someone seated on the bench with her/his shoulders aligned. See the diagram below for best practice recommendations for benches:

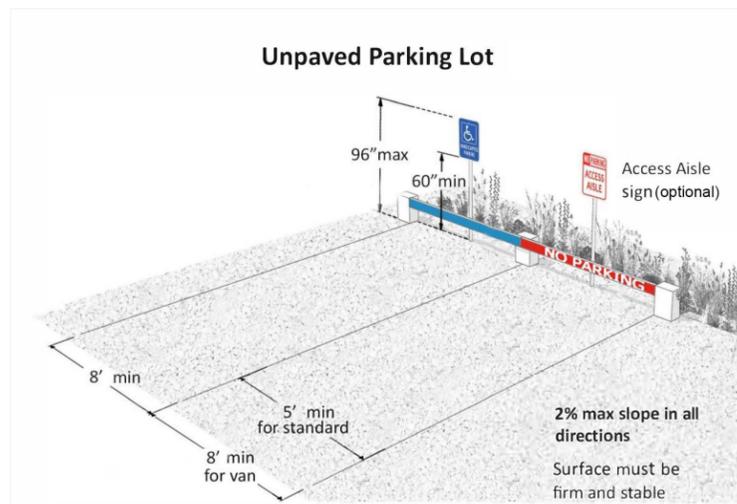
Figure 2: Illustration of one way to mark accessible parking spaces at unpaved parking areas.

Accessibility issues include lack of a van accessible parking space. (See Figure 2 for an example of an unpaved accessible parking space.)
