# UNITARIAN CHURCH OF BARNSTABLE

*Exterior Restoration Project Update - Barnstable CPC*

**BARNSTABLE UNITARIAN CHURCH**  
Barnstable, Massachusetts  
February 2021

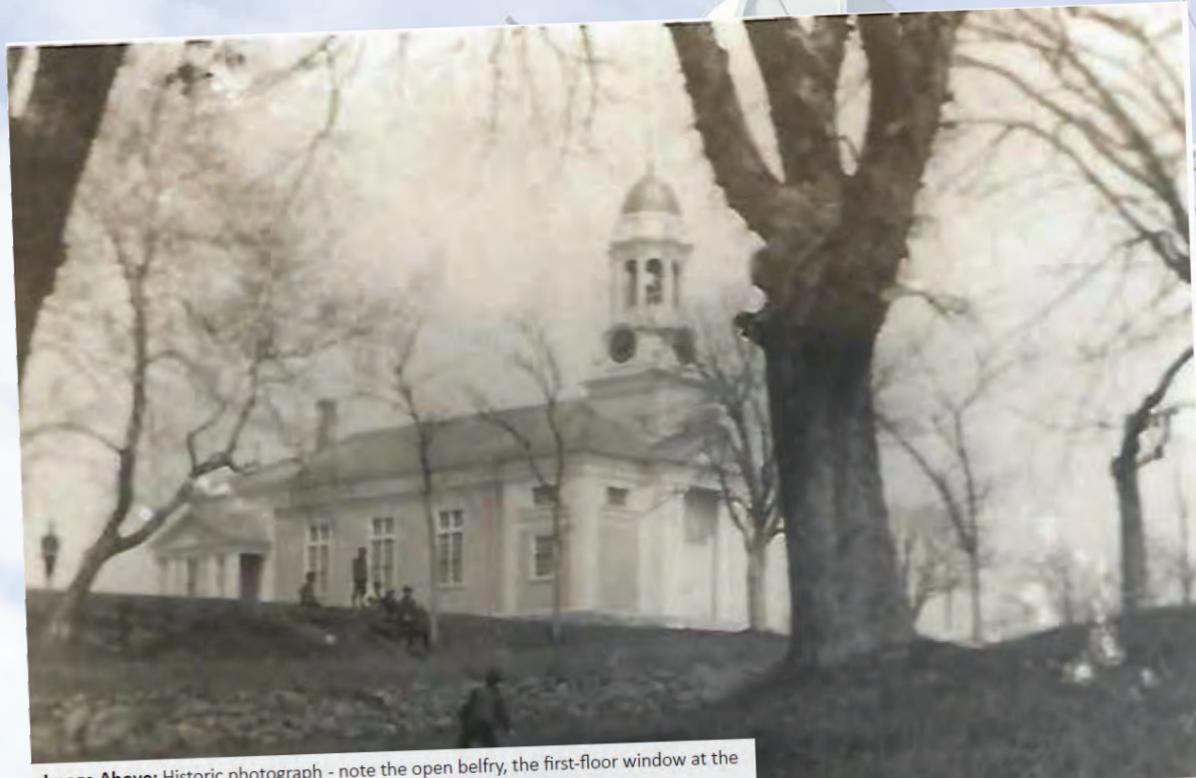
Image Above: Historic photograph - note the open belfry, the first-floor window at the front of the south elevation, and the chimney on the western roof slope.

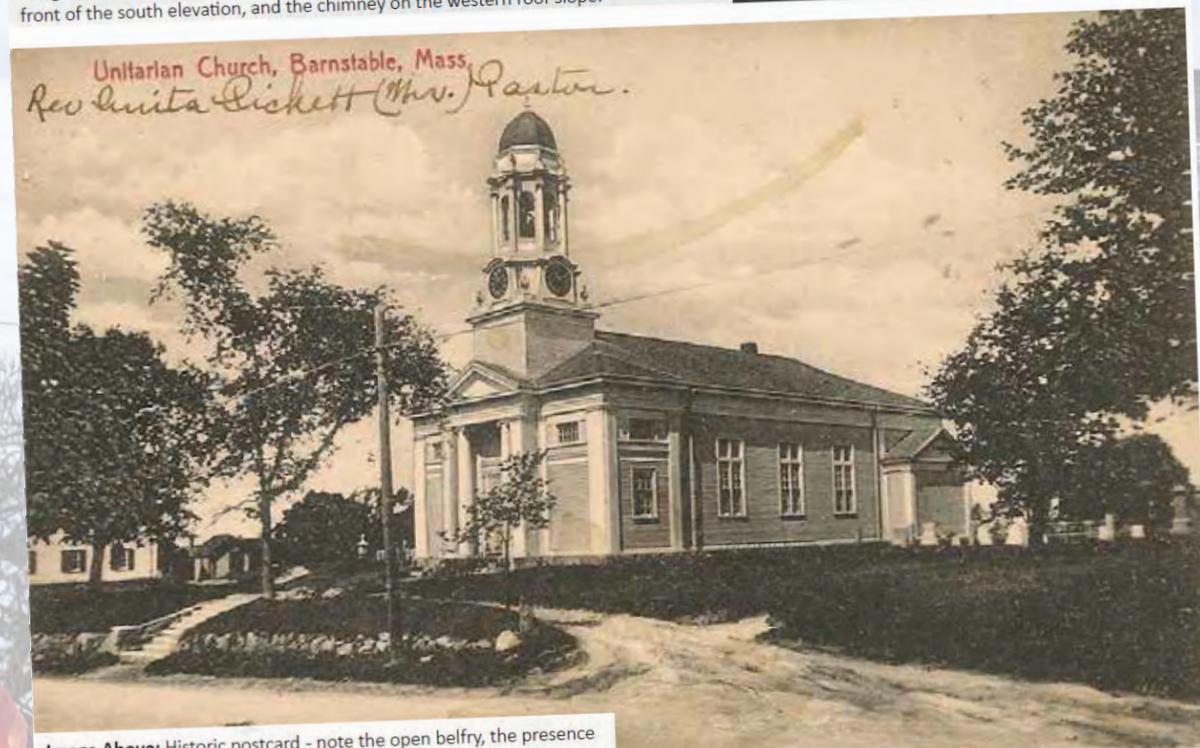
Image Above: Historic postcard - note the open belfry, the presence of cupola urns, and the chimney seen just over the ridge.

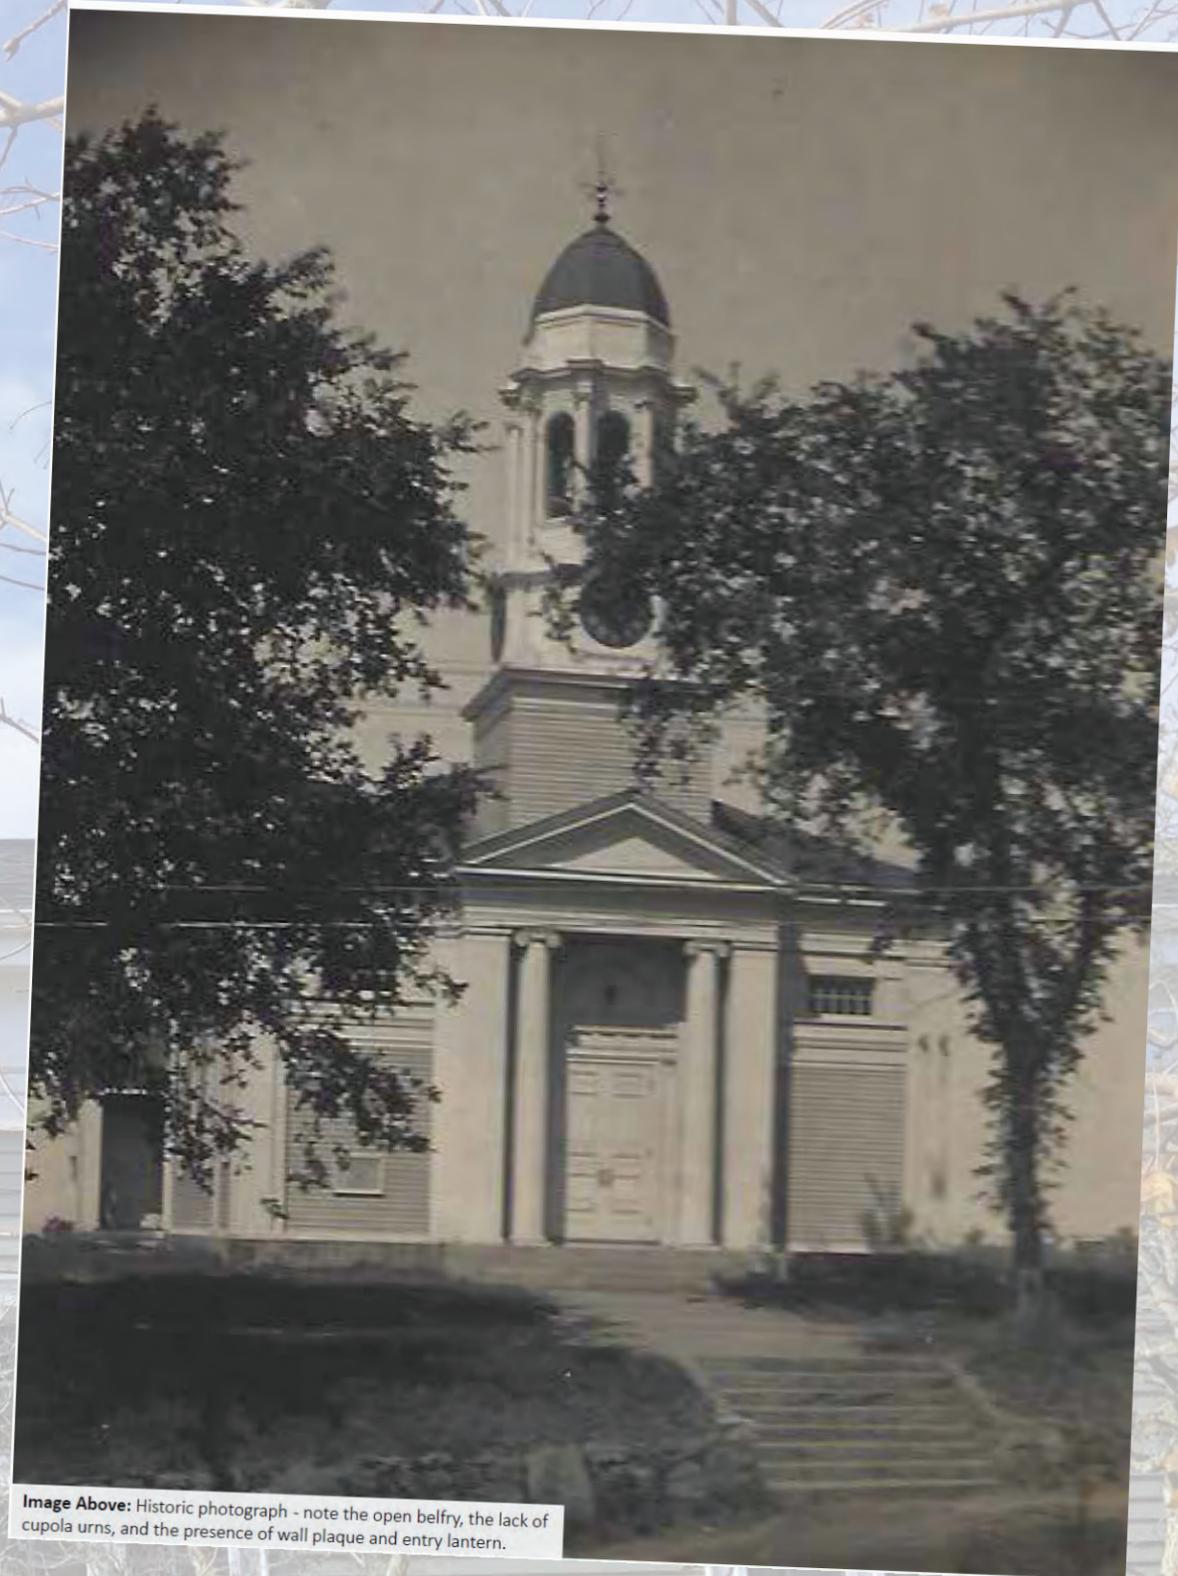
Image Above: Historic photograph - note the open belfry, the lack of cupola urns, and the presence of wall plaque and entry lantern.

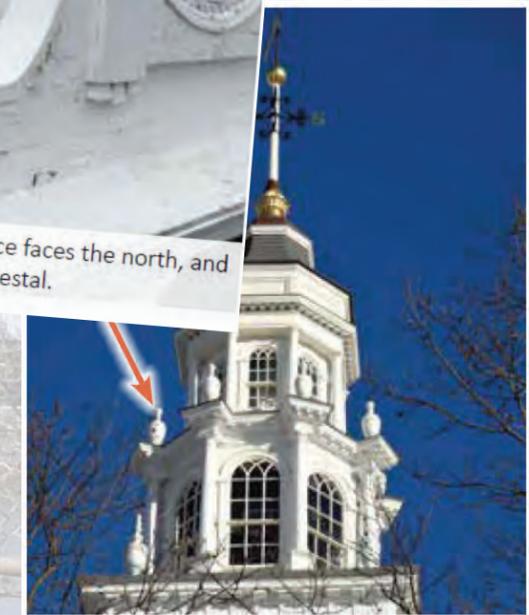
**Image 45:** Example of recently restored cupola at First Parish Dorchester, showing fabricated decorative urns.
