Wequaquet Lake Beach and **Bathhouse**

ADA Transition Plan

September 2021

Institute for Human Centered Design

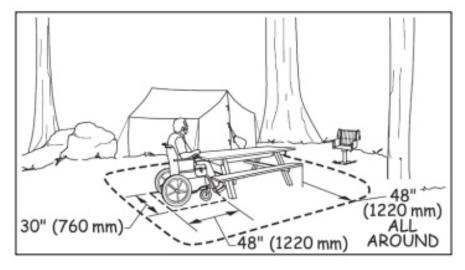
• When an accessible picnic table is provided on an accessible route, IHCD recommends providing a stable, firm and slip-resistant surface for 48" clear on all sides of the picnic table. See fig. below.
