West Barnstable Community Building

Town of Barnstable ADA Transition Plan

July 2021

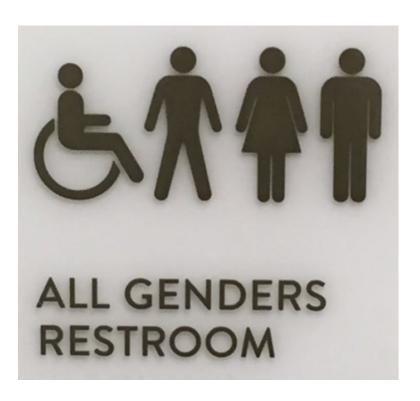
The following is an example of an "All Genders" toilet room sign for an accessible single-user toilet room. A compliant sign must also include raised characters and braille.

Note: Presently there is an accessible single-user women's toilet room on the first floor. As all the programing takes place on the first floor, the sign at that toilet room should be changed to indicate that it is an All Genders toilet room. This will eliminate the need for visitors who cannot descend the interior stairs and who do not use a women's toilet room to have to exit and circle the building to access the basement-level men's toilet room.
